Village of Irvington Town Hall Exterior Conditions Analysis
85 Main Street
Irvington, NY 10533

Re: **Village of Irvington Town Hall Exterior Conditions Analysis**

Exterior Conditions Analysis Irvington Town Hall

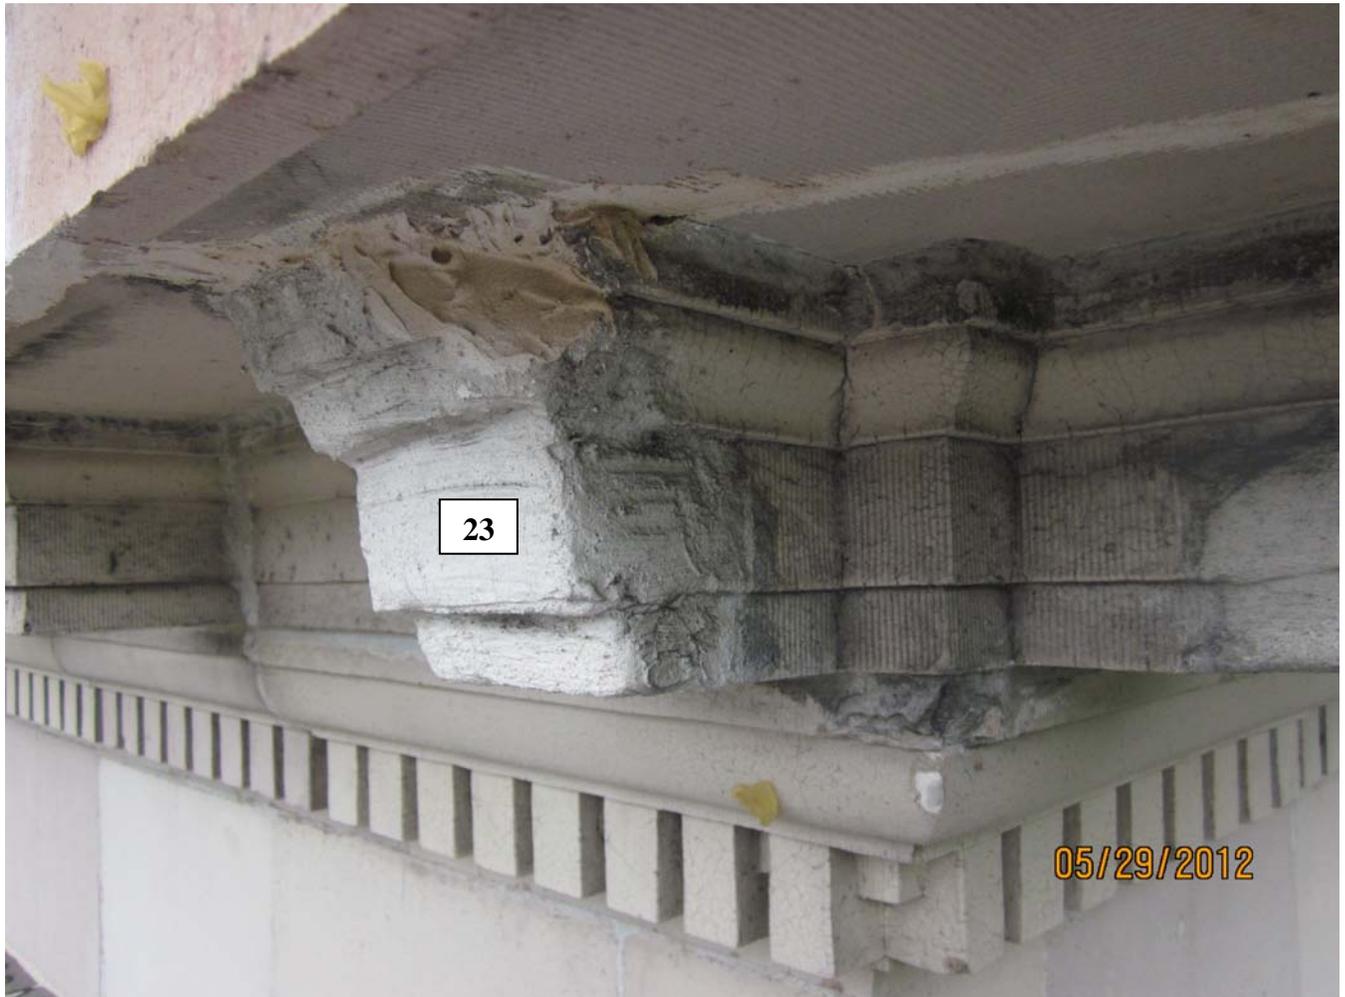
Photo 3

23. PREVIOUSLY PATCHED AND PINNED AREA IN POOR CONDITION.

Recommend: Remove and reconstruct entire portion or Terra Cotta corner using Custom System 45 and Elastowall 351 or similar.

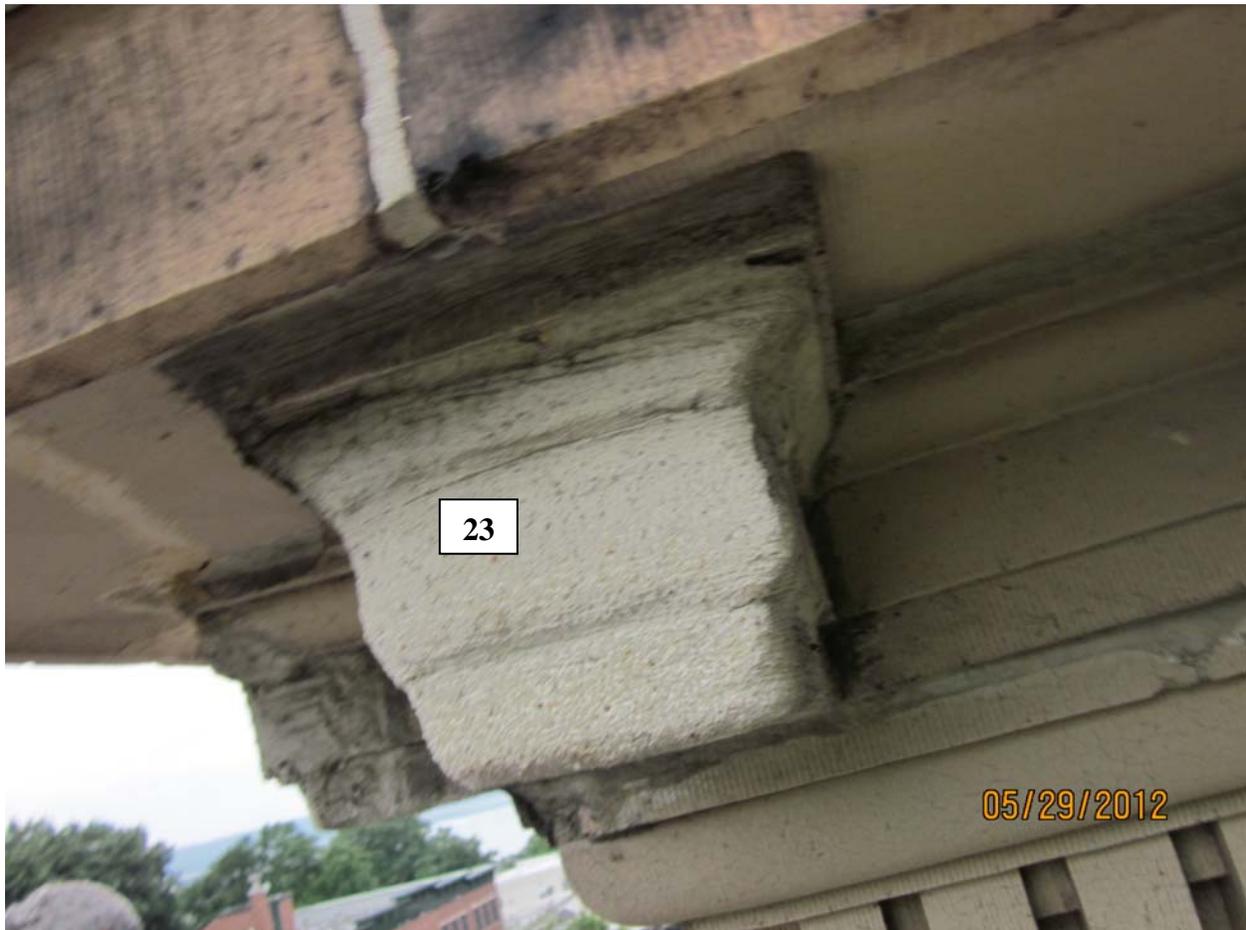
Photo 4

23. PREVIOUSLY PATCHED AND PINNED AREA IN POOR CONDITION.

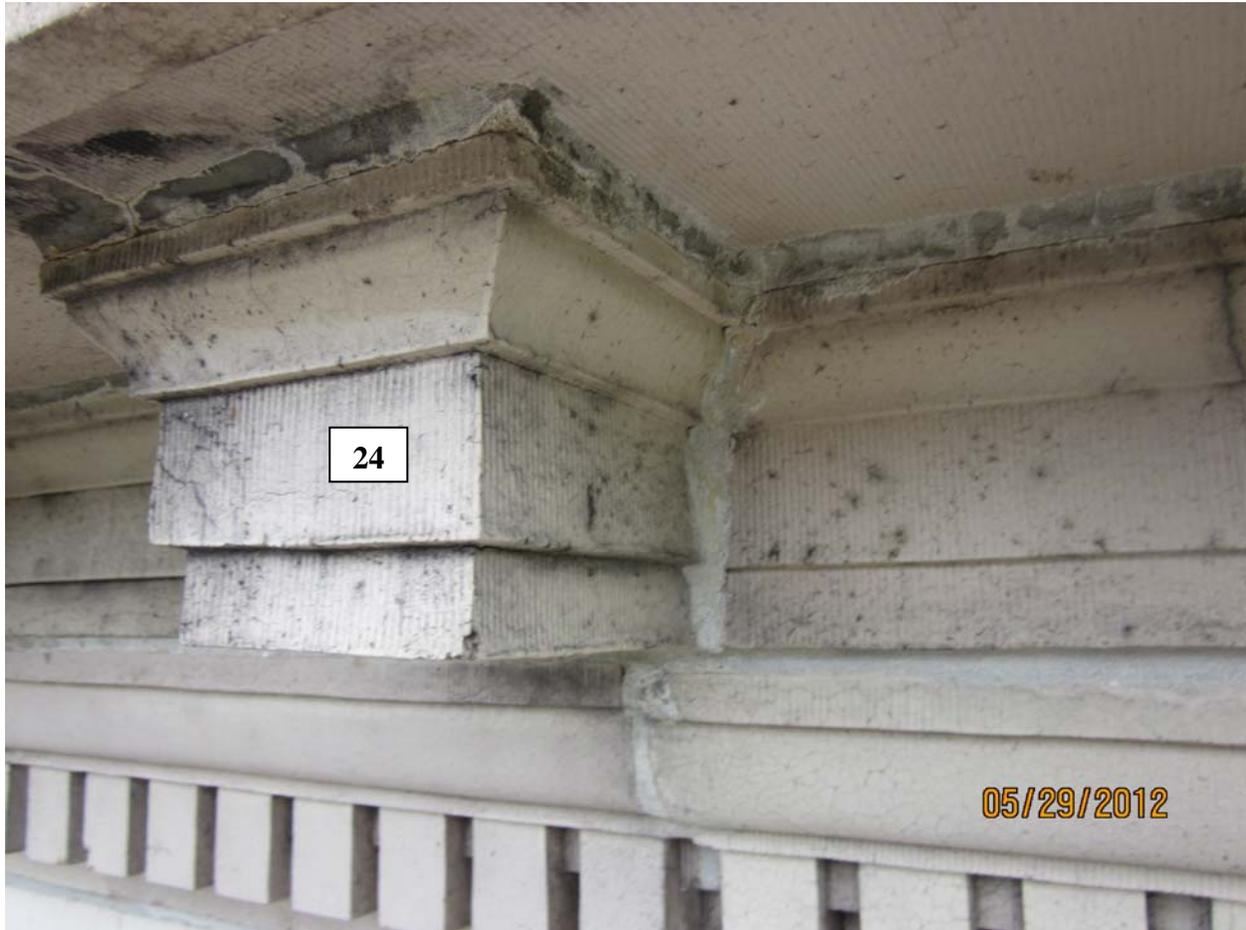
Photo 5

24. LOOSE MASONRY UNIT

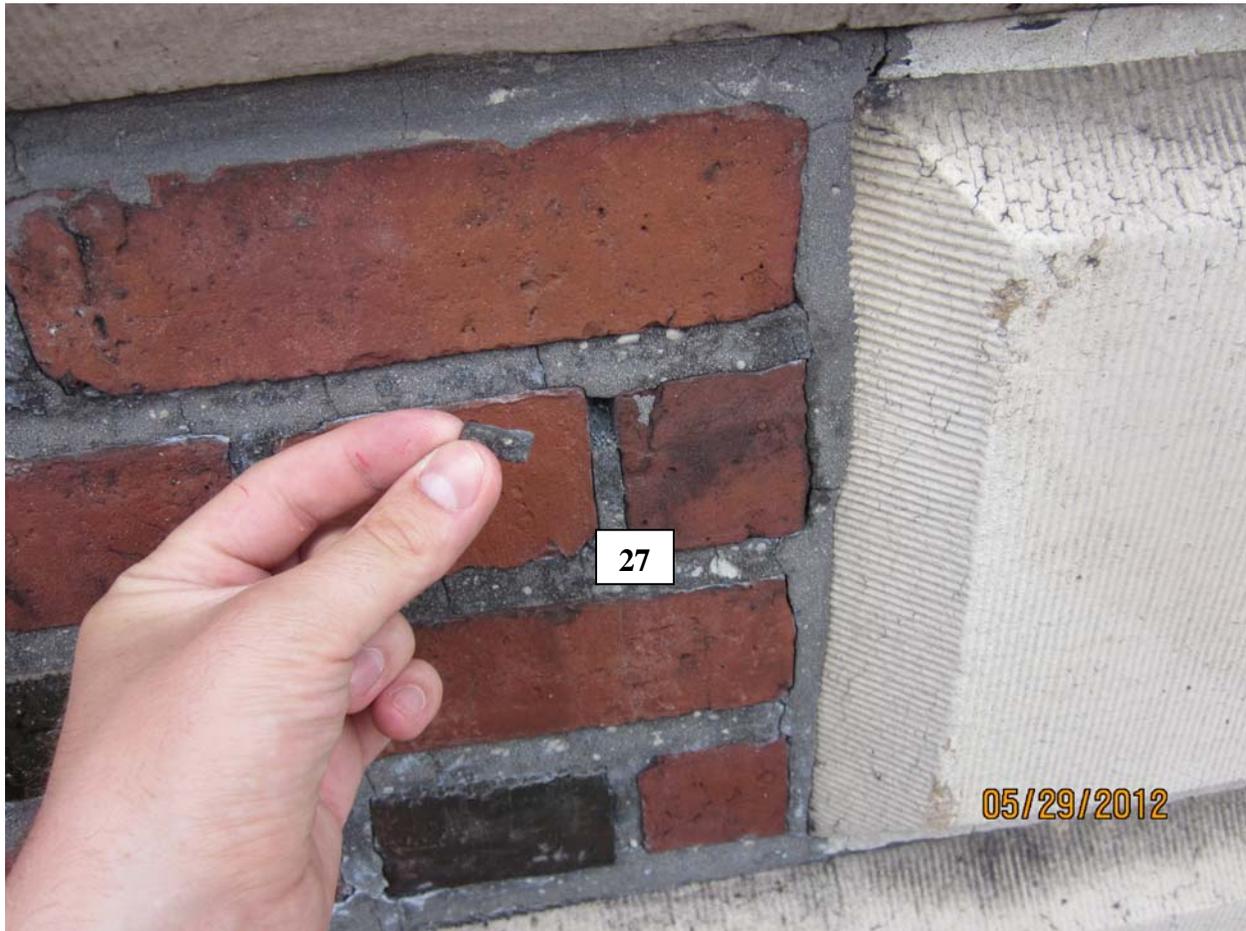
Photo 6

27. PATCHED AREA THAT SOUNDS AND FEELS LOOSE

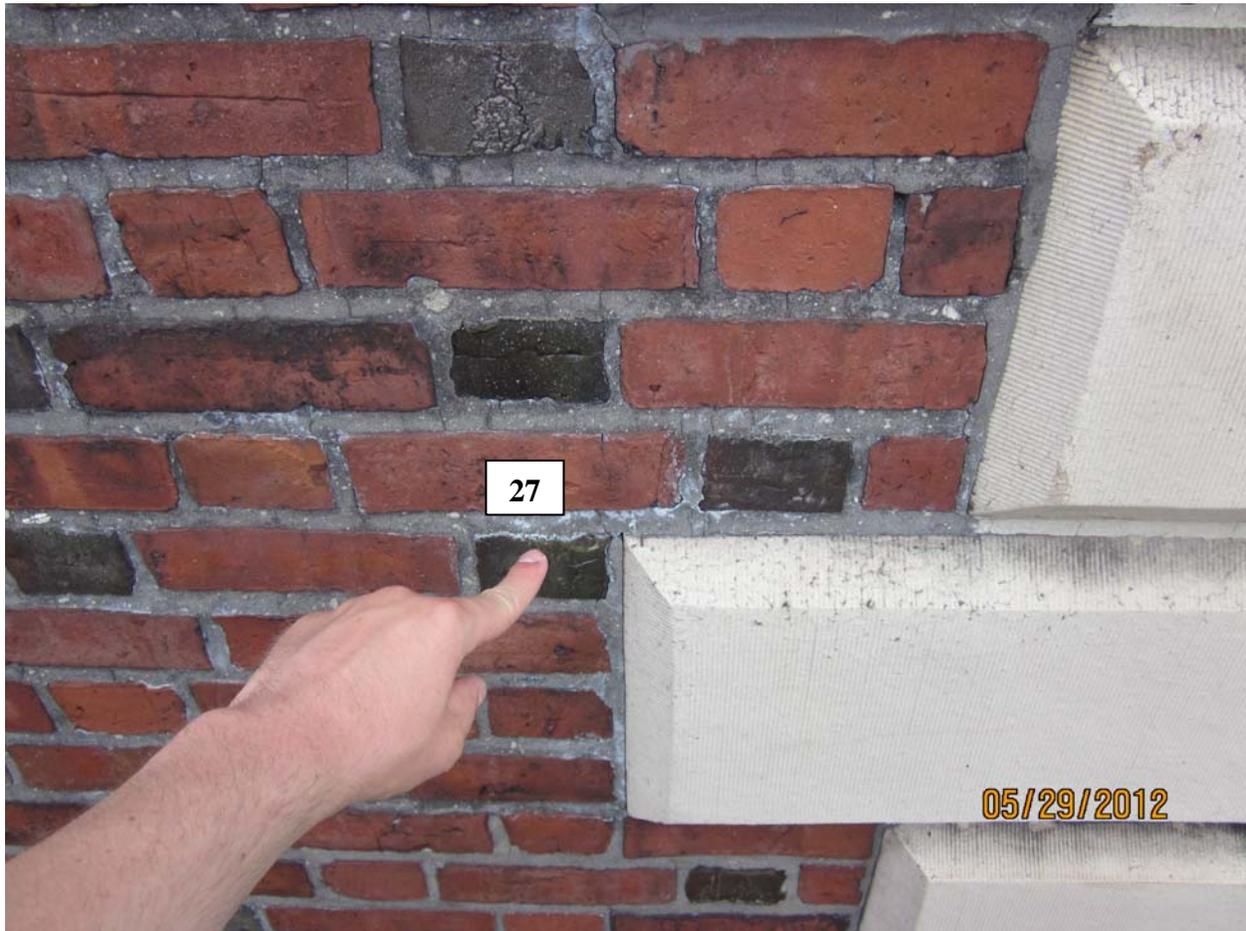
Photo 7

27. PATCHED AREA THAT SOUNDS AND FEELS LOOSE

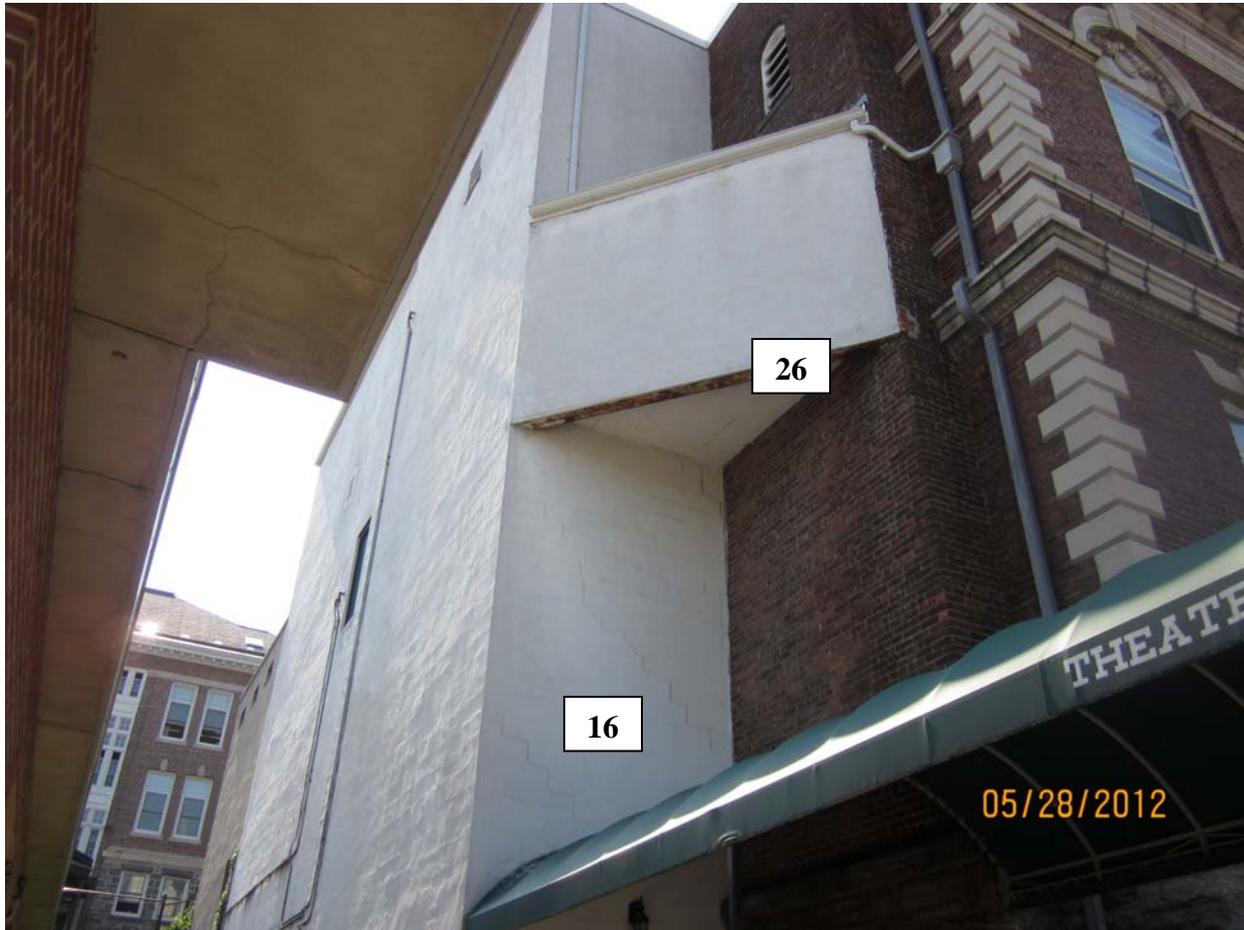
Refer to Section B Drawings Elevation Note 16; “Stepped cracks that run through the existing CMU joints”, (Reference Photo 8 & 65.) Settlement cracks in CMU walls are commonly known as “stair step cracks” or a crack that steps up as it moves horizontally across the wall. This is caused by unstable soil conditions under the buildings footings. These were primarily found along the North rear elevation. Building maintenance staff should be aware and expect additional movement if the settlement has not stopped.

- 16. STEPPED CRACKS THAT RUN THROUGH THE EXISTING MASONRY COATING IN THE CMU
- 26. STEEL BEAM IS EXPOSED AND DETERIORATING

We recommend that the masonry surrounding the steel beam should be pinned up and areas below removed. All steel should be scraped, primed, painted and waterproofed. New masonry should be installed and a waterproof coating applied at CMU surfaces. Where existing, sealant at the control joints between substrates should be removed and resealed at all control joint locations.

Recommend patching and re-pointing of existing cracks to keep water, bugs etc from entering the building. After proper re-pointing of the stepped cracks we recommend applying a new weatherproof coating at all CMU surfaces.

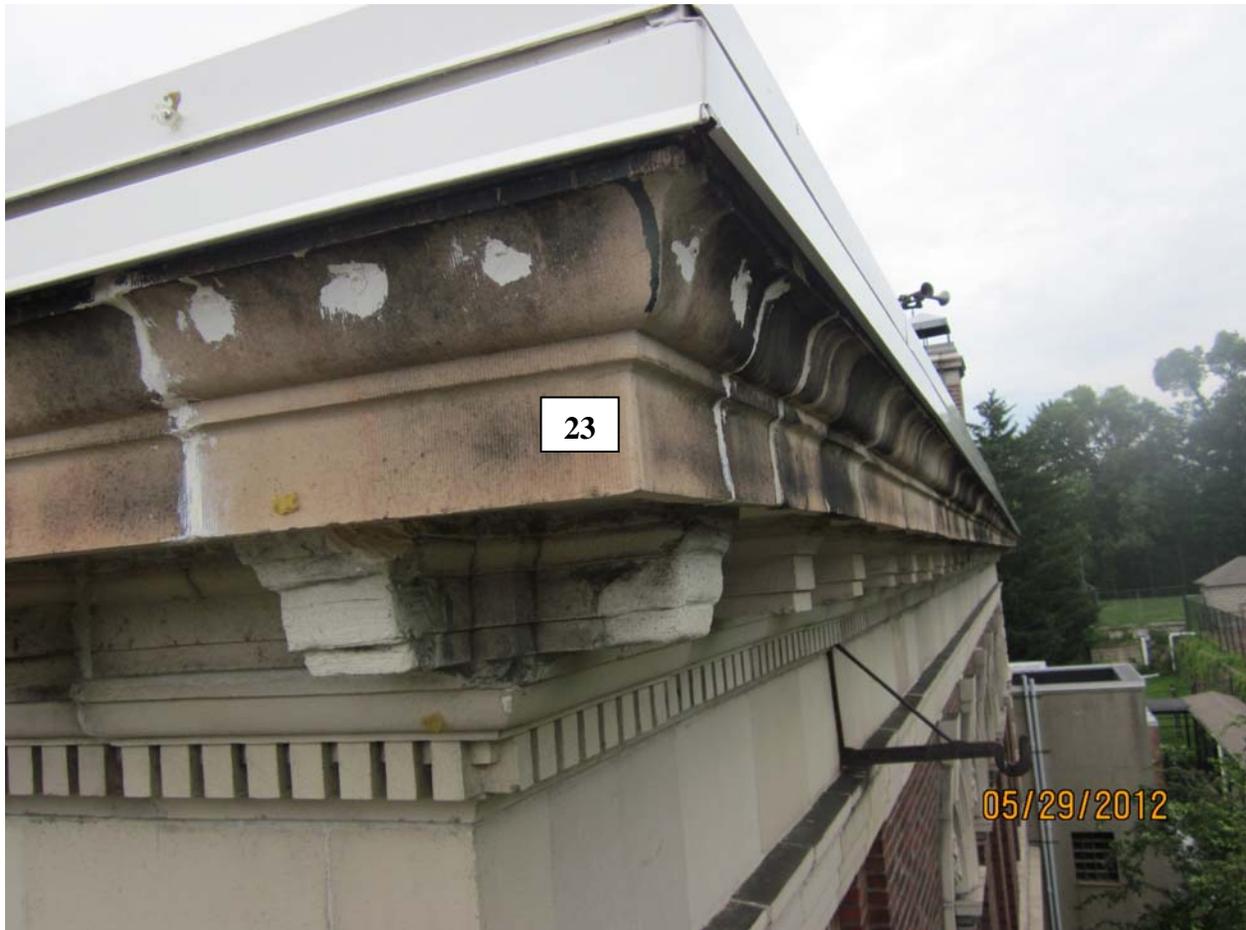
Photo 10

23. PREVIOUSLY PATCHED AND PINNED AREA. IN POOR CONDITION

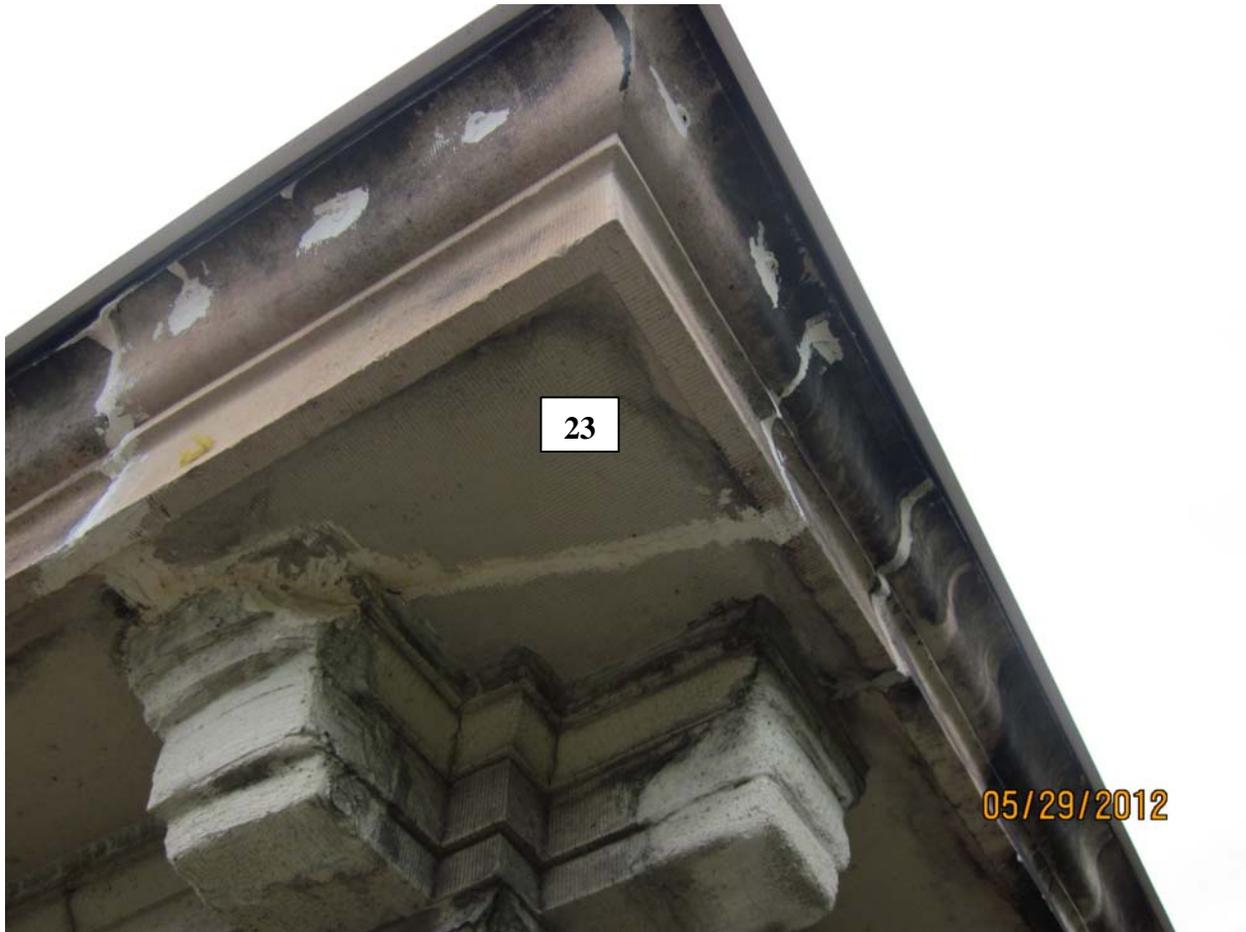
Photo 11

23. PREVIOUSLY PATCHED AND PINNED AREA. IN POOR CONDITION

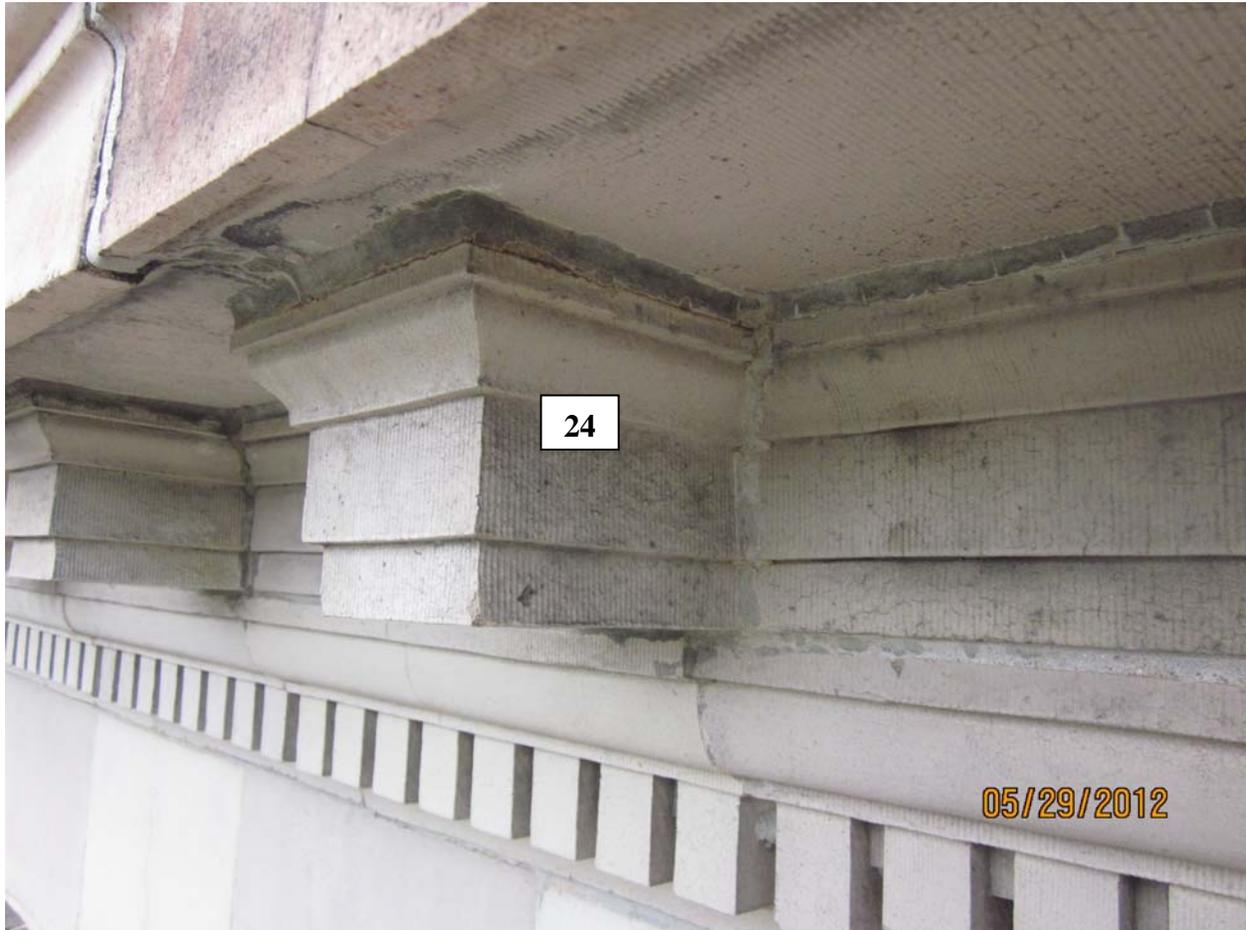
Photo 12

24. LOOSE MASONRY UNIT

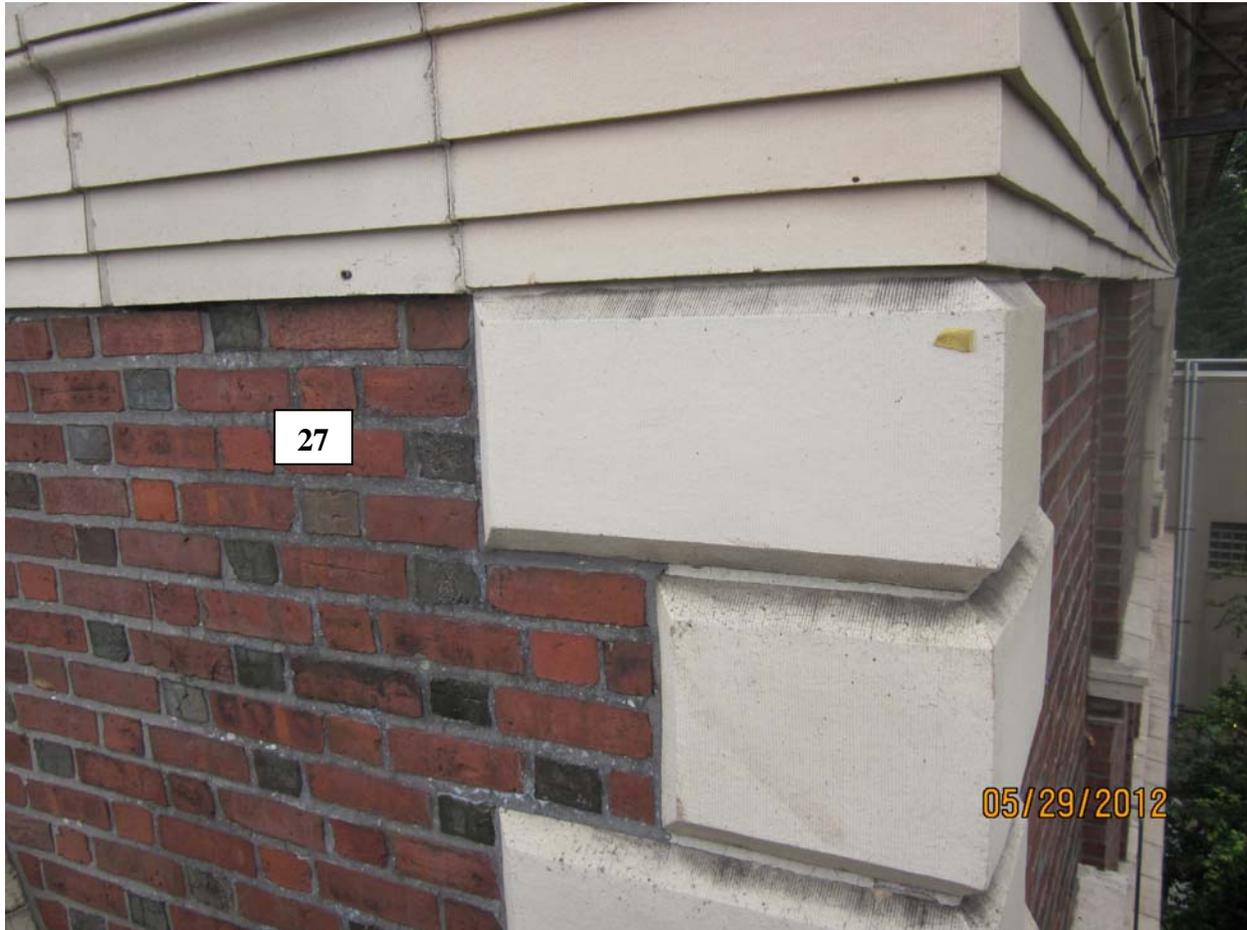
Photo 13

27. PATCHED AREA THAT SOUNDS AND FEELS LOOSE

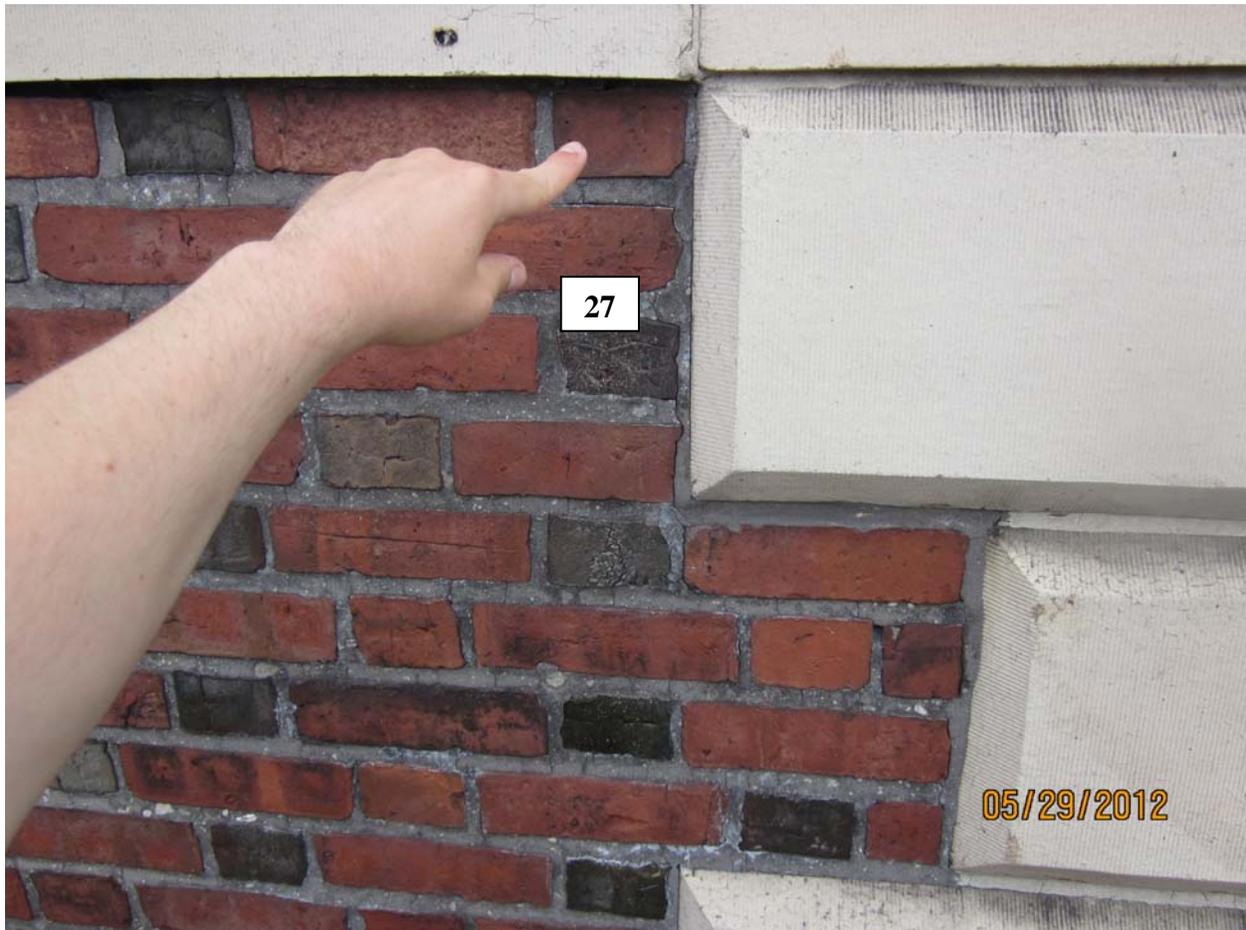
Photo 14

27. PATCHED AREA THAT SOUNDS AND FEELS LOOSE

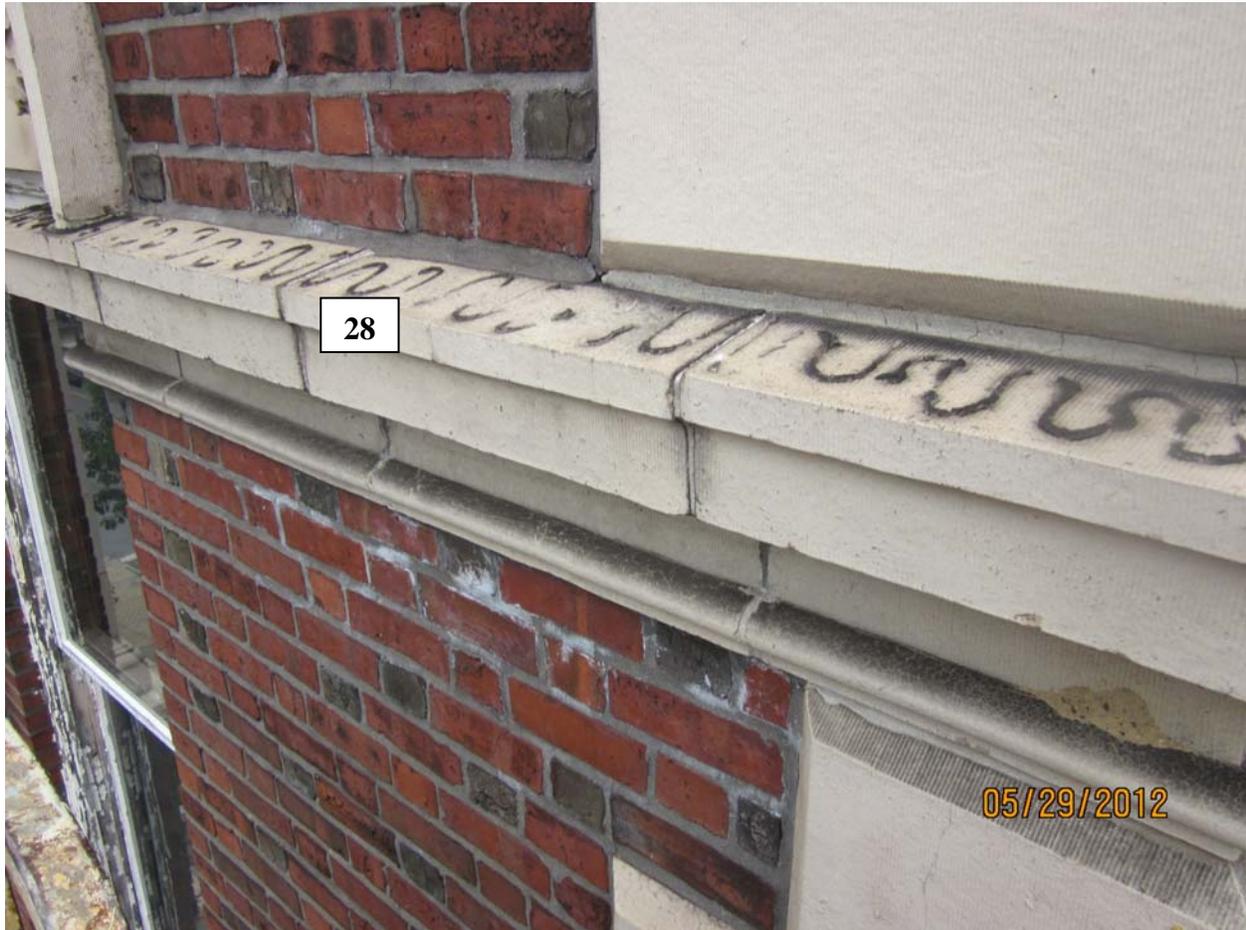
Photo 15

28. MASONRY UNITS THAT SOUND LOOSE

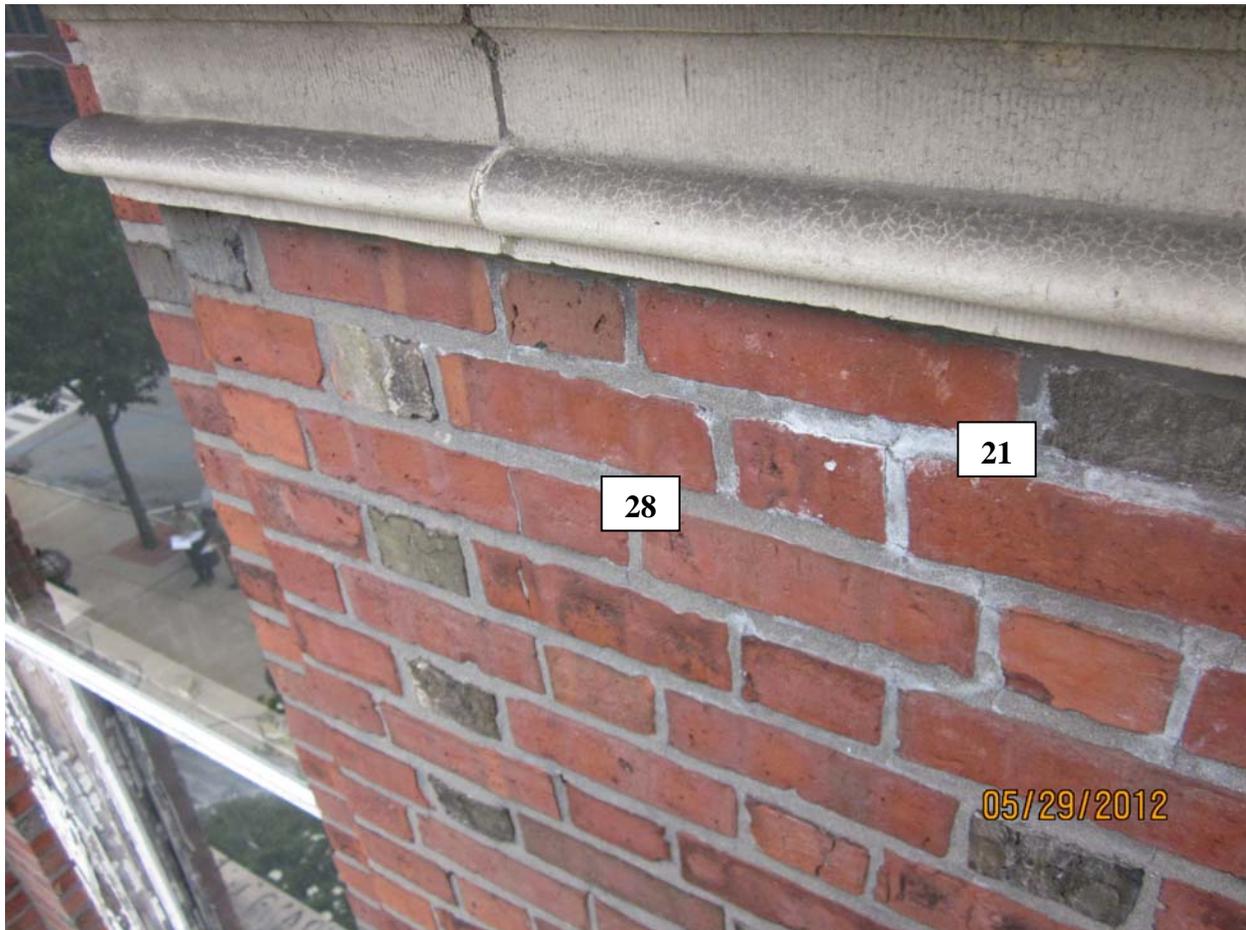
Photo 16

28. MASONRY UNITS THAT SOUND LOOSE

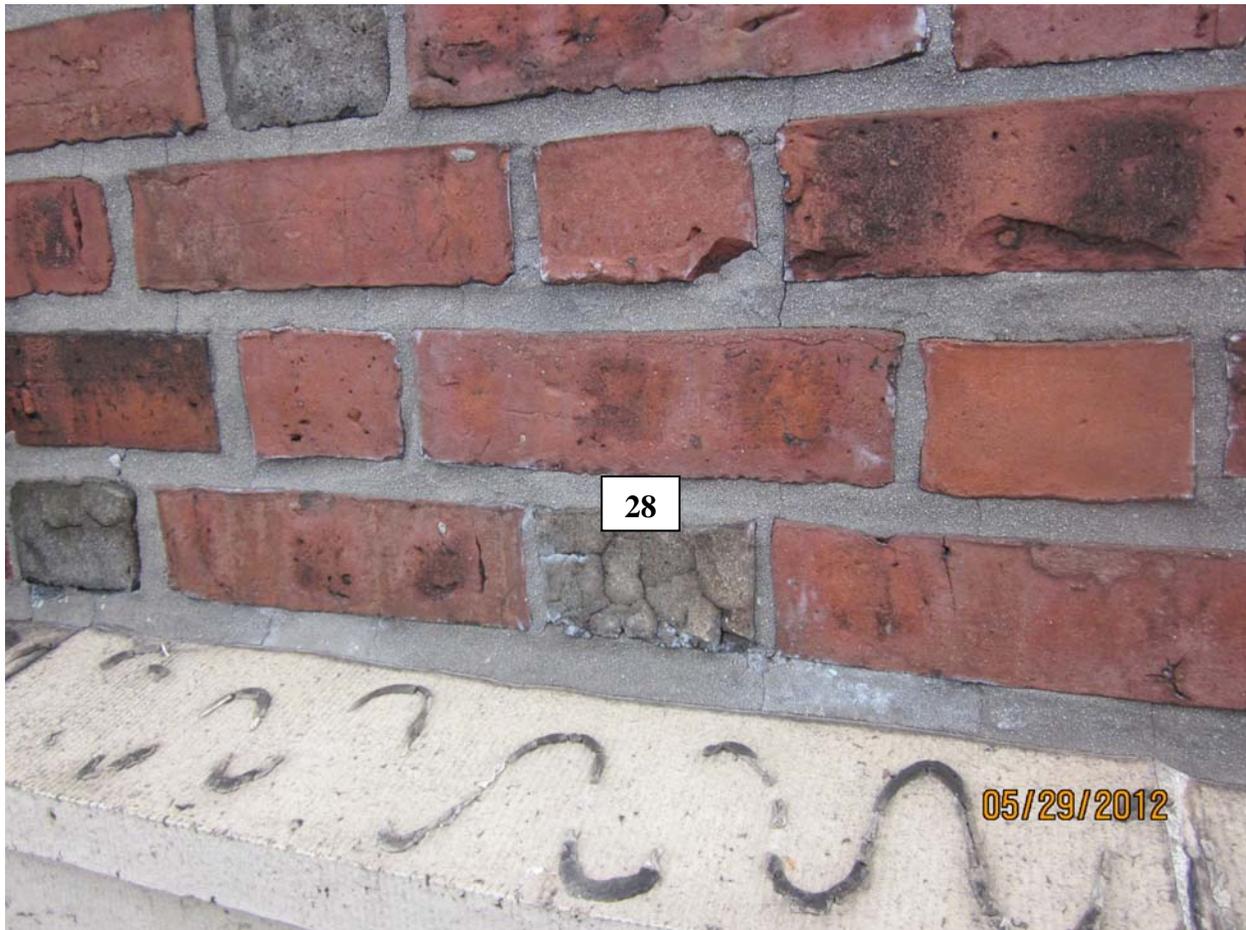
Photo 17

28. MASONRY UNITS THAT SOUND LOOSE

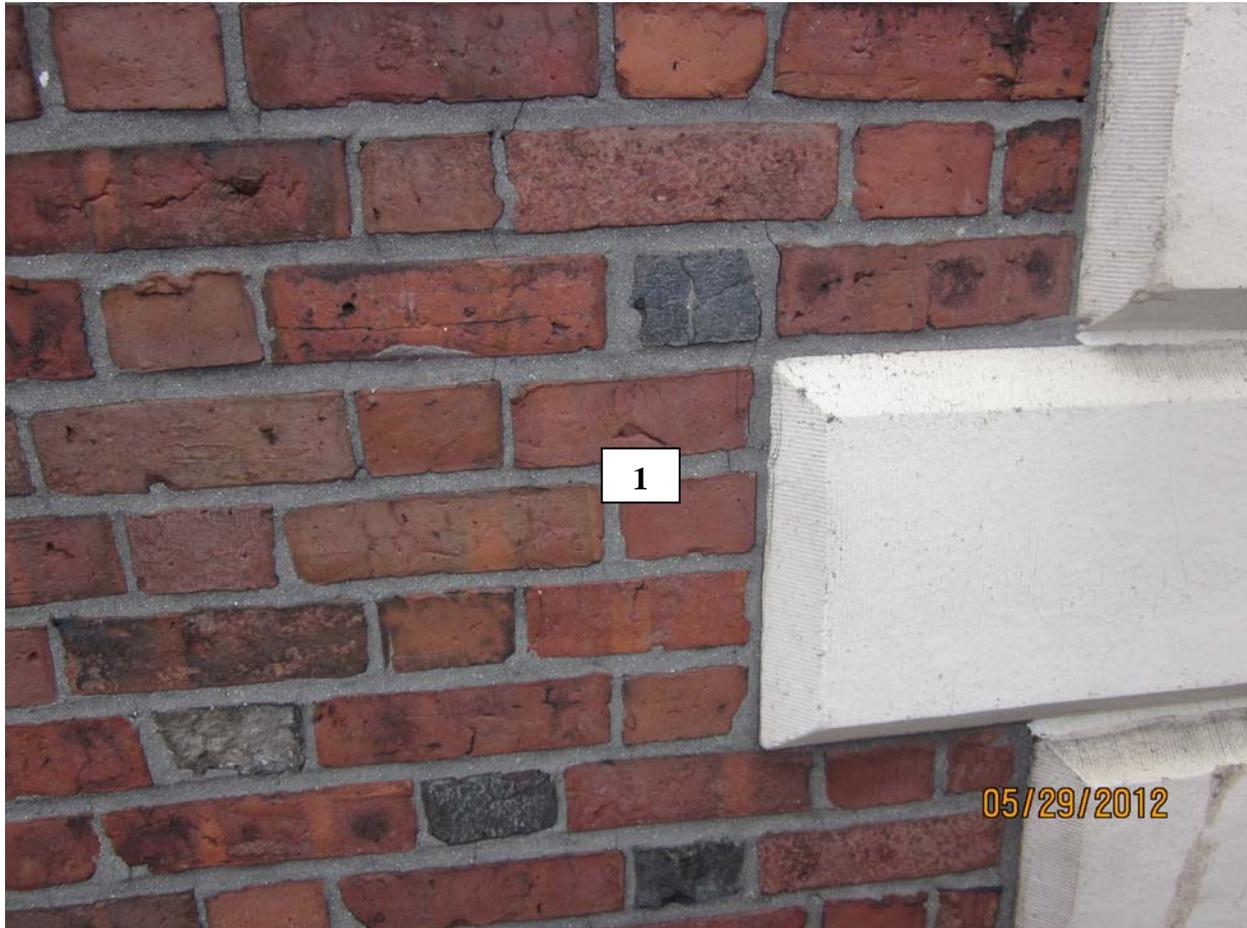
Photo 18

28. REPOINTING/EXTENSIVE ERODING OF ORIGINAL POINTING OF MASONRY

Re-pointing is recommended in areas where original re-pointing has deteriorated, eroded or brick is showing signs of efflorescence. Brick cleaning should involve hand washing with a mild detergent and a stiff bristle brush. Sandblasting is not recommended for cleaning of these areas. If sandblasting method is chosen, sandblasting should be used with caution and afterwards the masonry should be sealed with a waterproofing material. Regardless of what cleaning method is used, post cleaning the masonry should be sealed with a high quality waterproofing material or sealant. The efflorescence may reappear however because there still may be water inside the wall. The efflorescence already indicates that soluble alkali sulfates may exist in the wall and that the sulfates have found viable paths to the surface. The goal is to now prevent moisture from re-entering the masonry and rendering the sulfates into solution.

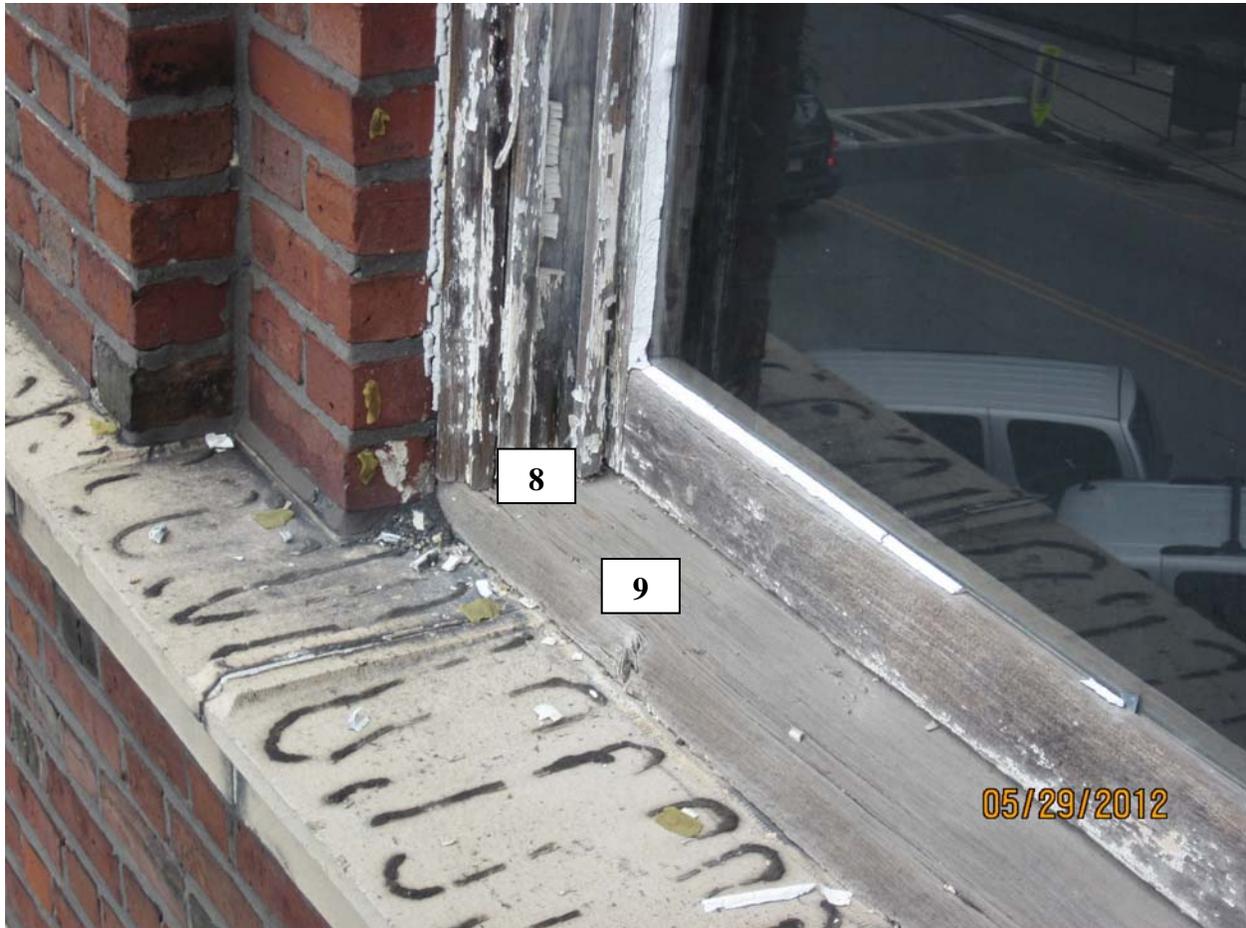
Photo 19

The majority of windows are wood double hung type with single paned glazing. The existing trim and paint are in poor condition, however the windows themselves are in fair condition (refer to Paint Condition Key below). It appears the original oak sash was previously retrofitted with bronze weather stripping. The paint around the sash is cracking and in most cases has deteriorated. (Refer to reference Photo 19)

- 8. EXISTING TRIM AND PAINT IN POOR CONDITION
- 9. EXISTING CAULK JOINT IN POOR CONDITION

The existing windows have exceeded the anticipated lifespan without a complete restoration. Even after restoration, the windows will still be a single glazed system which is not energy efficient by today's standards. We recommend a full window replacement with a high performance wood window with aluminum clad exterior and natural finish interior. The glazing should be insulated with a low-e coating. Window perimeter trim should be replaced to match existing details.

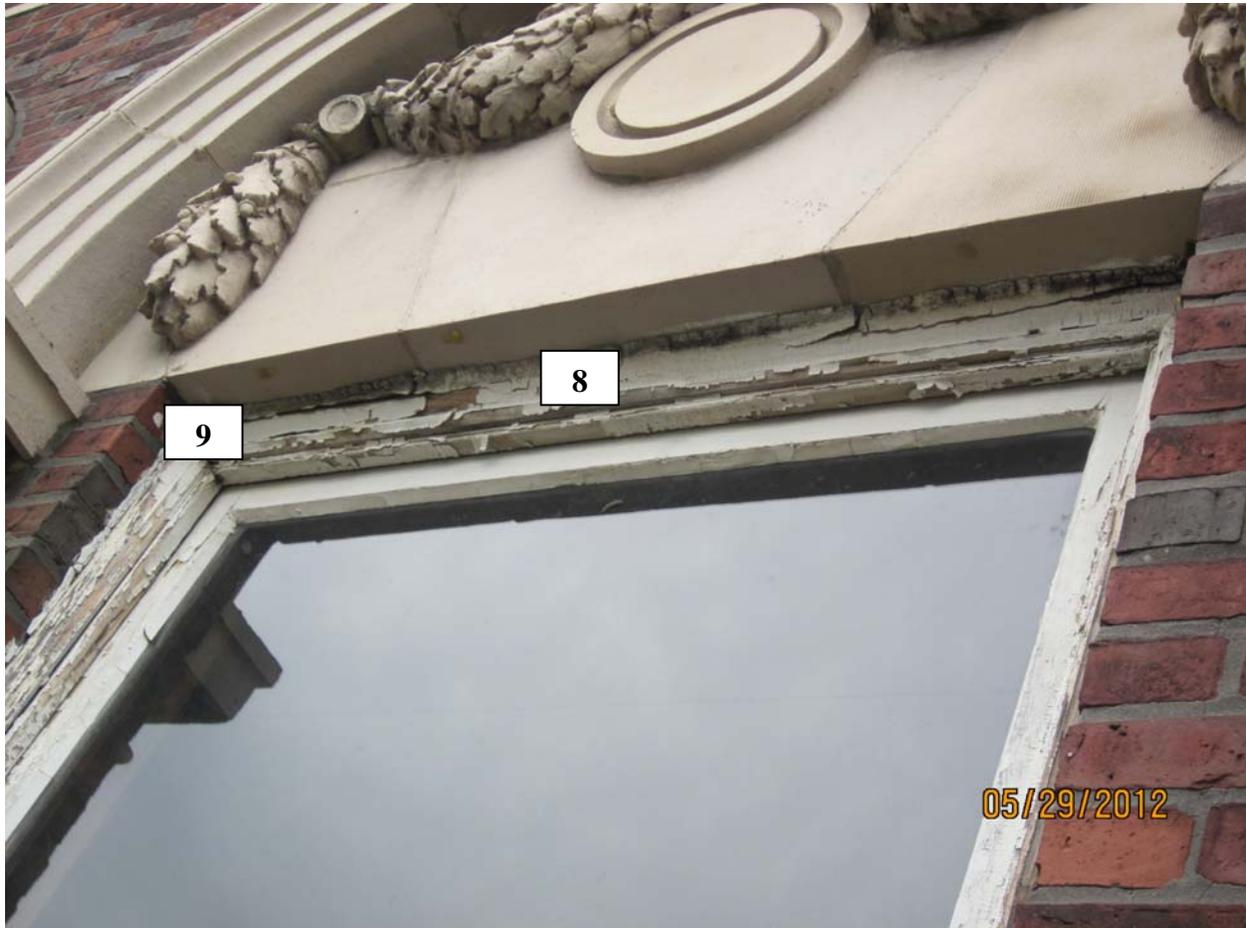
Photo 20

- 8. EXISTING TRIM AND PAINT IN POOR CONDITION
- 9. EXISTING CAULK JOINT IN POOR CONDITION

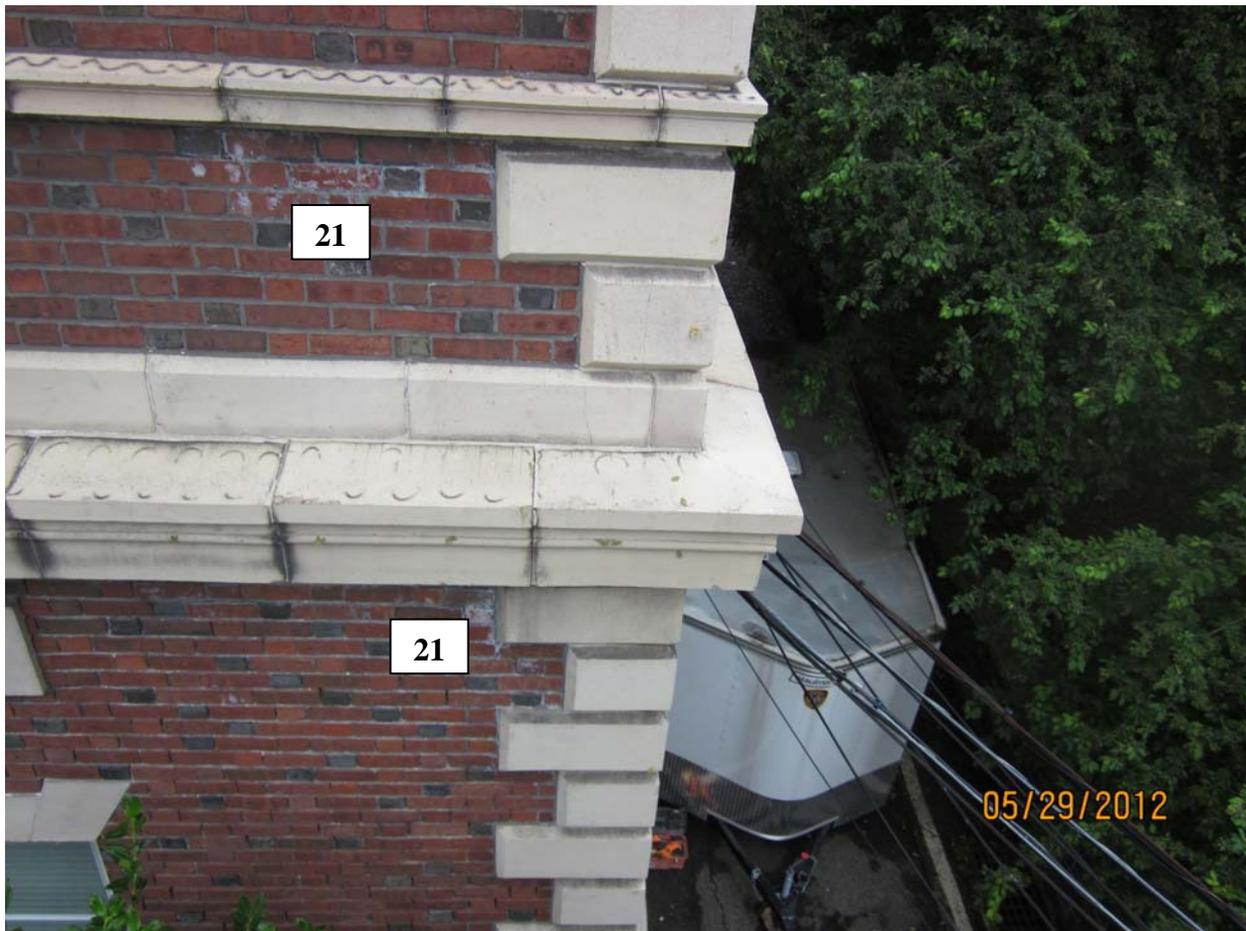
Photo 23

21. PRESENCE OF EFFLORESCENCE
