Village of Irvington Town Hall Exterior Conditions Analysis
85 Main Street
Irvington, NY 10533

Re: **Village of Irvington Town Hall Exterior Conditions Analysis**

Exterior Conditions Analysis Irvington Town Hall

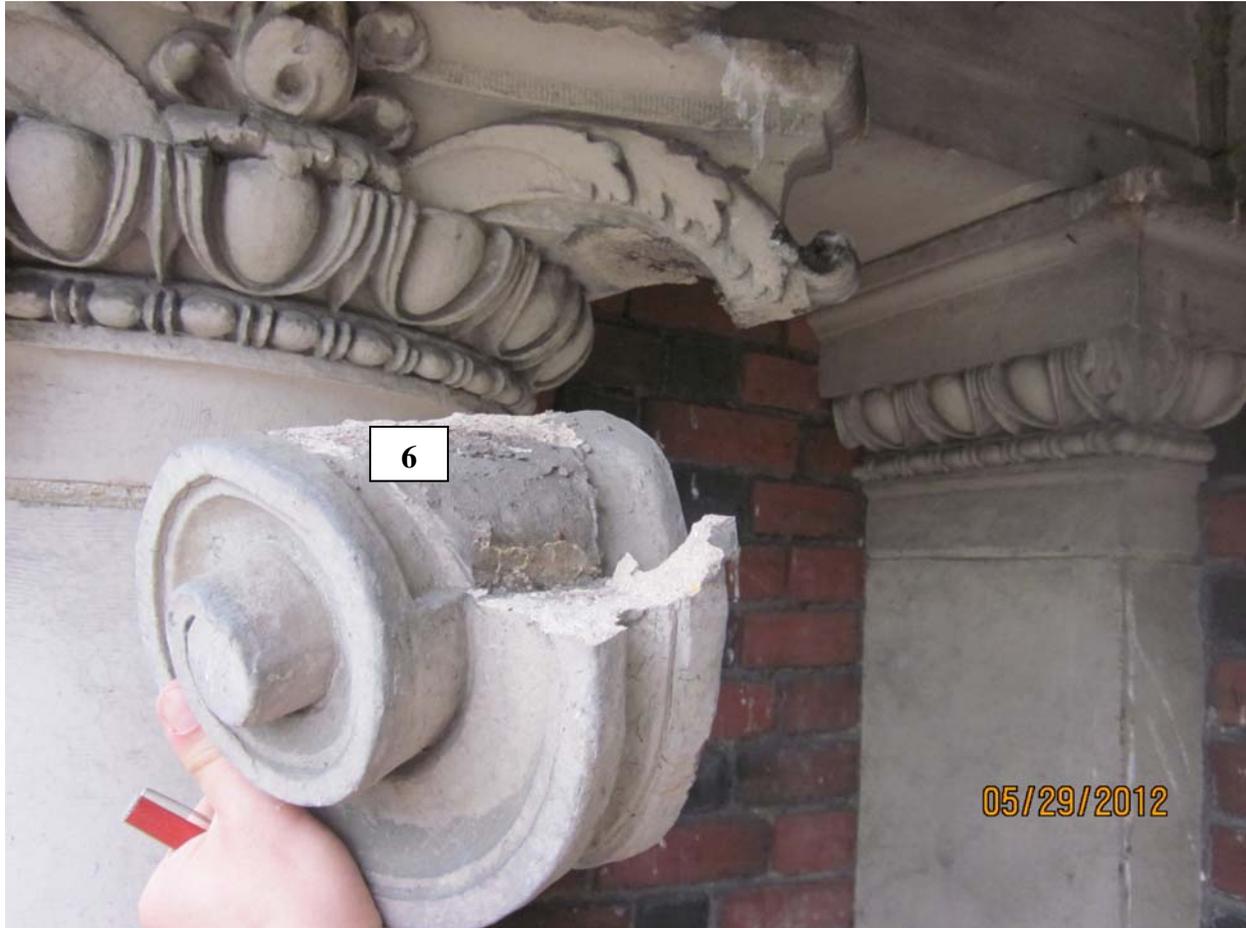
Photo 24

6. BROKEN OFF CAPITAL VOLUTE

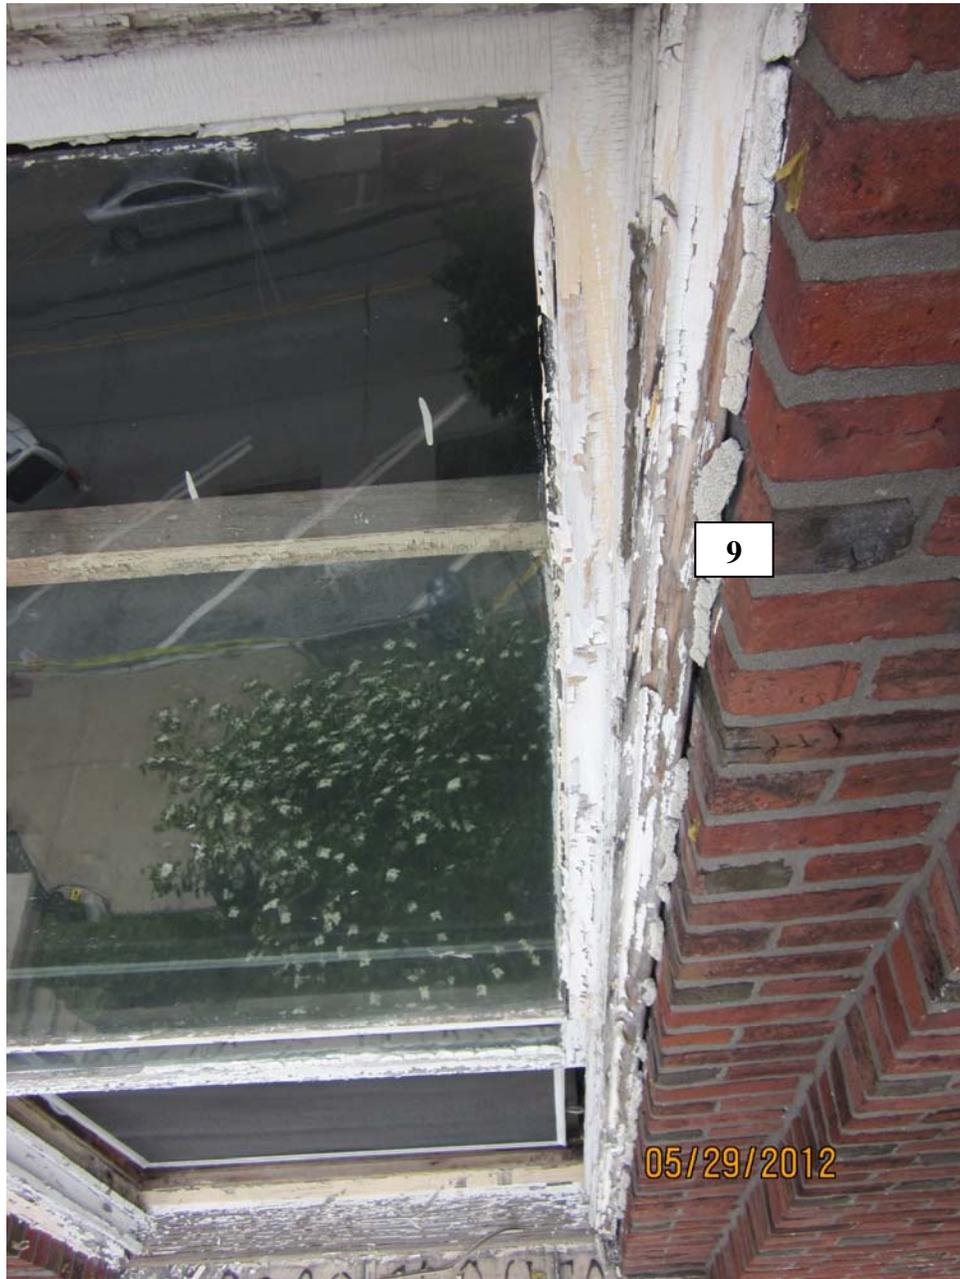
Photo 26

9. EXISTING CAULK JOINT IN POOR CONDITION

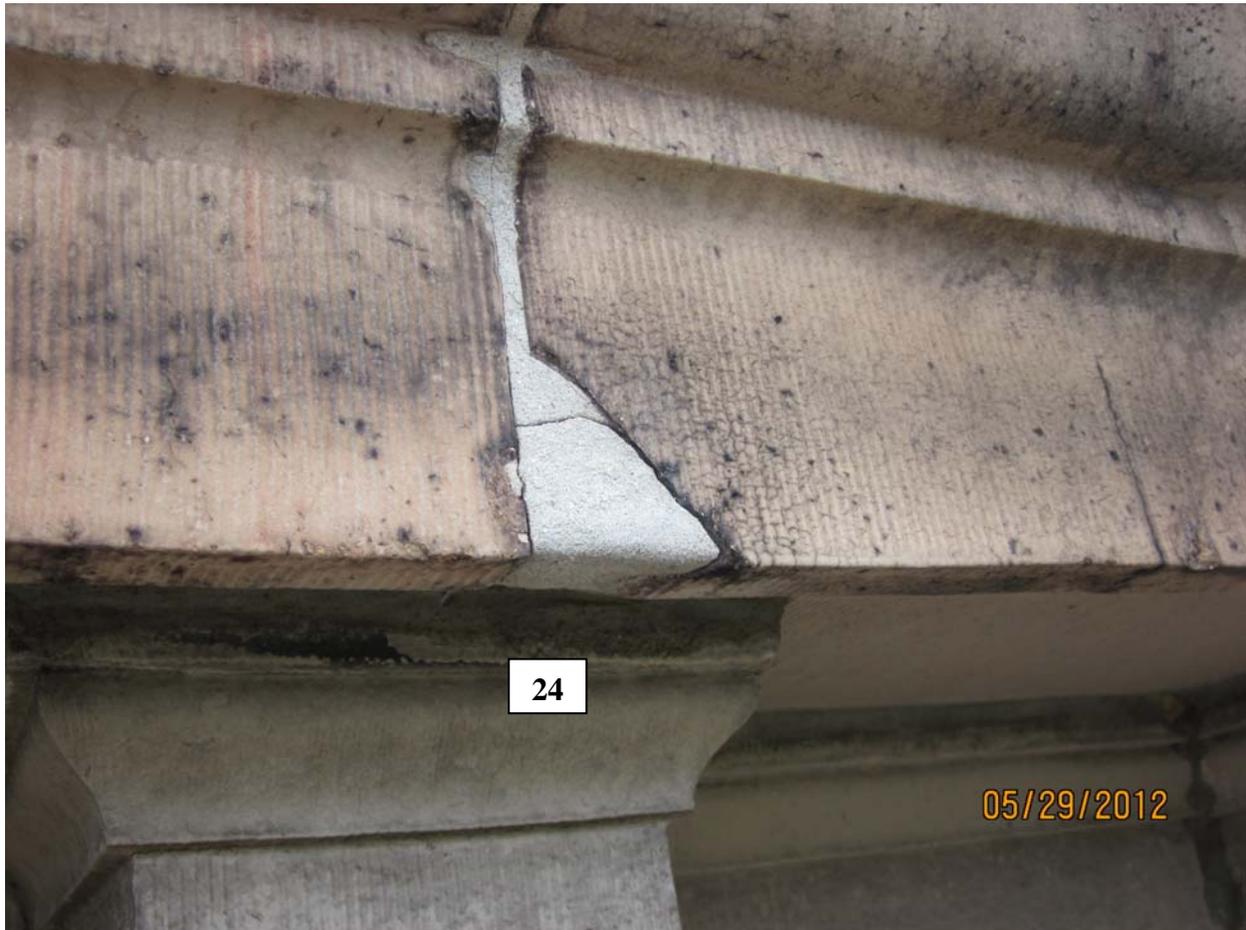
Photo 27

24. LOOSE MASONRY UNIT

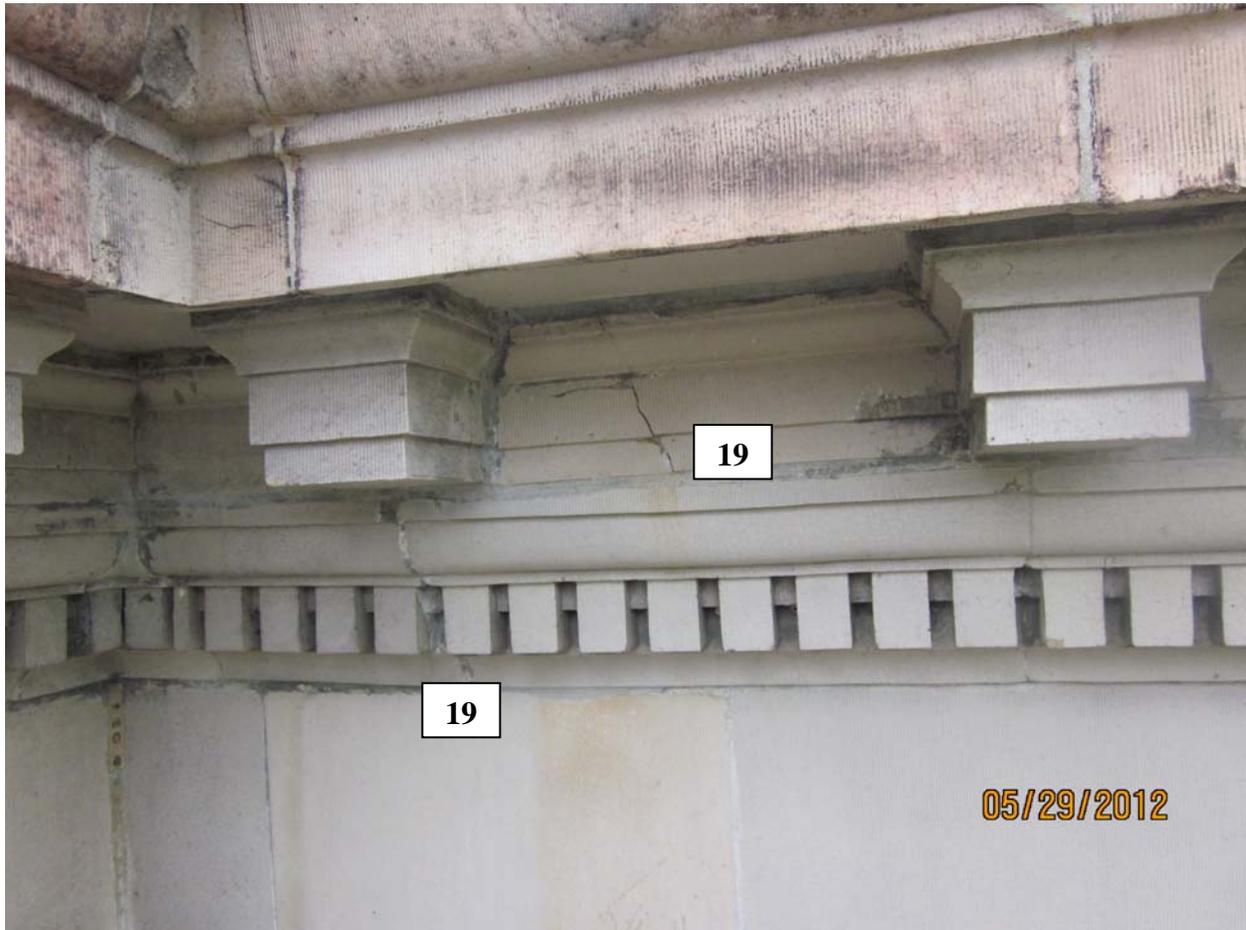
Photo 28

19. CRACKED TERRA COTTA

Terra Cotta spalling and cracking areas throughout the building we recommend the use of Custom System 45 and Elastowall 351, Elastomastic 352 or similar products for the miscellaneous patching and repair of the damaged areas. An allowance is also recommended for miscellaneous isolated areas requiring patching.

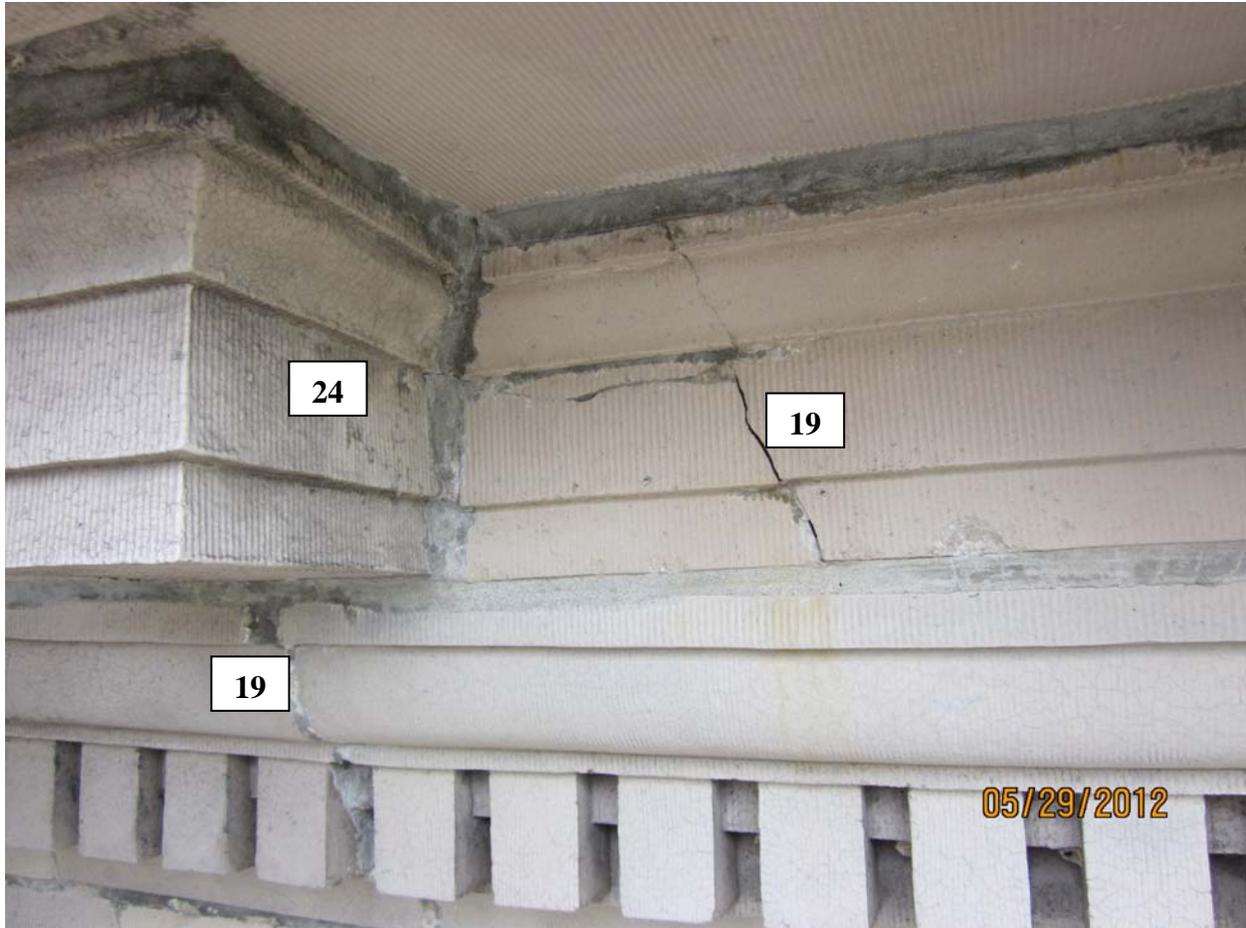
Photo 29

- 19. CRACKED TERRA COTTA
- 24. LOOSE MASONRY UNIT

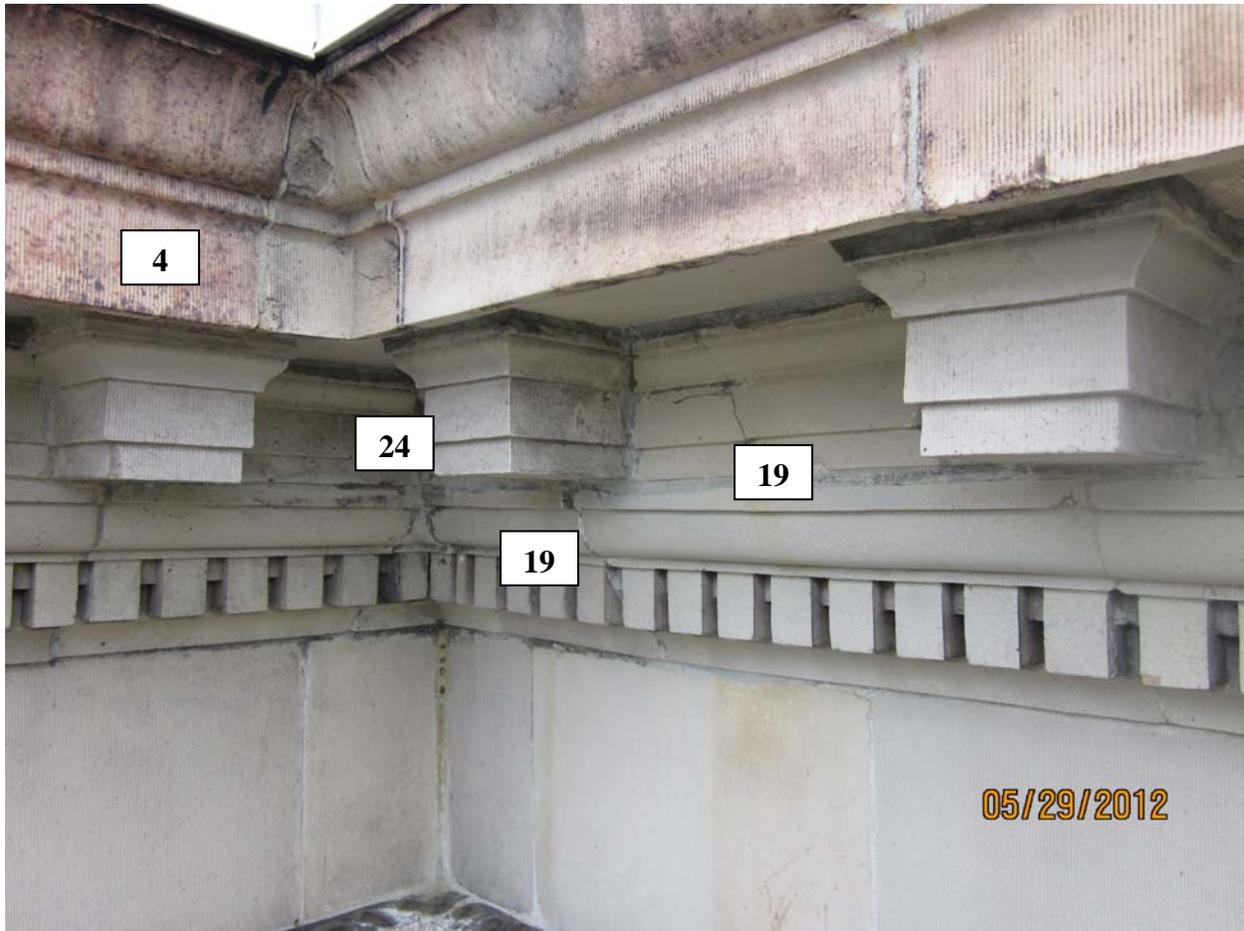
Photo 30

- 4. OFFSET TILE AND OR TILE DISCOLORATION
- 19. CRACKED TERRA COTTA
- 24. LOOSE MASONRY UNIT

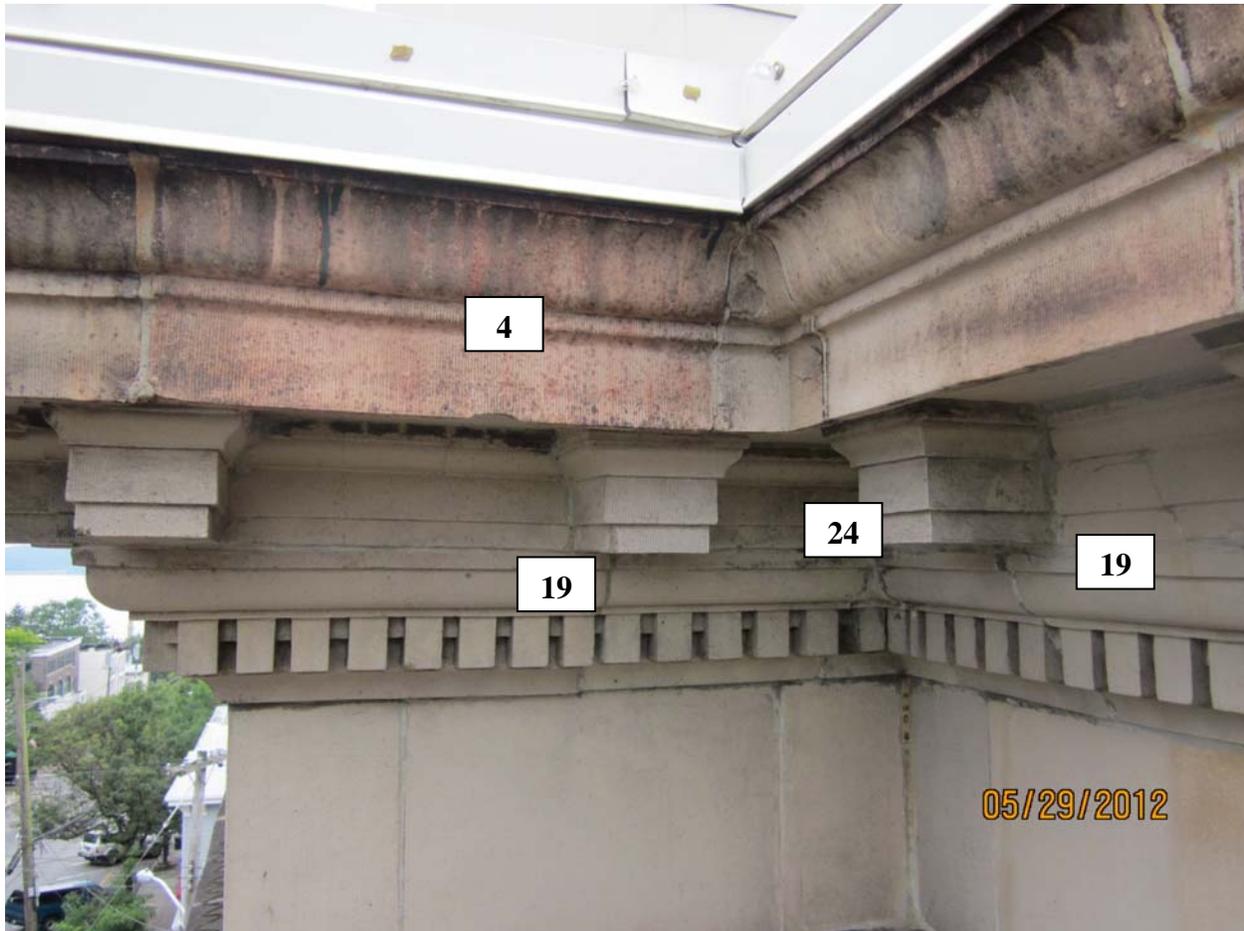
Photo 31

- 4. OFFSET TILE AND OR TILE DISCOLORATION
- 19. CRACKED TERRA COTTA
- 24. LOOSE MASONRY UNIT

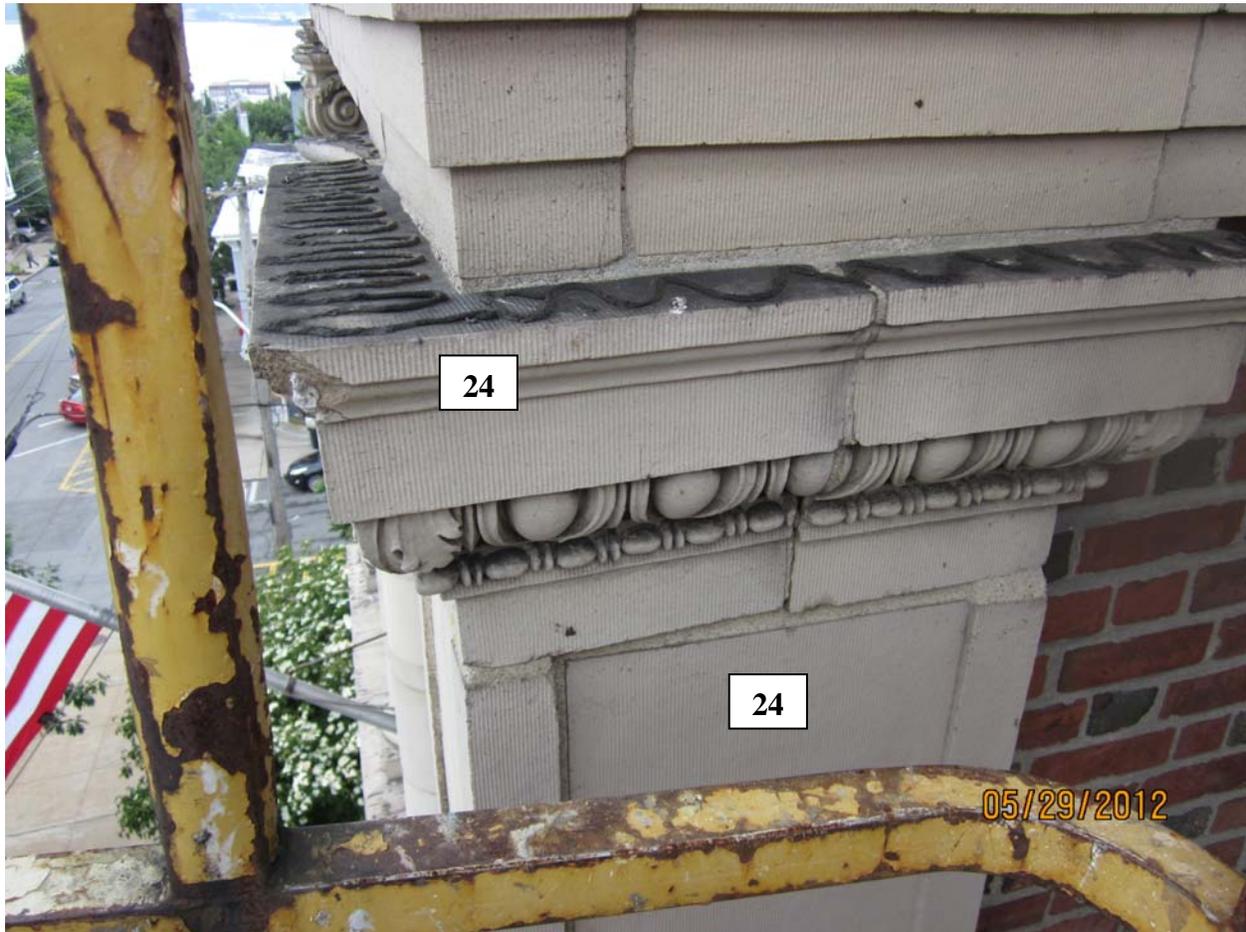
Photo 32

24. LOOSE MASONRY UNIT

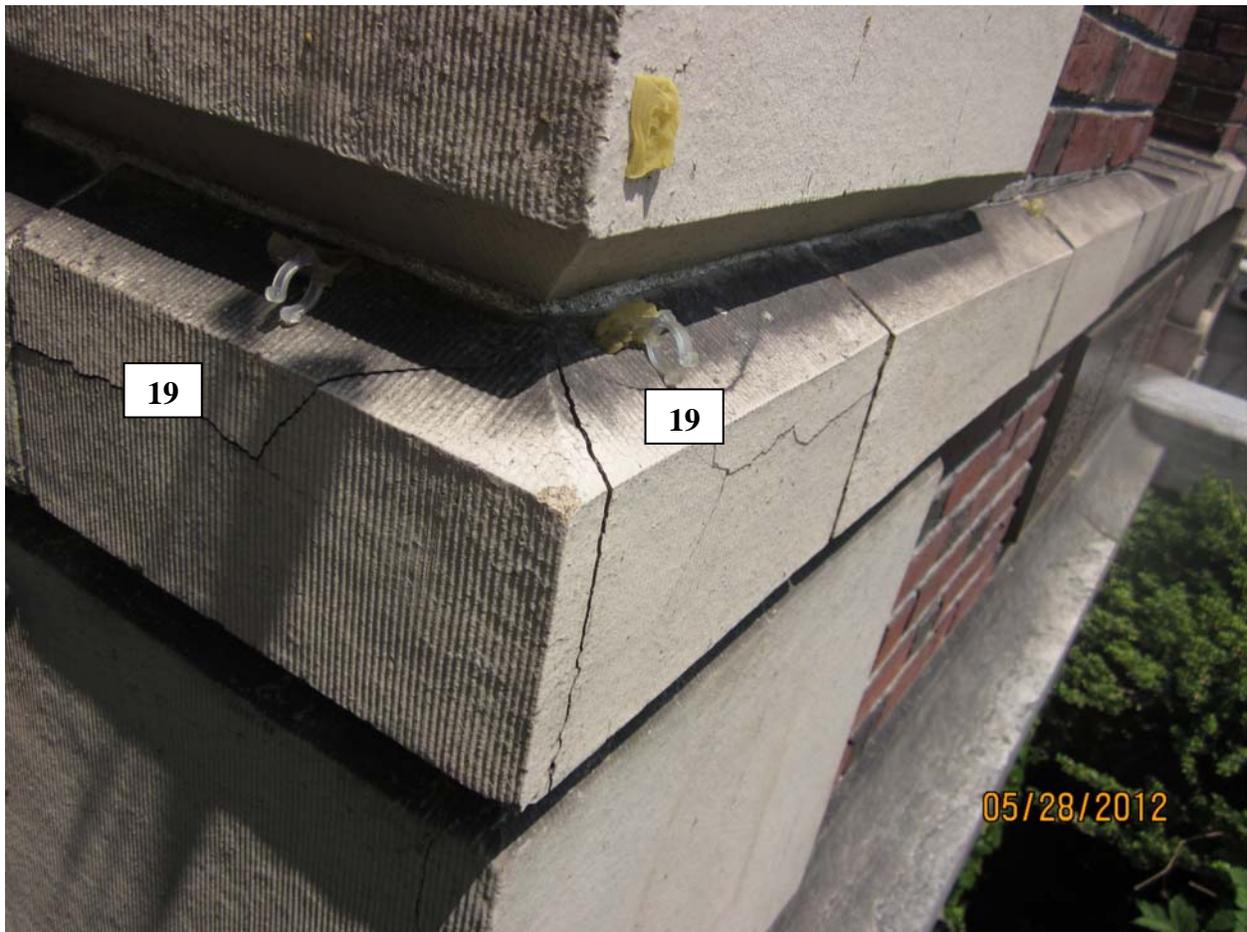
Photo 33

19. CRACKED TERRA COTTA

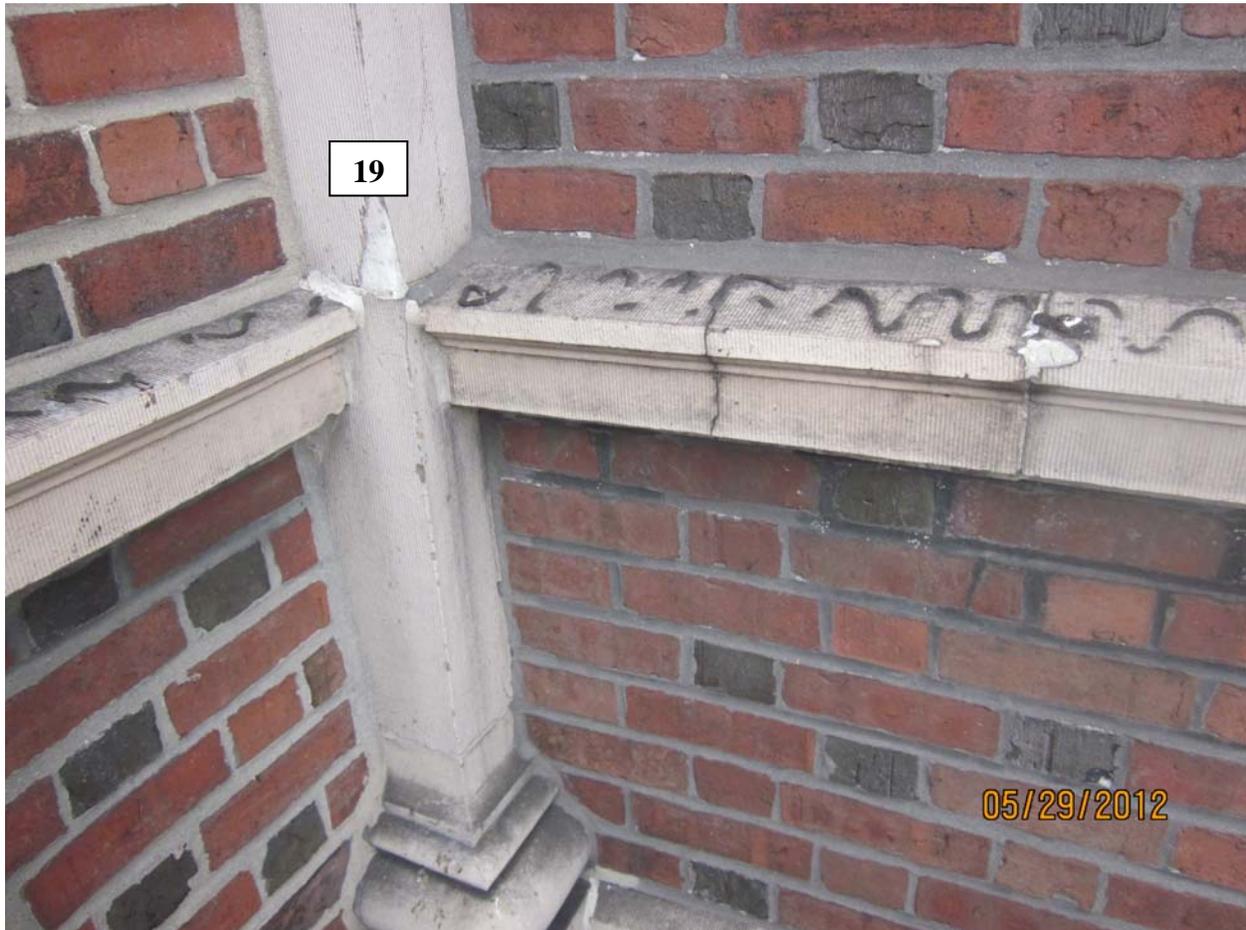
Photo 34

19. CRACKED TERRA COTTA

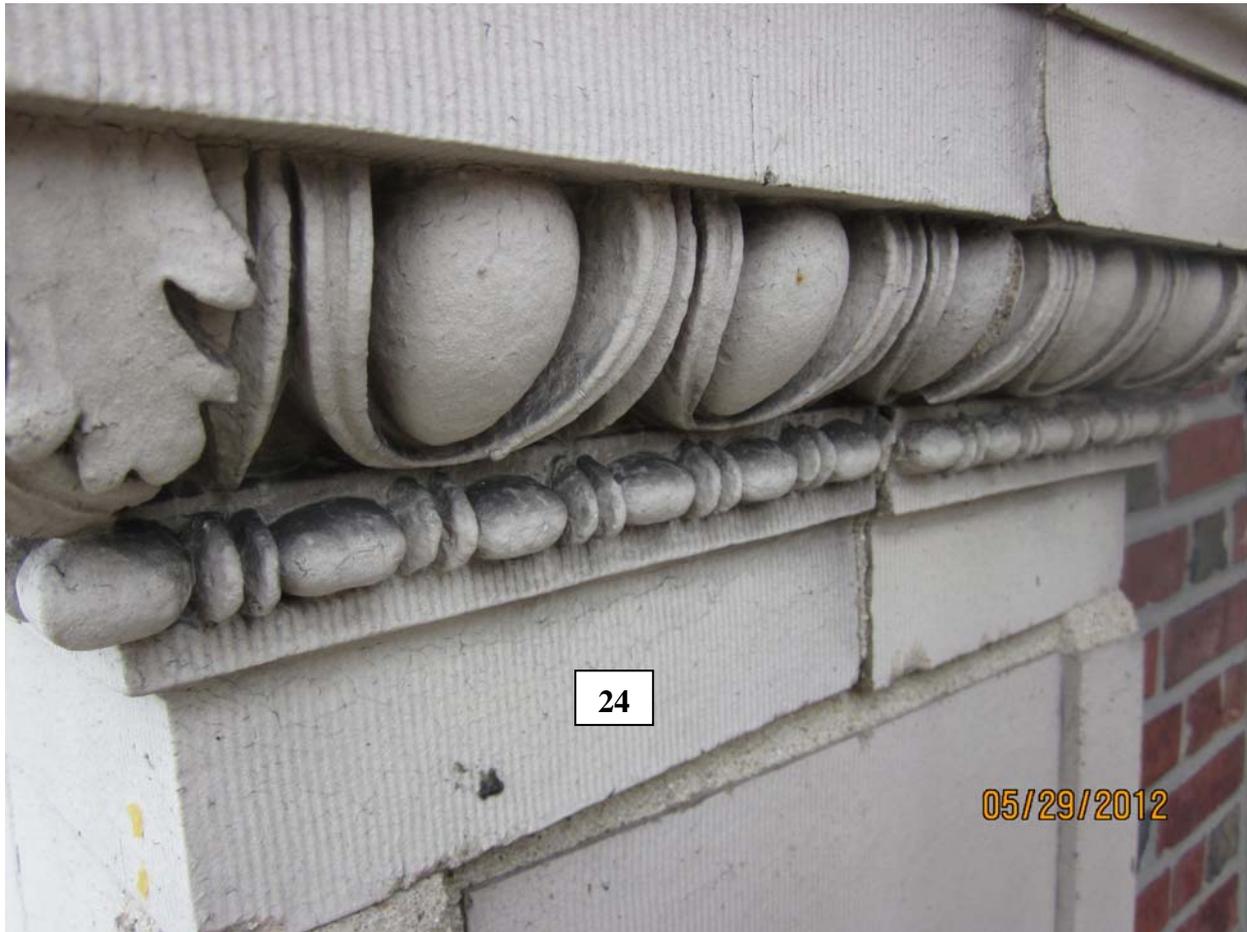
Photo 35

24. LOOSE MASONRY UNIT

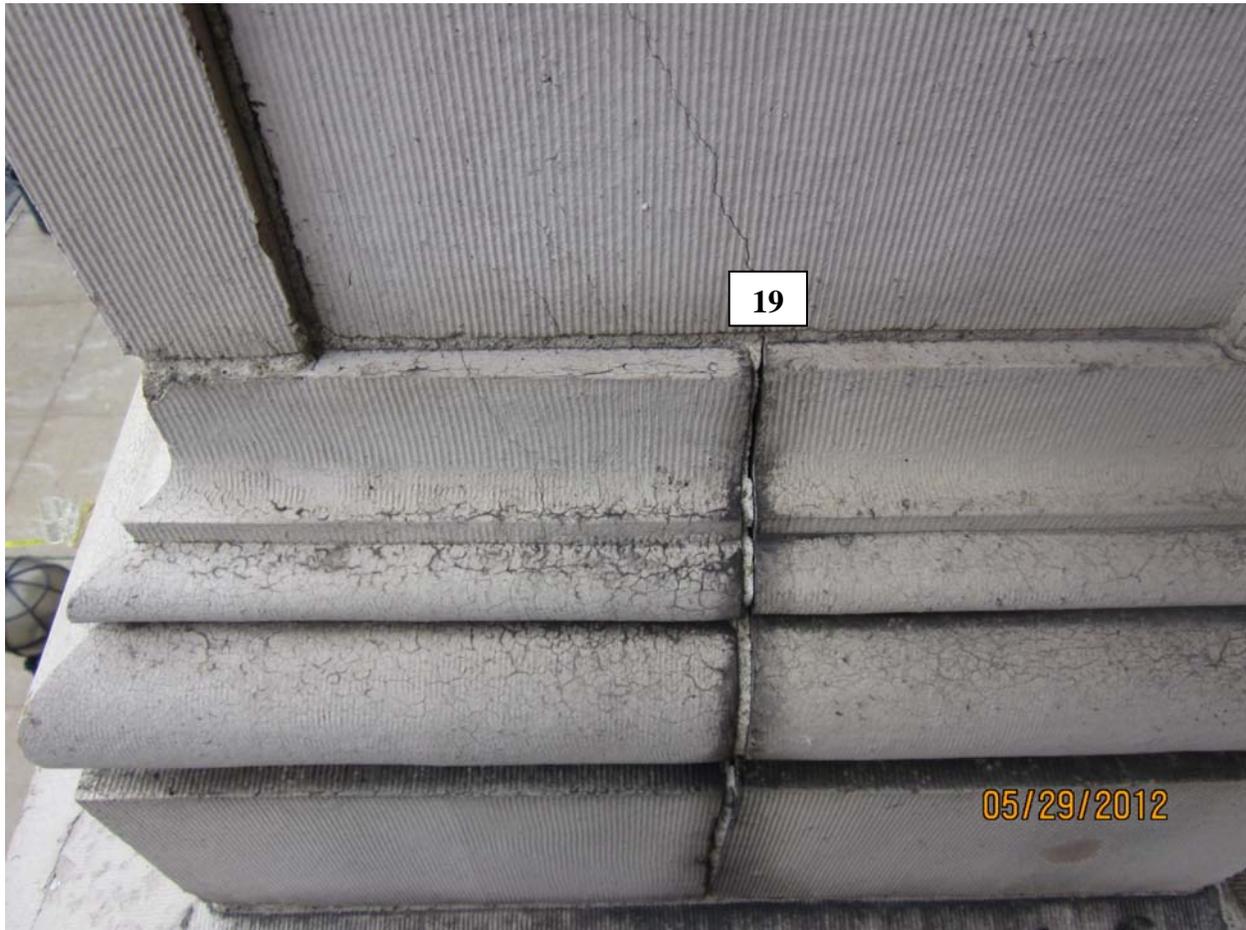
Photo 36

19. CRACKED TERRA COTTA

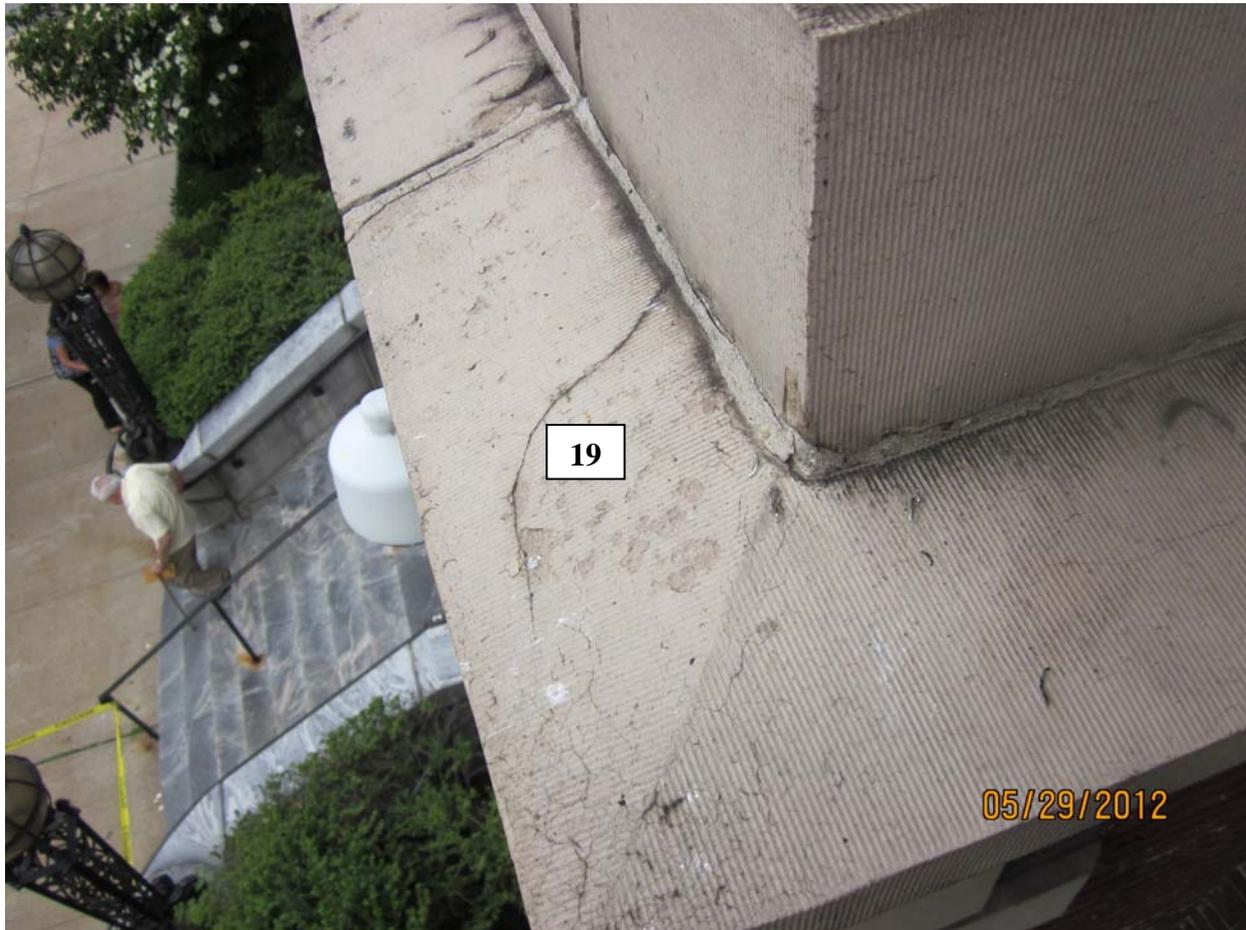
Photo 37

19. CRACKED TERRA COTTA

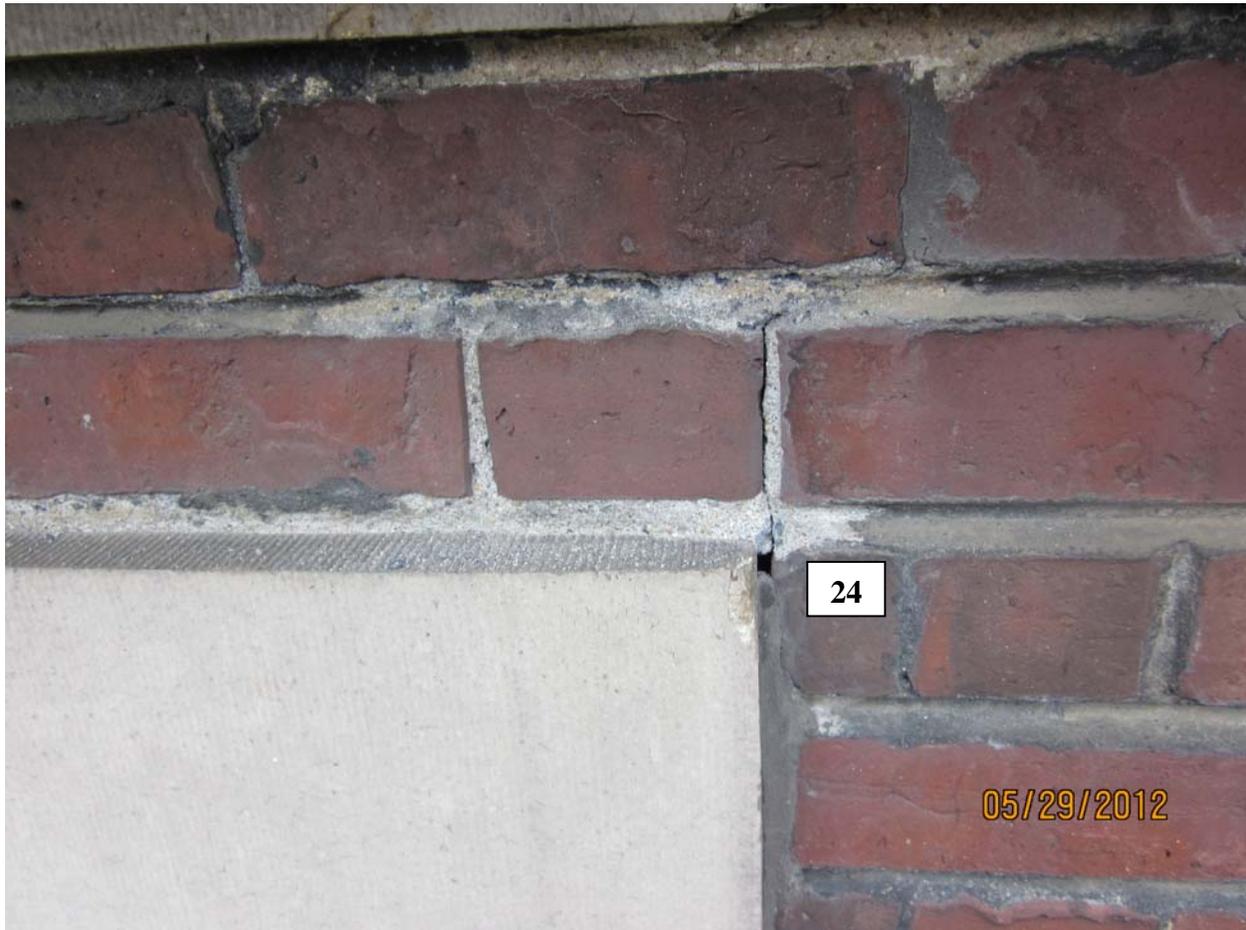
Photo 38

24. LOOSE MASONRY UNIT

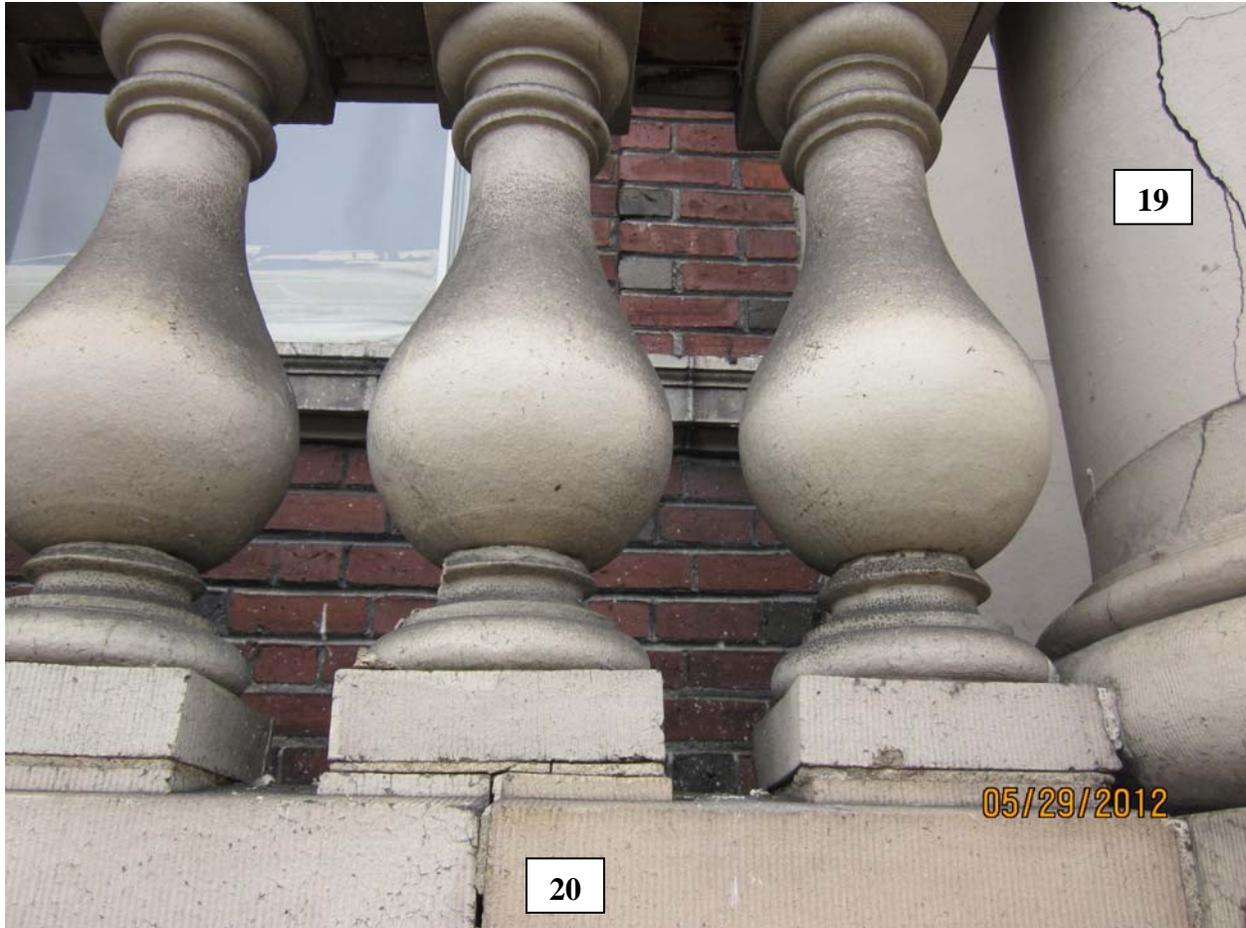
Photo 39

- 19. CRACKED TERRA COTTA
- 20. SPALLED TERRA COTTA

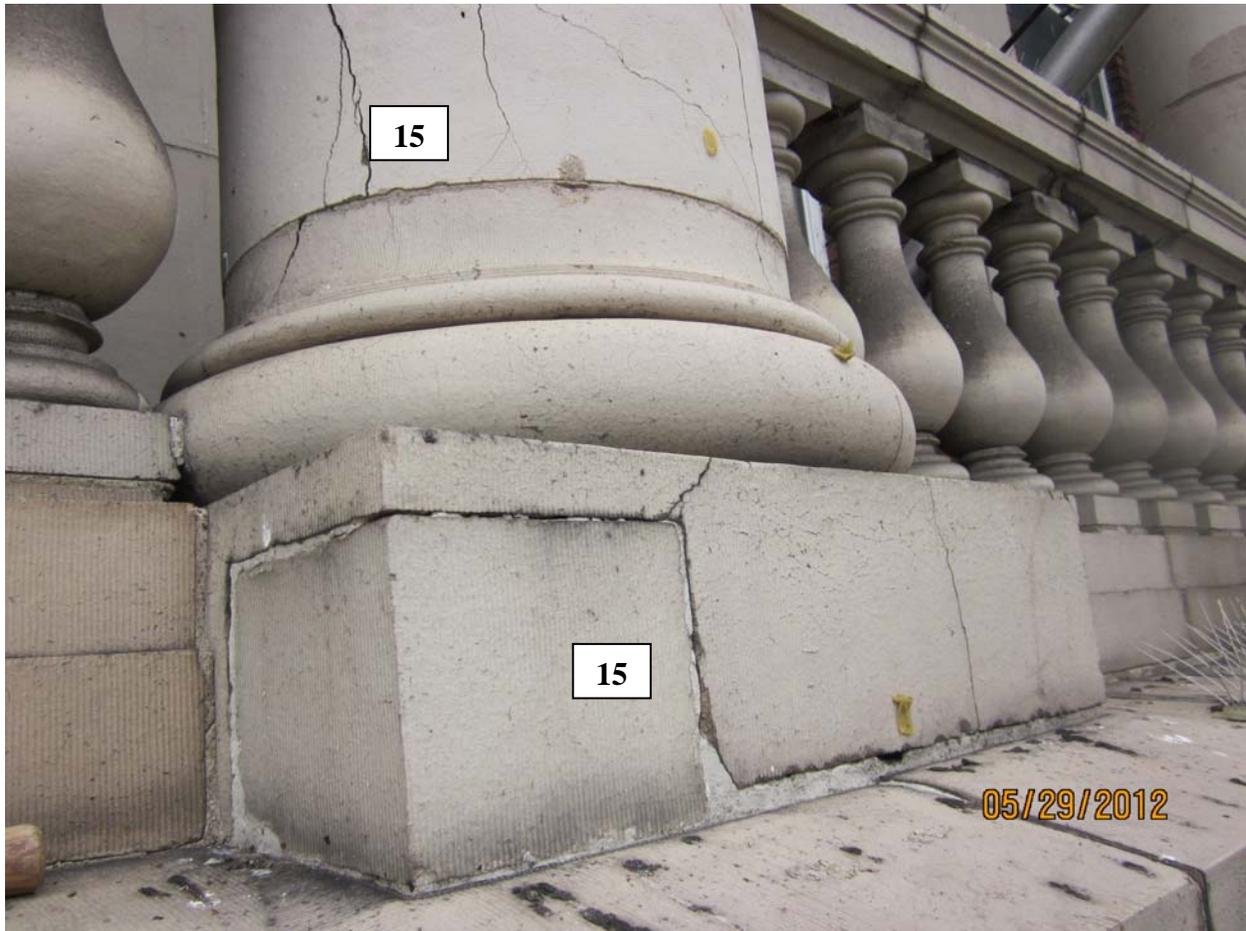
Photo 40

The town hall’s extensive ornamentation of terra cotta bands, arches, columns, and capitals are overall in fair condition. The four Ionic columns of the main tetra-style portico on the South façade are an exception and are in very poor condition. There are extensive large cracks at each of the columns. Many of these cracks appear to have been repaired at some point however many are still failing. The capitals are also in poor condition. One of the volutes was loose and detached during our field survey. The bases of each of the columns are also experiencing extensive cracking. This extensive terra cotta deterioration and cracking is often a result of significant

quantities of liquid moisture often found within the compromised terra cotta building wall systems. The primary reason for terra cotta failure is water penetration and freeze-thaw cycles and this will need to be addressed during a proper restoration project (Phase II).

15. TERRA COTTA COLUMNS AND PILASTERS IN THE PORTICO ARE IN POOR CONDITION. THE BASE AND CAPITALS ARE ALSO IN POOR CONDITION WITH VISUAL SIGNS OF EXTENSIVE CRACKING

Due to the severity of the cracking on the South face portico we recommend completely replacing all the individual pieces of each of the four columns and ornamental work in this area. The new should match existing in material, design and finish.

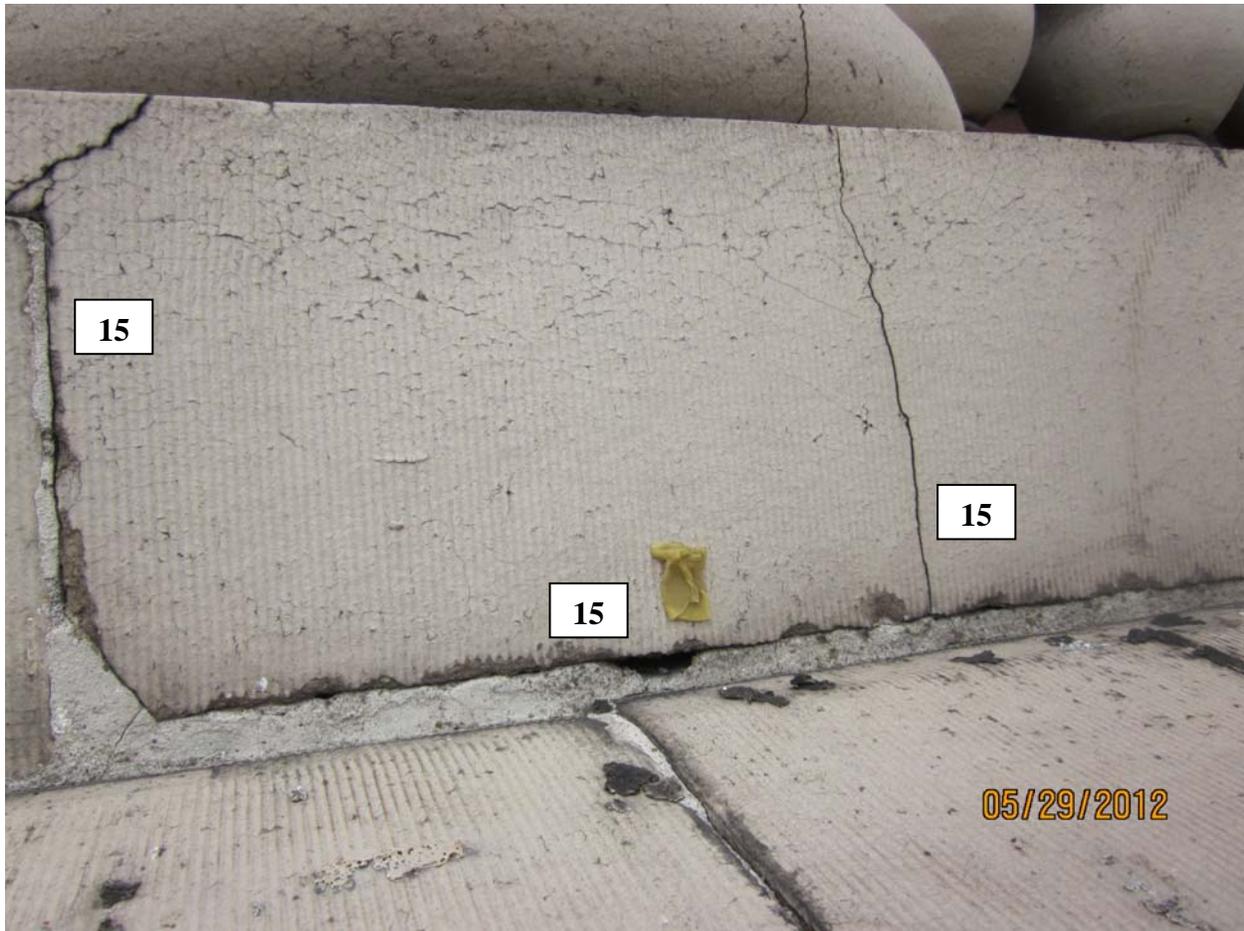
Photo 41

15. TERRA COTTA COLUMNS AND PILASTERS IN THE PORTICO ARE IN POOR CONDITION. THE BASE AND CAPITALS ARE ALSO IN POOR CONDITION WITH VISUAL SIGNS OF EXTENSIVE CRACKING

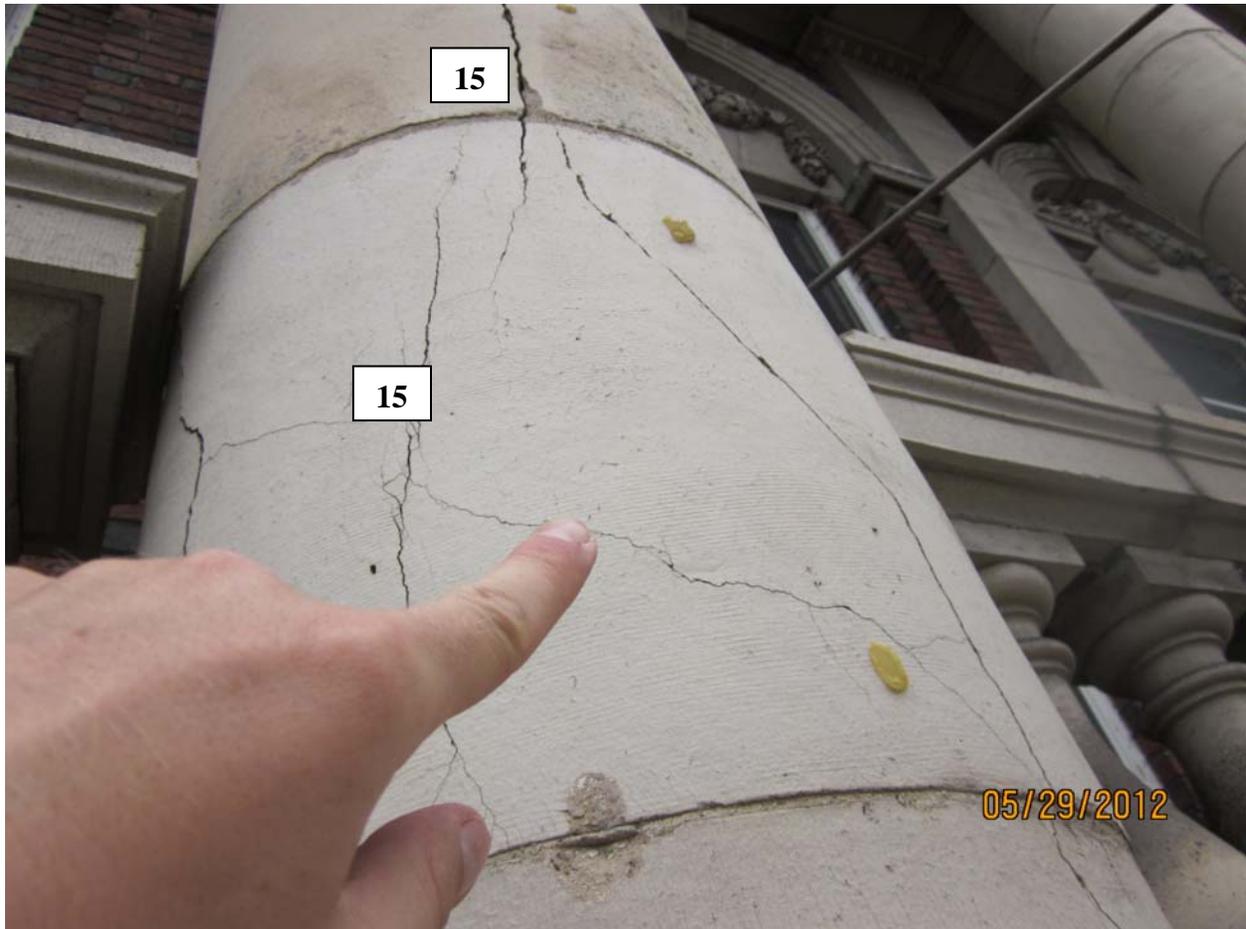
Photo 42

15. TERRA COTTA COLUMNS AND PILASTERS IN THE PORTICO ARE IN POOR CONDITION. THE BASE AND CAPITALS ARE ALSO IN POOR CONDITION WITH VISUAL SIGNS OF EXTENSIVE CRACKING

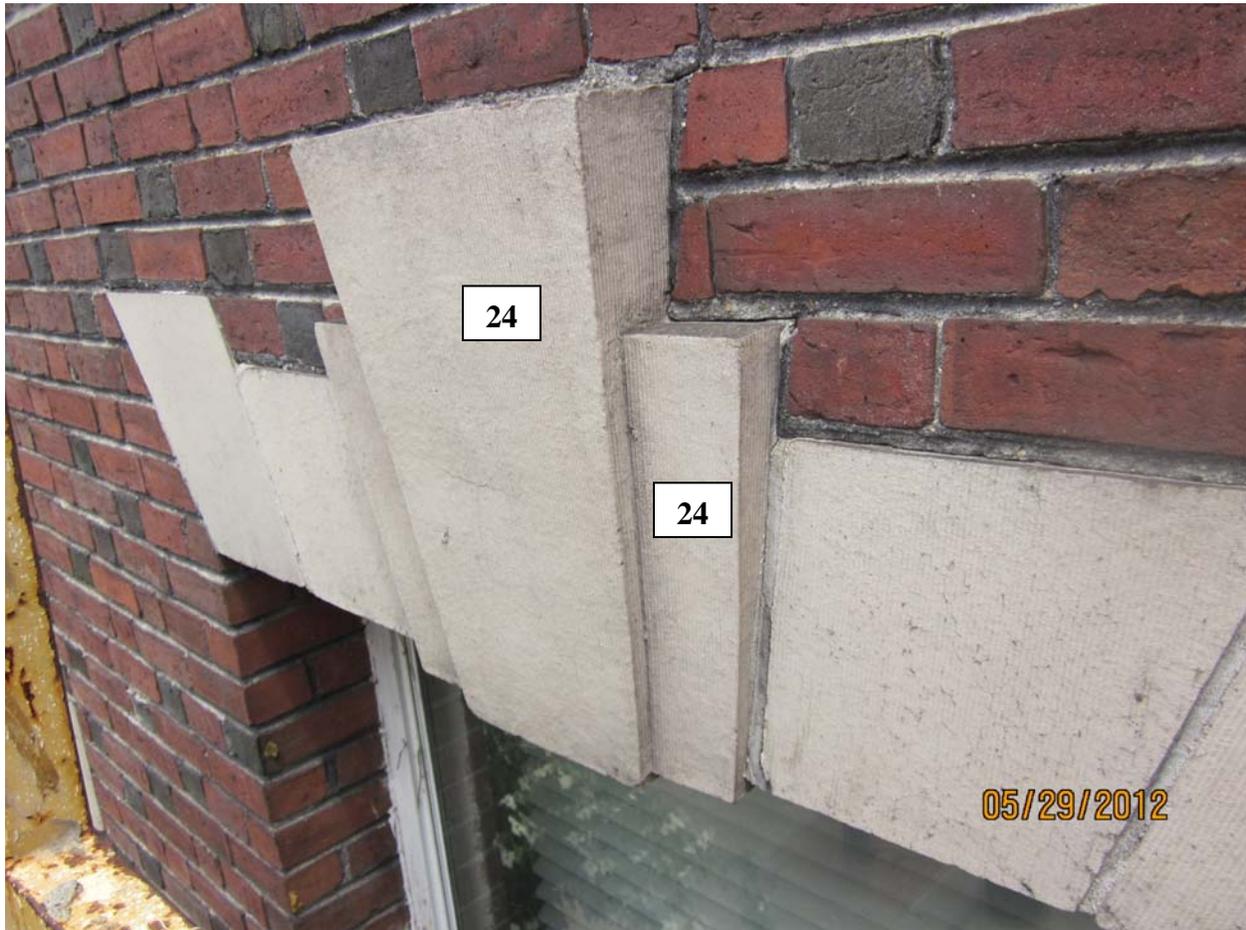
Photo 43

24. LOOSE MASONRY UNIT
