Village of Irvington Town Hall Exterior Conditions Analysis
85 Main Street
Irvington, NY 10533

Re: **Village of Irvington Town Hall Exterior Conditions Analysis**

Exterior Conditions Analysis Irvington Town Hall

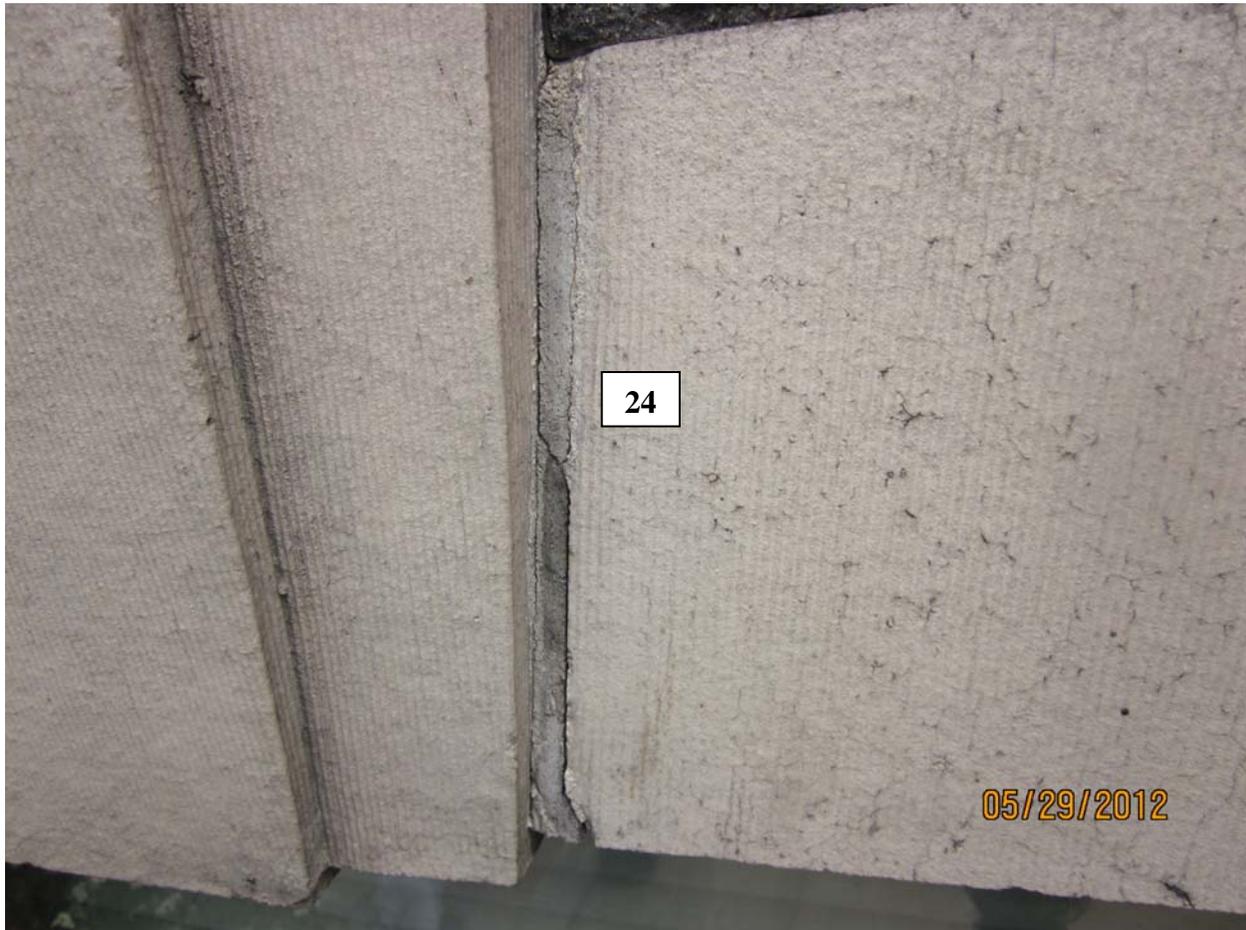
Photo 44

24. LOOSE MASONRY UNIT

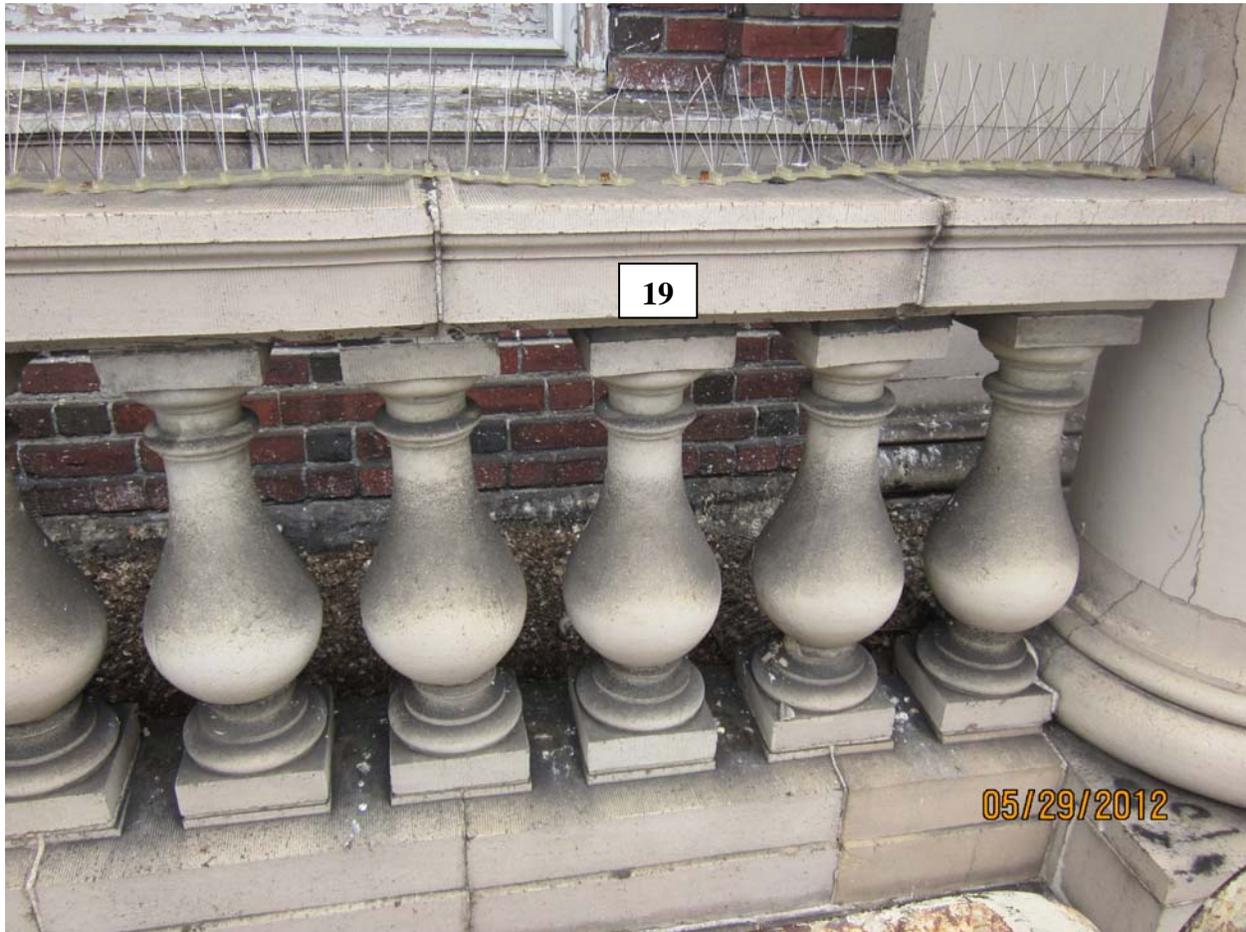
Photo 45

19. CRACKED TERRA COTTA

Terra Cotta spalling and cracking areas throughout the building we recommend the use of Custom System 45 and Elastowall 351, Elastomastic 352 or similar products for the miscellaneous patching and repair of the damaged areas. An allowance is also recommended for miscellaneous isolated areas requiring patching.

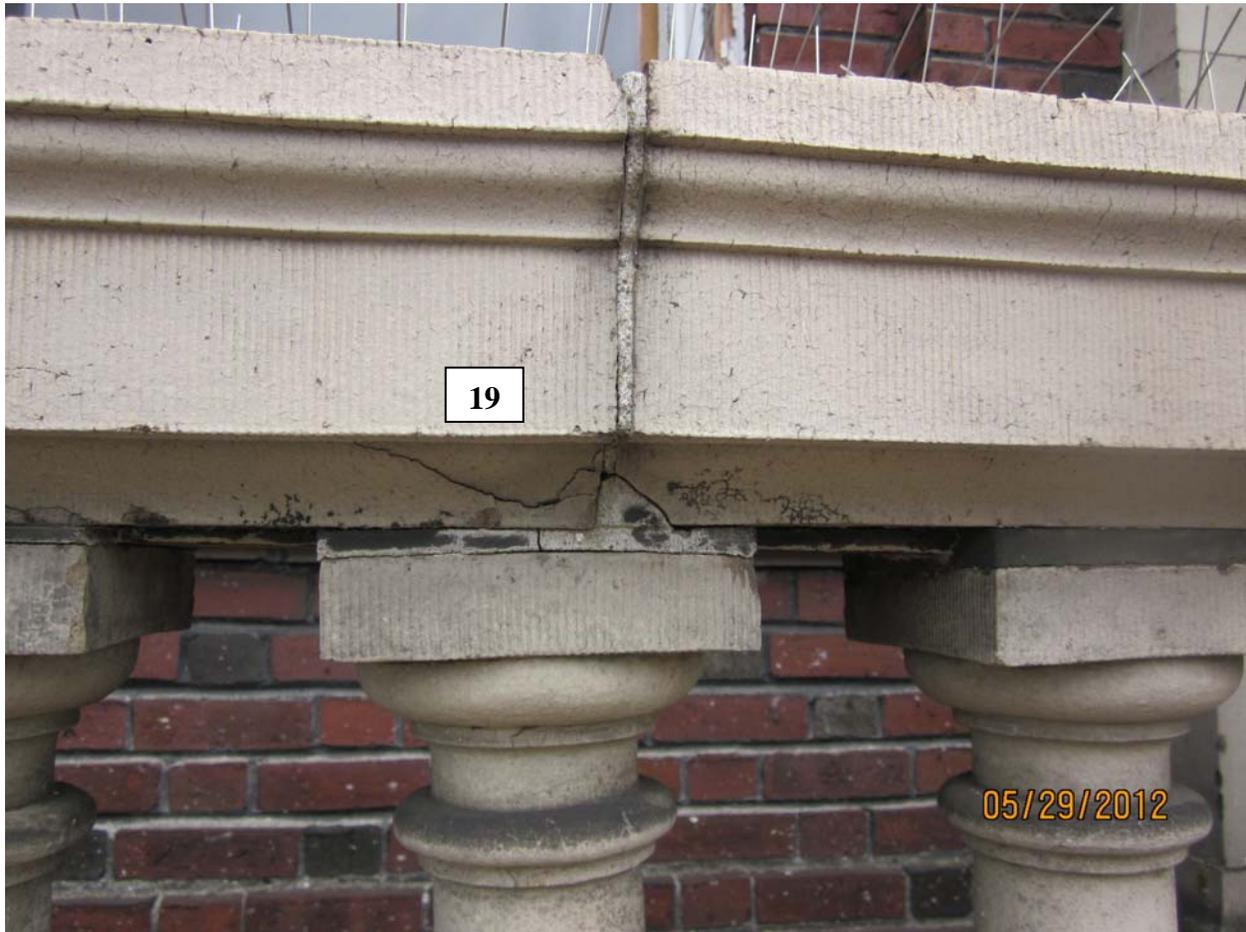
Photo 46

19. CRACKED TERRA COTTA

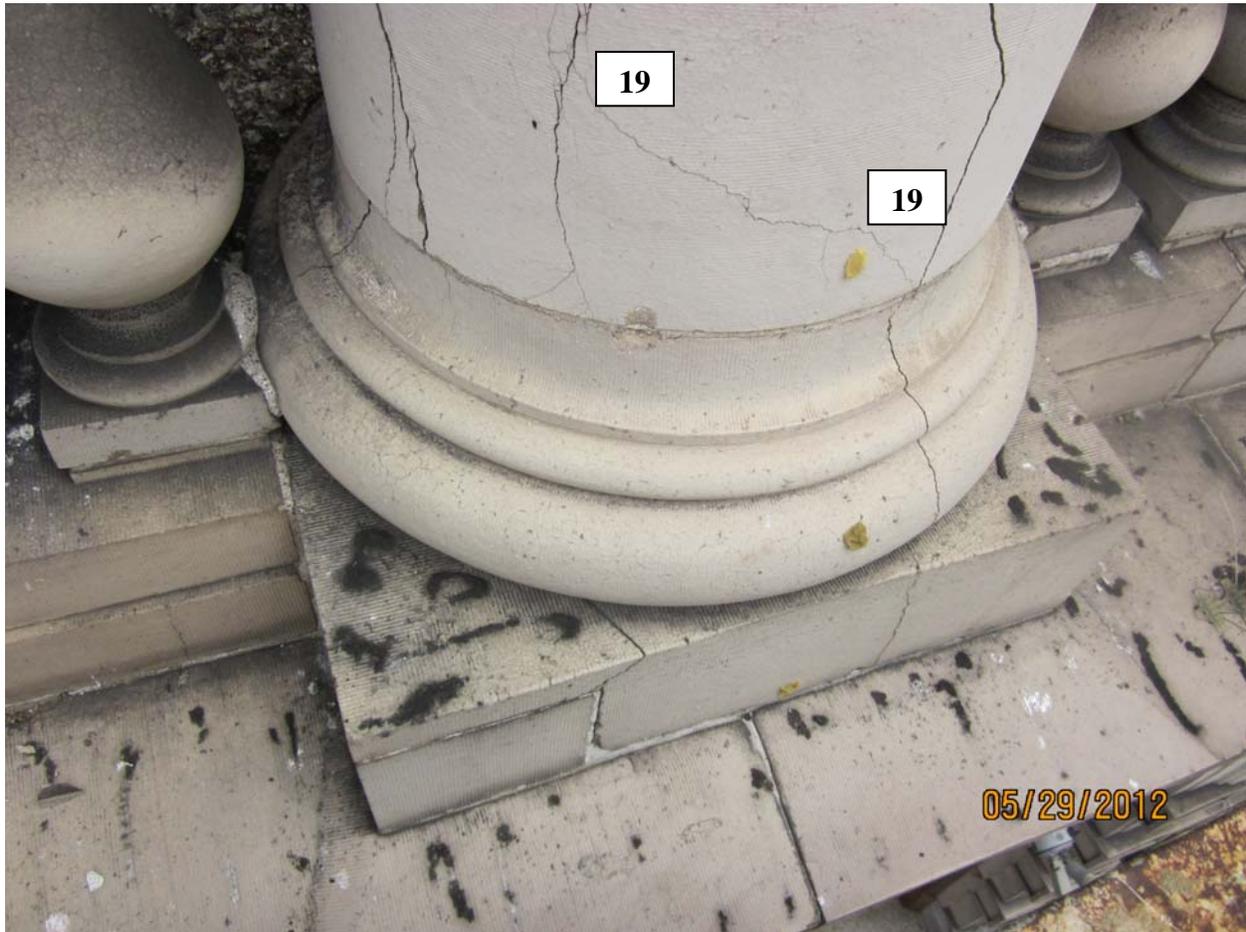
Photo 47

19. CRACKED TERRA COTTA

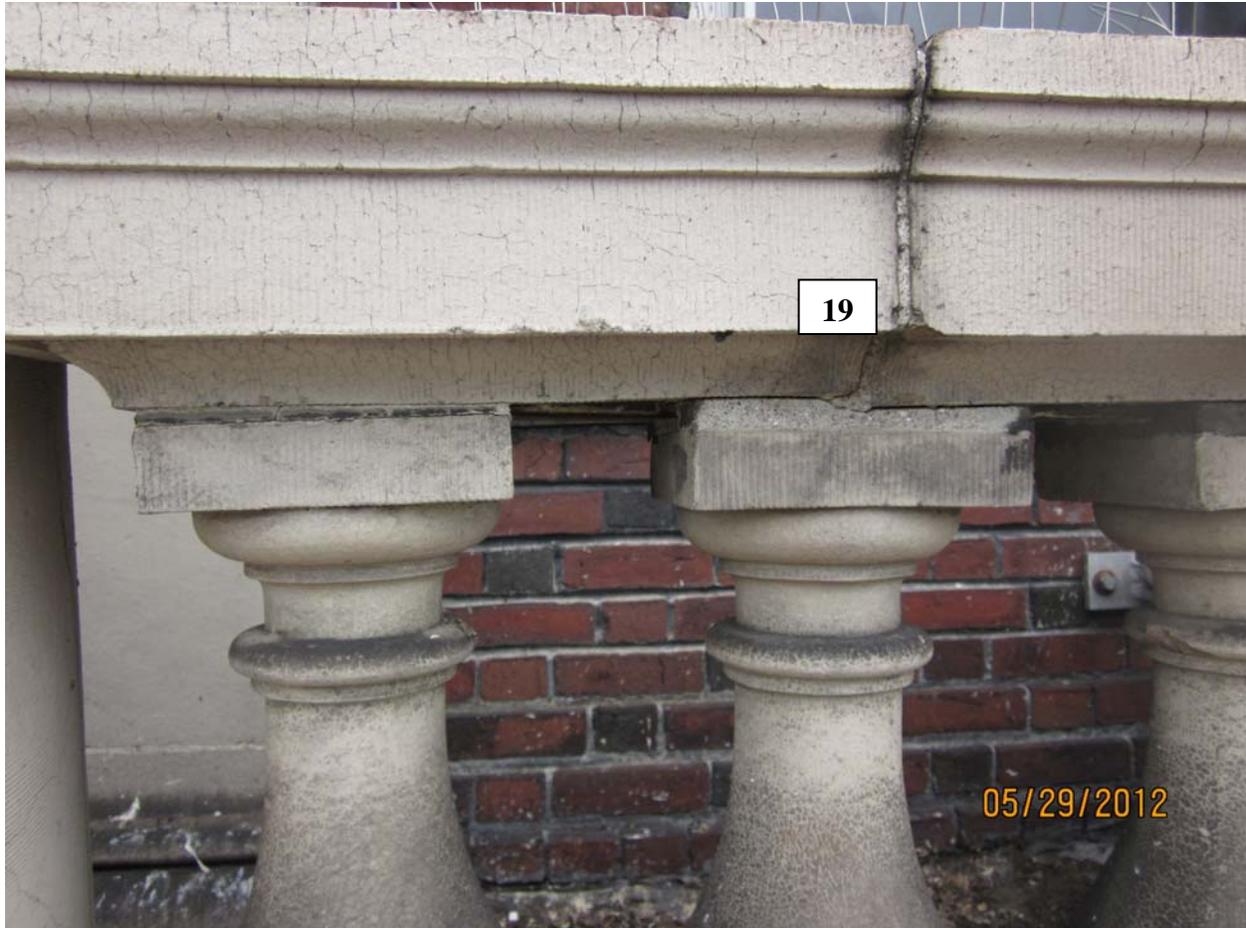
Photo 48

19. CRACKED TERRA COTTA

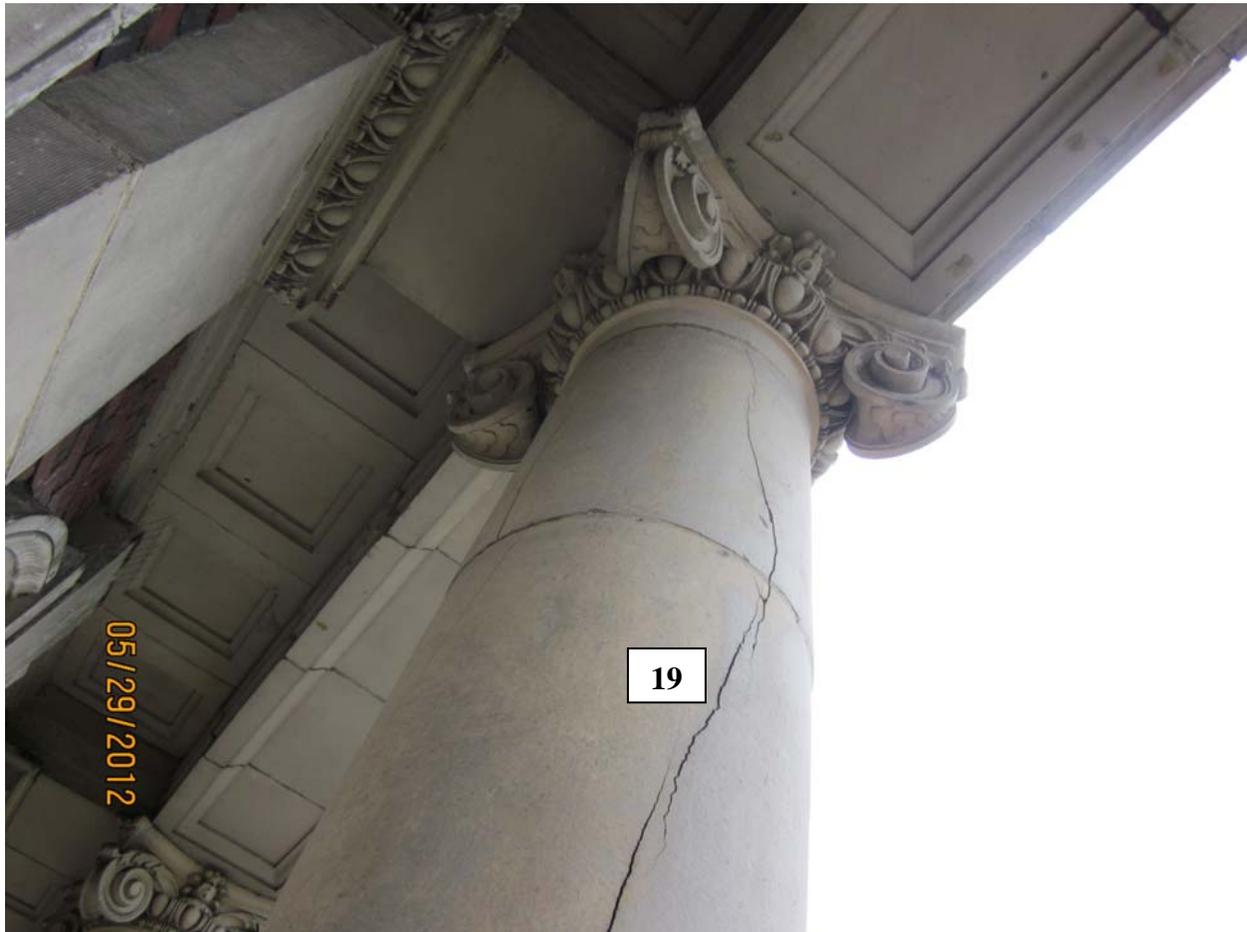
Photo 49

19. CRACKED TERRA COTTA

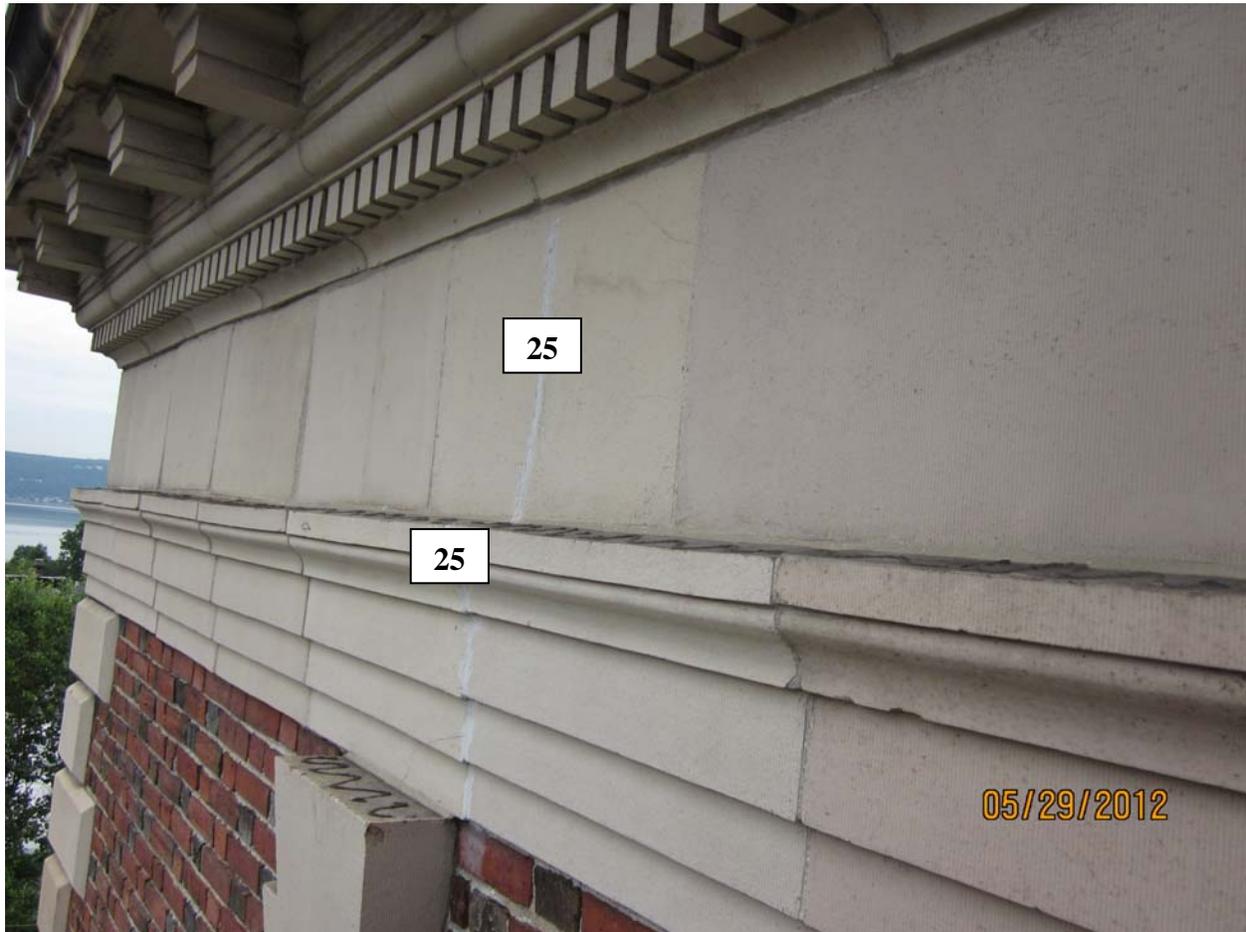
Photo 50

25. PREVIOUSLY PATCHED AREA

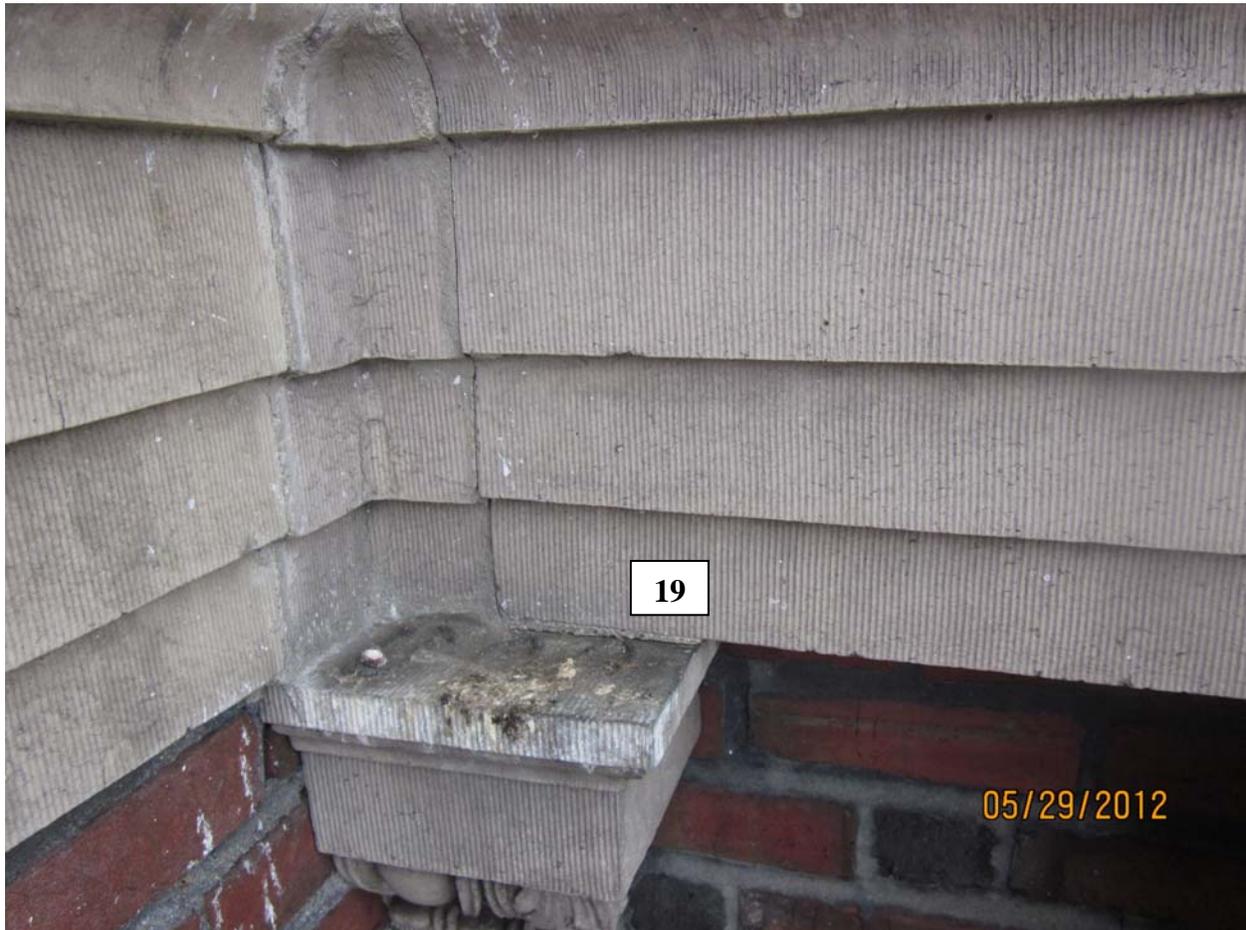
Photo 51

19. CRACKED TERRA COTTA

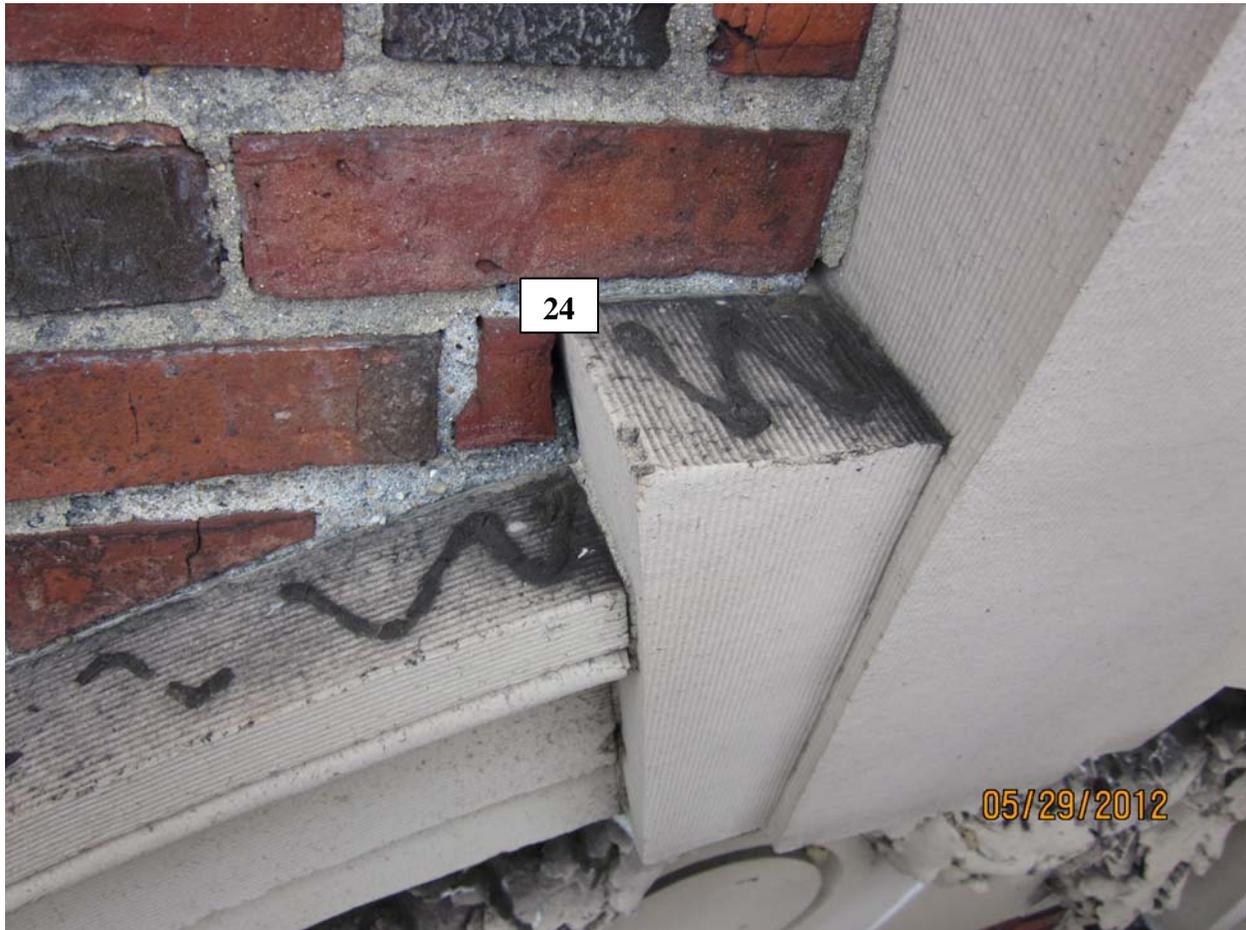
Photo 52

24. LOOSE MASONRY UNIT

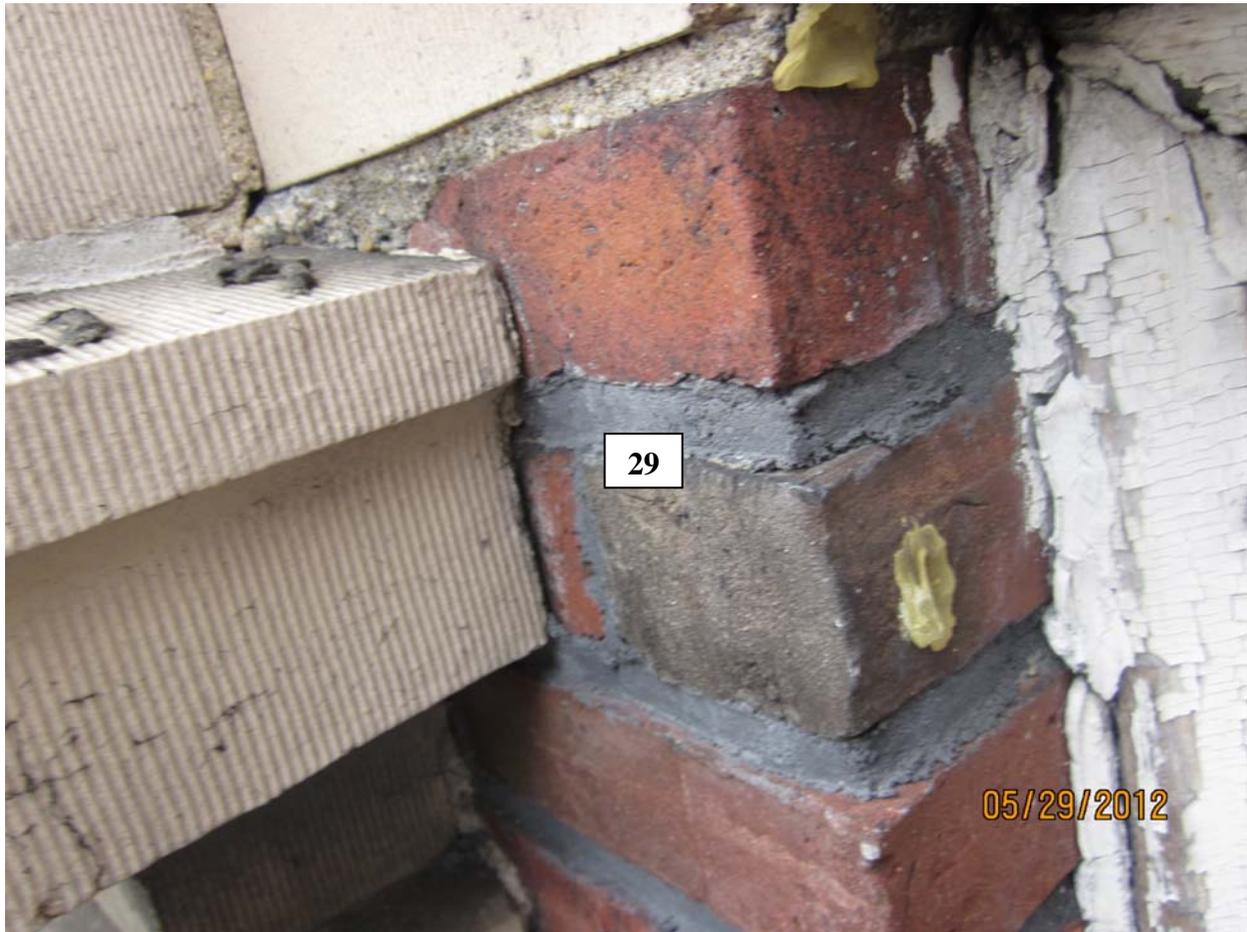
Photo 54

29. DISPLACED BRICK

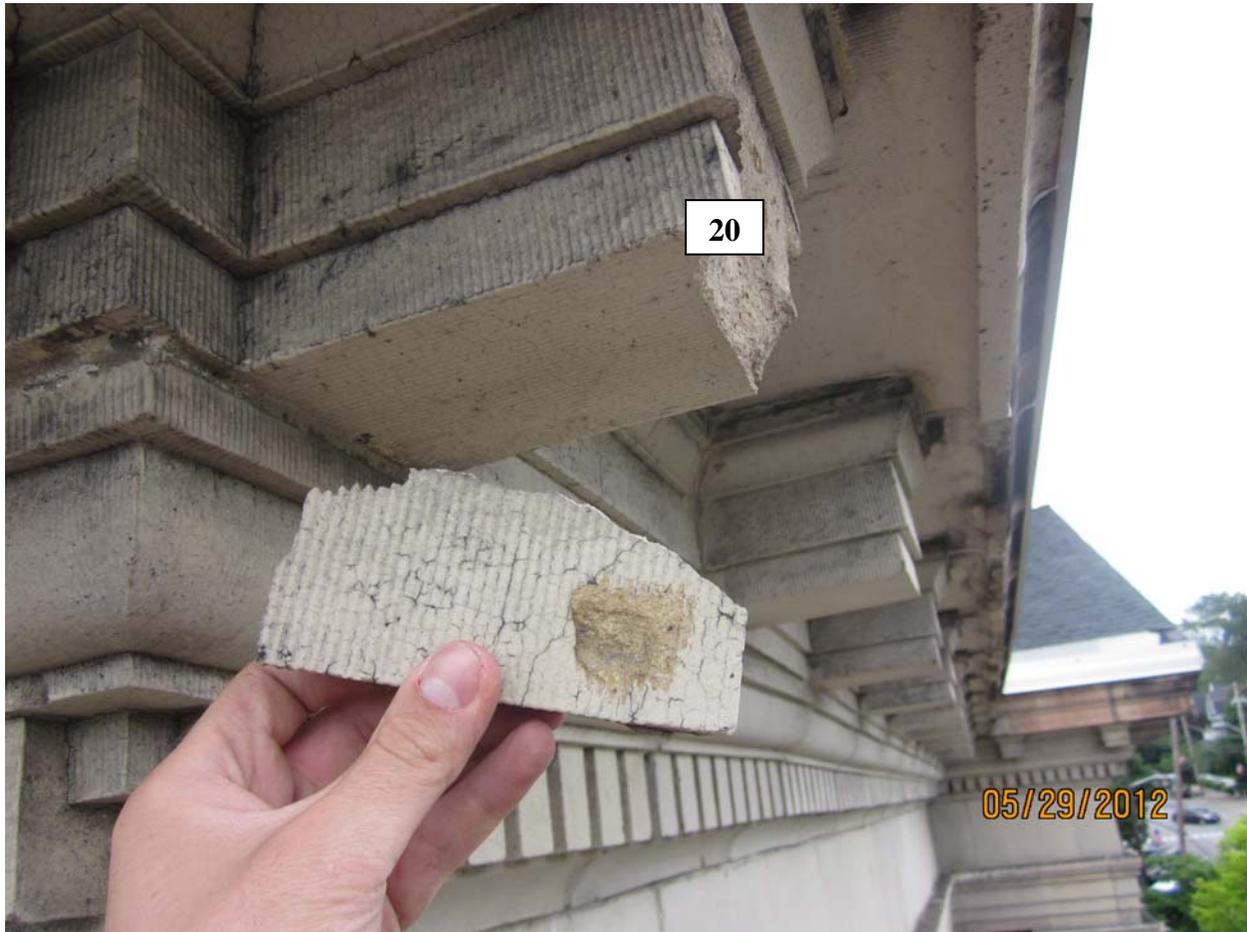
Photo 55

20. SPALLED TERRA COTTA

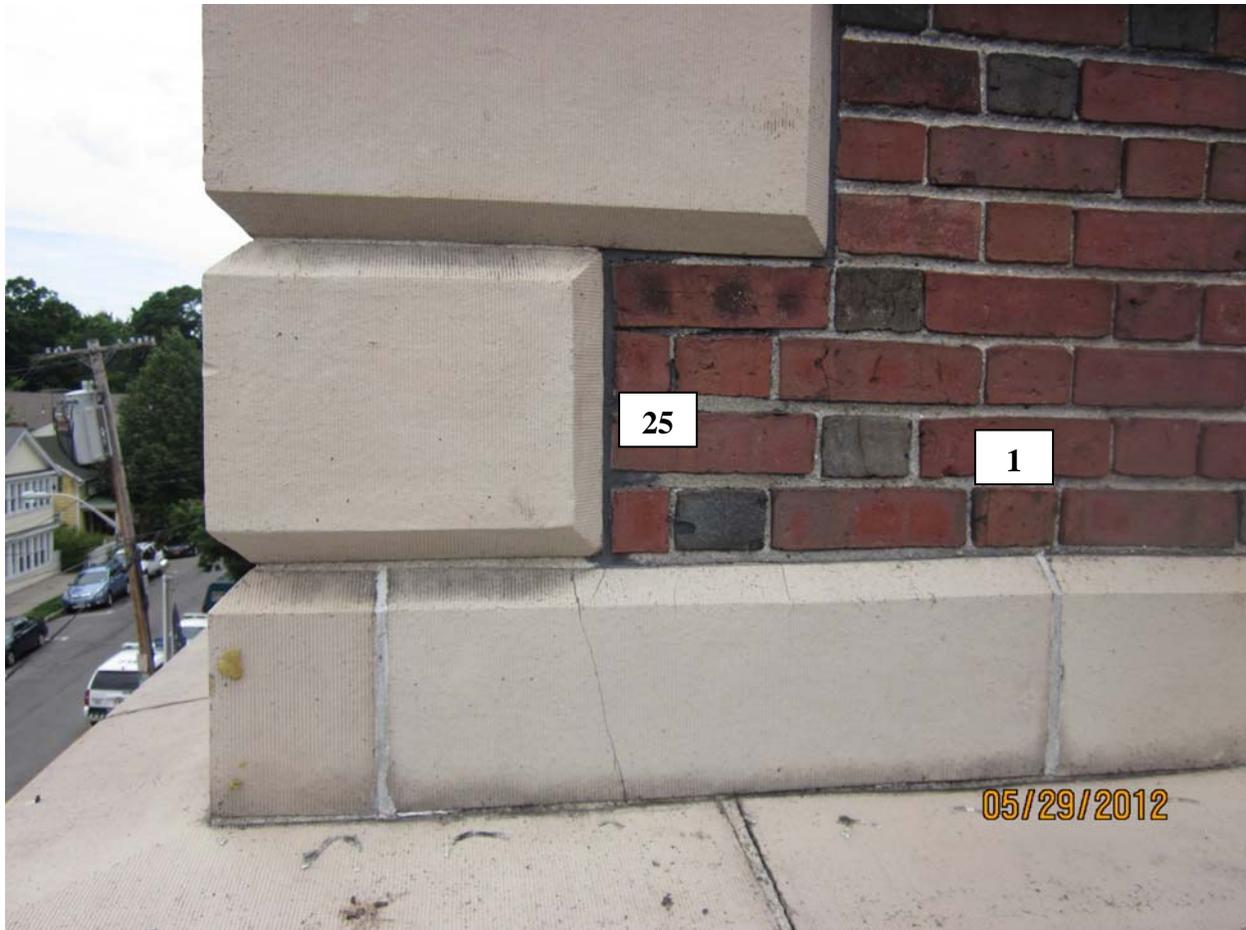
Photo 59

1. REPOINTING/EXTENSIVE ERODING OF ORIGINAL POINTING OF MASONRY
25. PREVIOUSLY PATCHED AREA

Re-pointing is recommended in areas where original re-pointing has deteriorated, eroded or brick is showing signs of efflorescence. Brick cleaning should involve hand washing with a mild detergent and a stiff bristle brush. Sandblasting is not recommended for cleaning of these areas. If sandblasting method is chosen, sandblasting should be used with caution and afterwards the masonry should be sealed with a waterproofing material. Regardless of what cleaning method is used, post cleaning the masonry should be sealed with a high quality waterproofing material or sealant. The efflorescence may reappear however because there still may be water inside the wall. The efflorescence already indicates that soluble alkali sulfates may exist in the wall and that the sulfates have found viable paths to the surface. The goal is to now prevent moisture from re-entering the masonry and rendering the sulfates into solution.

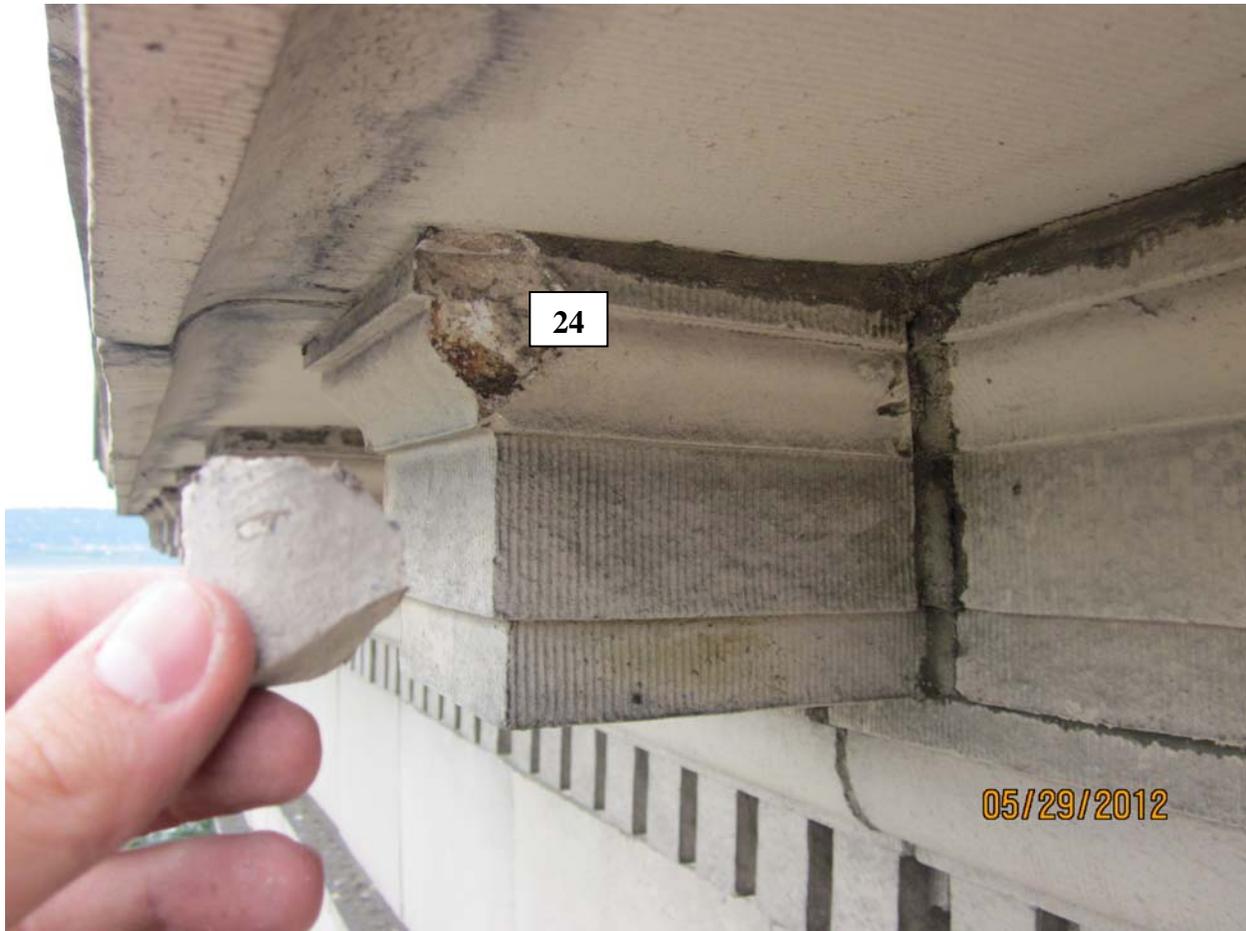
Photo 60

- 20. SPALLED TERRA COTTA
- 24. LOOSE MASONRY UNIT

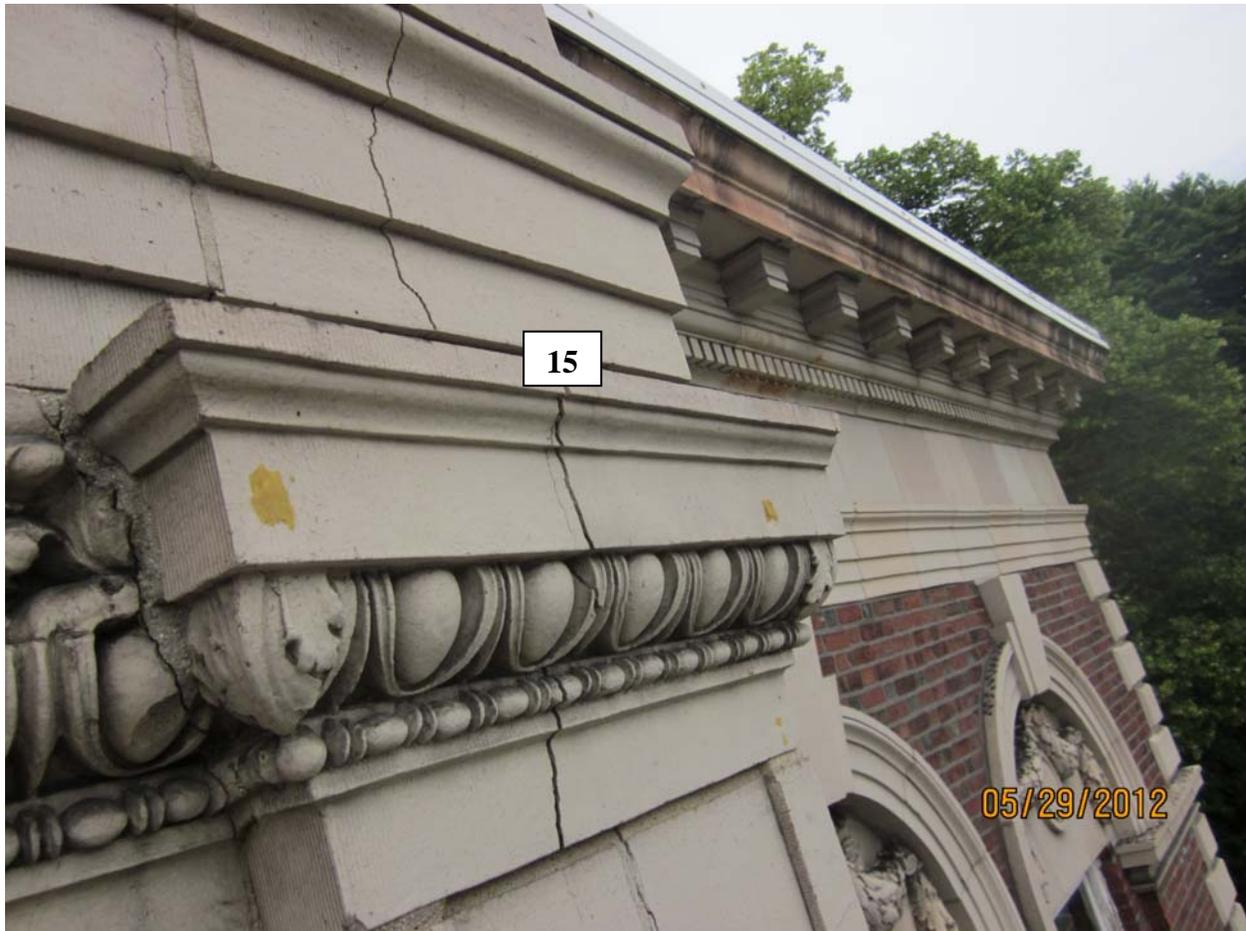
Photo 61

15. TERRA COTTA COLUMNS AND PILASTERS IN THE PORTICO ARE IN POOR CONDITION. THE BASE AND CAPITALS ARE ALSO IN POOR CONDITION WITH VISUAL SIGNS OF EXTENSIVE CRACKING

Due to the severity of the cracking on the South face portico we recommend completely replacing all the individual pieces of each of the four columns and ornamental work in this area. The new should match existing in material, design and finish.

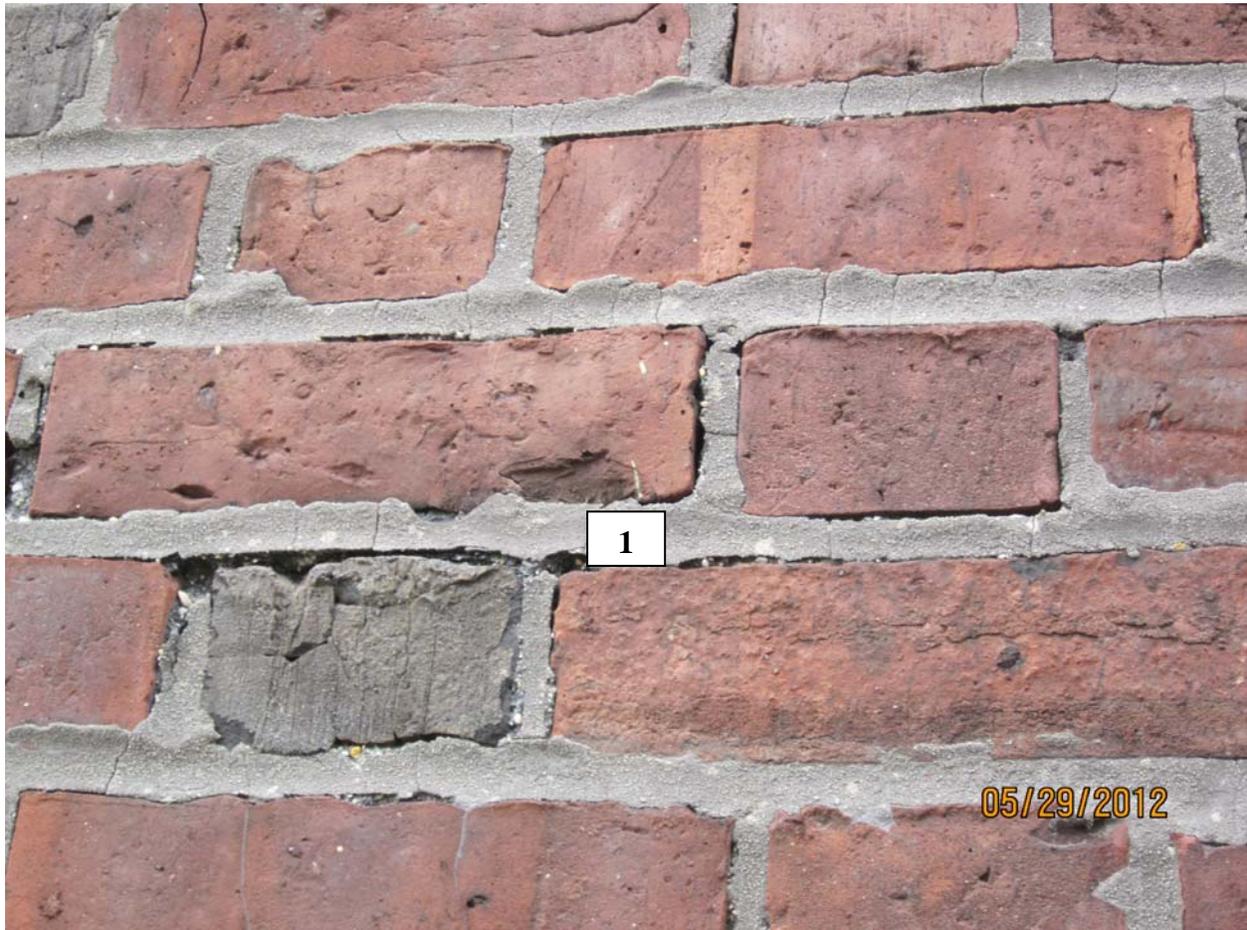
Photo 62

1. REPOINTING/EXTENSIVE ERODING OF ORIGINAL POINTING OF MASONRY

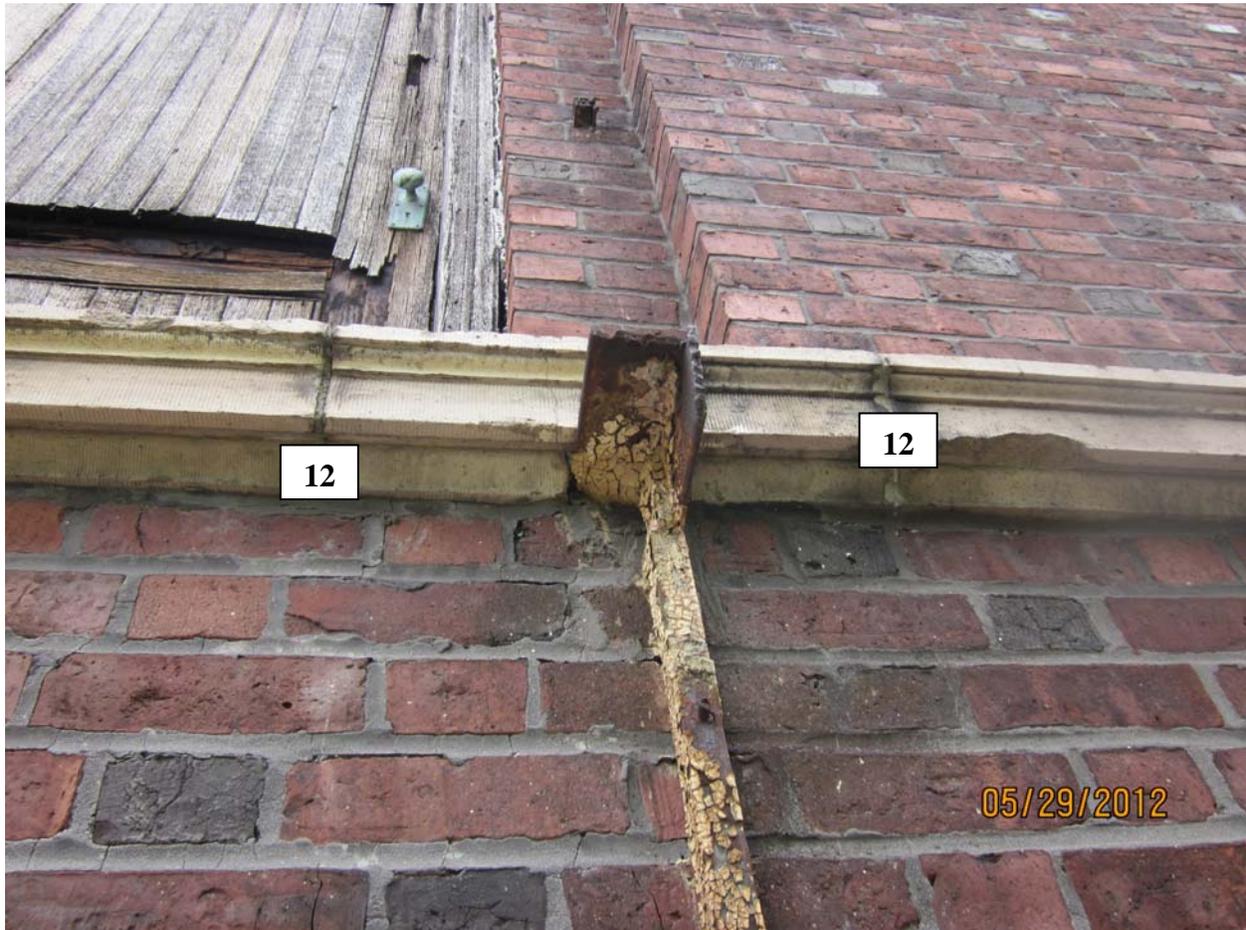
Photo 63

12. JOINTS IN POOR CONDITION

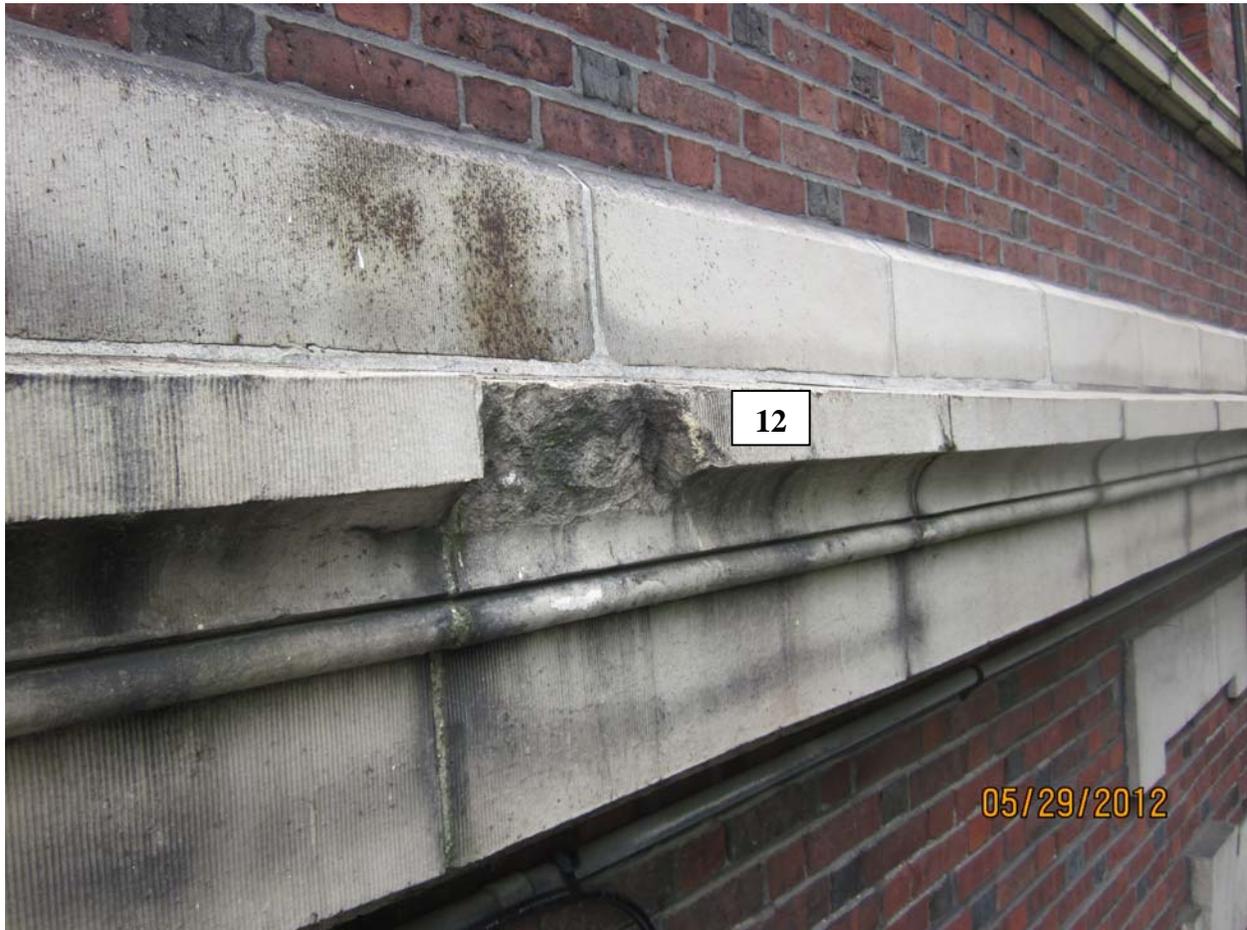
Photo 64

12. JOINTS IN POOR CONDITION

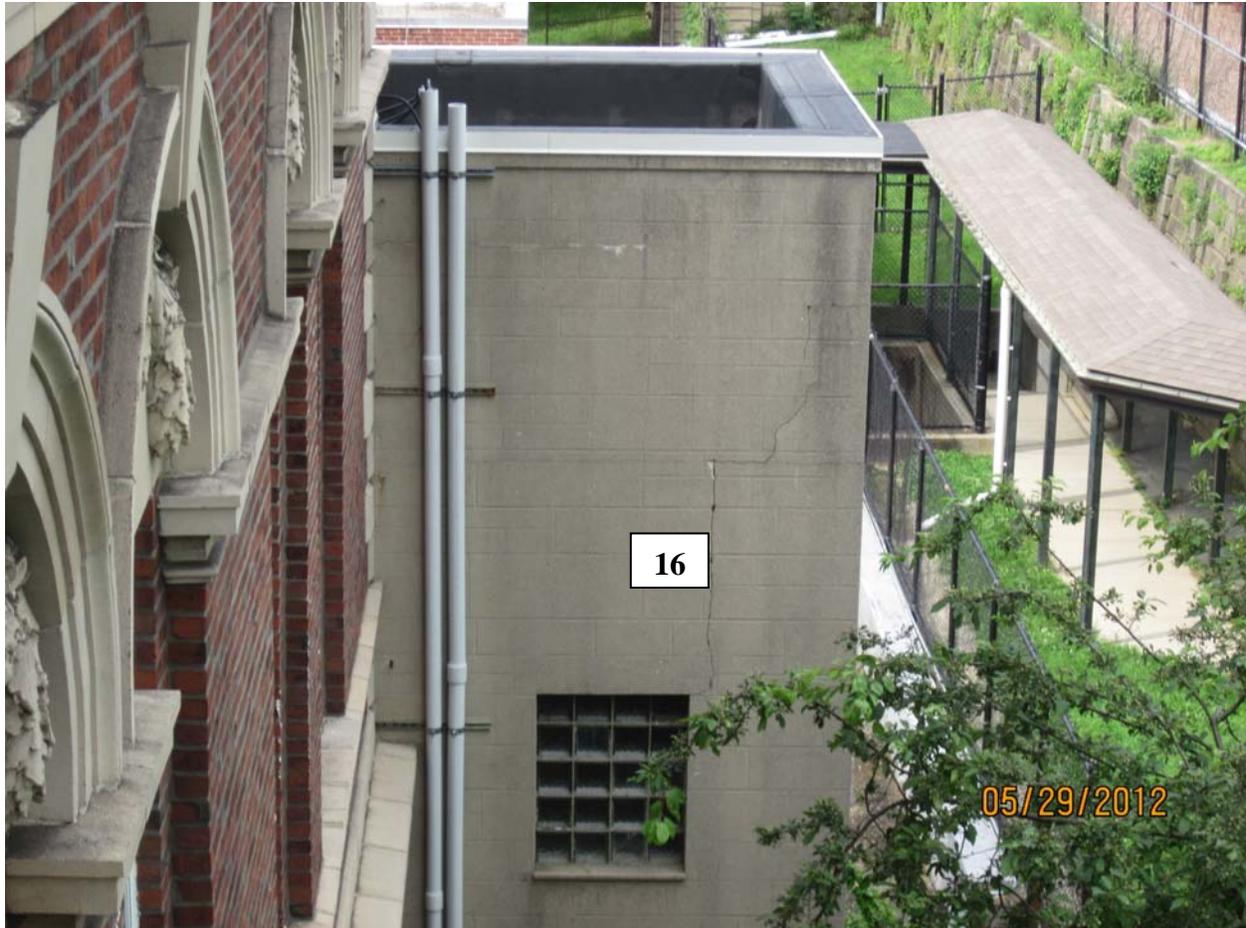
Photo 65

Refer to Section B Drawings Elevation Note 16; “Stepped cracks that run through the existing CMU joints”, (Reference Photo 8 & 65.) Settlement cracks in CMU walls are commonly known as “stair step cracks” or a crack that steps up as it moves horizontally across the wall. This is caused by unstable soil conditions under the buildings footings. These were primarily found along the North rear elevation. Building maintenance staff should be aware and expect additional movement if the settlement has not stopped.

16. STEPPED CRACKS THAT RUN THROUGH THE EXISTING MASONRY COATING IN THE CMU

Recommend patching and re-pointing of existing cracks to keep water, bugs etc from entering the building. After proper re-pointing of the stepped cracks we recommend applying a new weatherproof coating at all CMU surfaces.

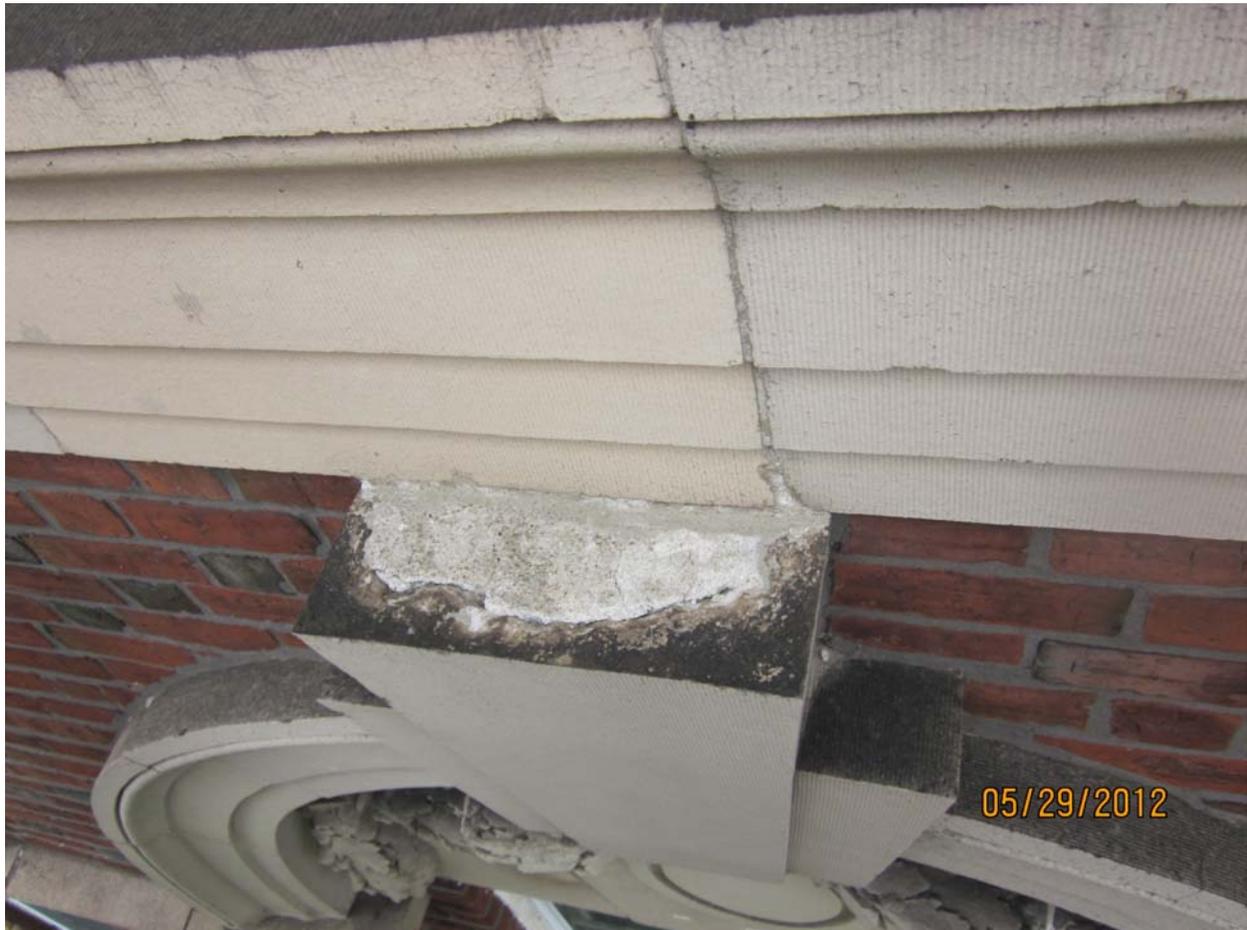
Photo 66

30. PREVIOUSLY PATCHED WINDOW HEAD
