Village of Irvington Town Hall Exterior Conditions Analysis
85 Main Street
Irvington, NY 10533

Re: **Village of Irvington Town Hall Exterior Conditions Analysis**

Exterior Conditions Analysis Irvington Town Hall

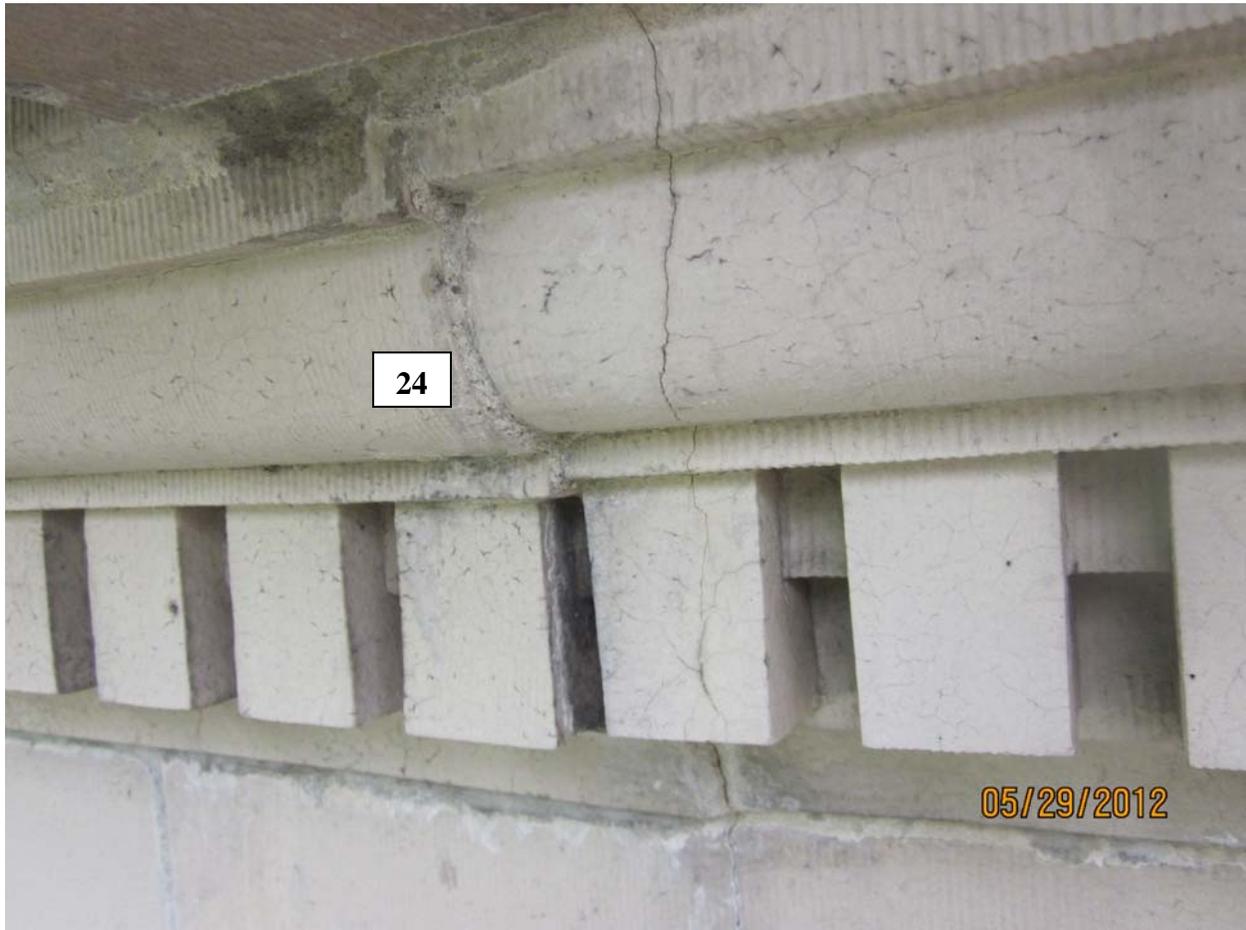
Photo 67

24. LOOSE MASONRY UNIT

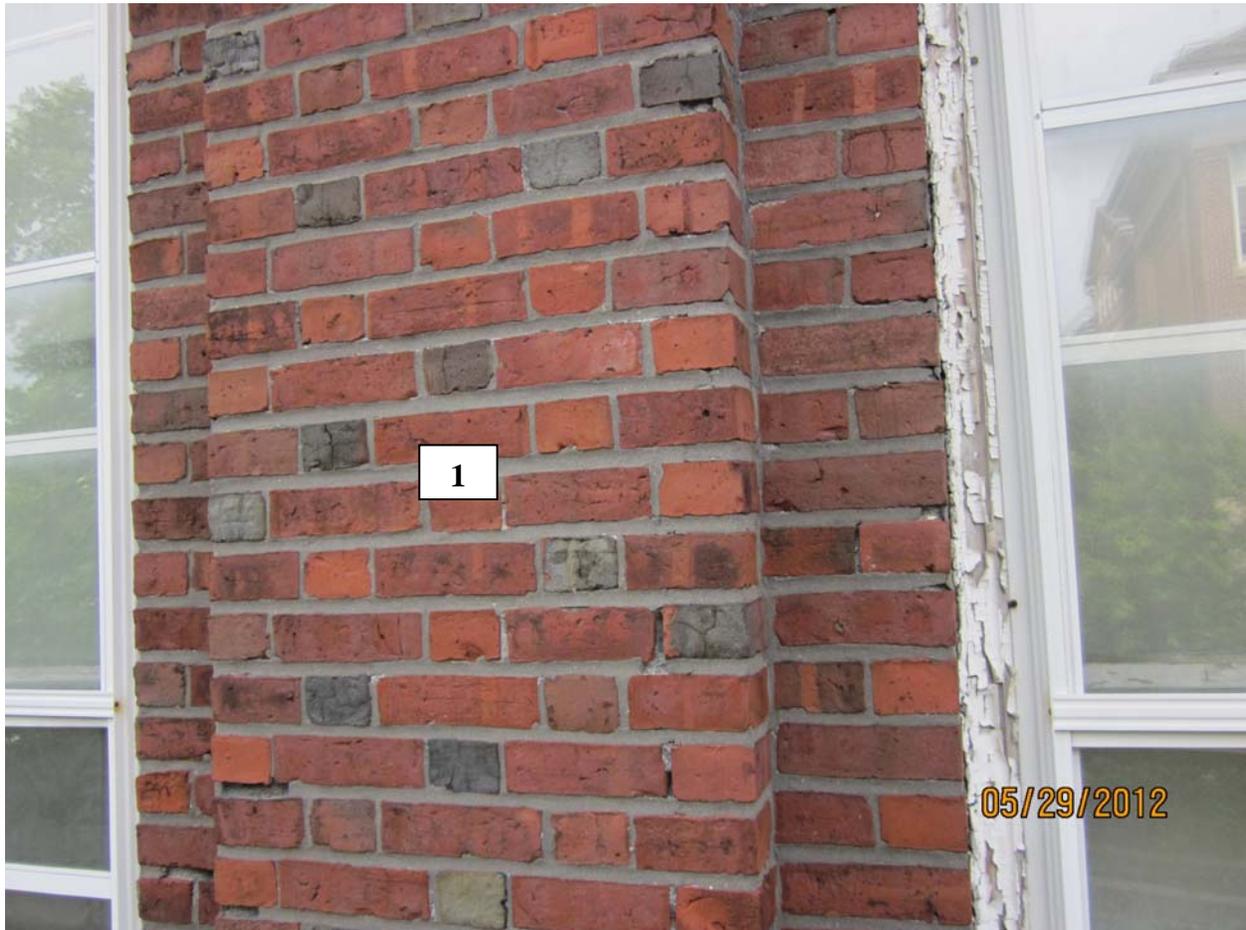
Photo 68

1. REPOINTING/EXTENSIVE ERODING OF ORIGINAL POINTING OF MASONRY

Re-pointing is recommended in areas where original re-pointing has deteriorated, eroded or brick is showing signs of efflorescence. Brick cleaning should involve hand washing with a mild detergent and a stiff bristle brush. Sandblasting is not recommended for cleaning of these areas. If sandblasting method is chosen, sandblasting should be used with caution and afterwards the masonry should be sealed with a waterproofing material. Regardless of what cleaning method is used, post cleaning the masonry should be sealed with a high quality waterproofing material or sealant. The efflorescence may reappear however because there still may be water inside the wall. The efflorescence already indicates that soluble alkali sulfates may exist in the wall and that the sulfates have found viable paths to the surface. The goal is to now prevent moisture from re-entering the masonry and rendering the sulfates into solution.

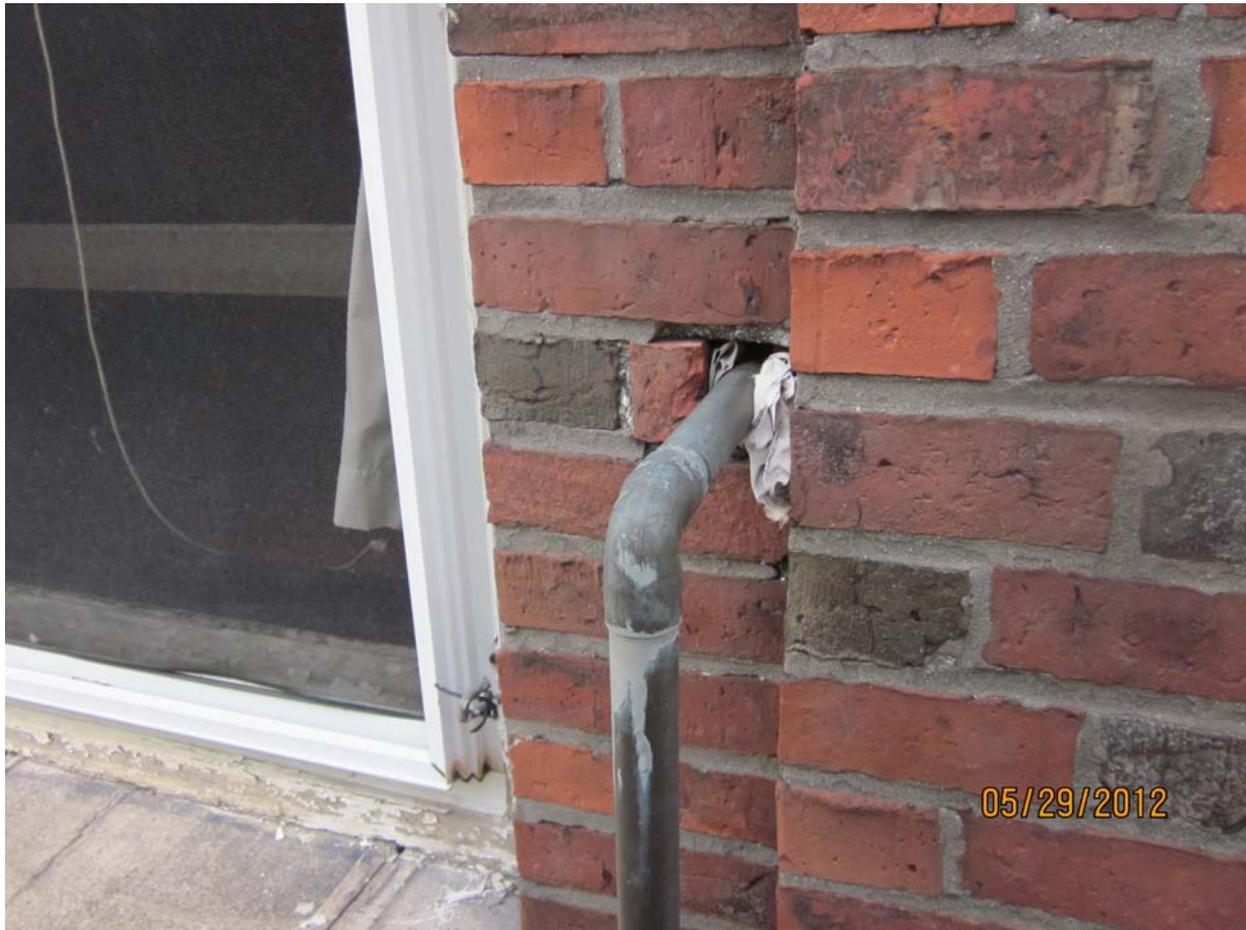
Photo 69

31. EXPOSED PIPE AND ASSOCIATED LOOSE BRICK

Recommend: Removing the loose brick, lay new mortar bed and reinsert loose bricks. Reseal and repoint surrounding areas.

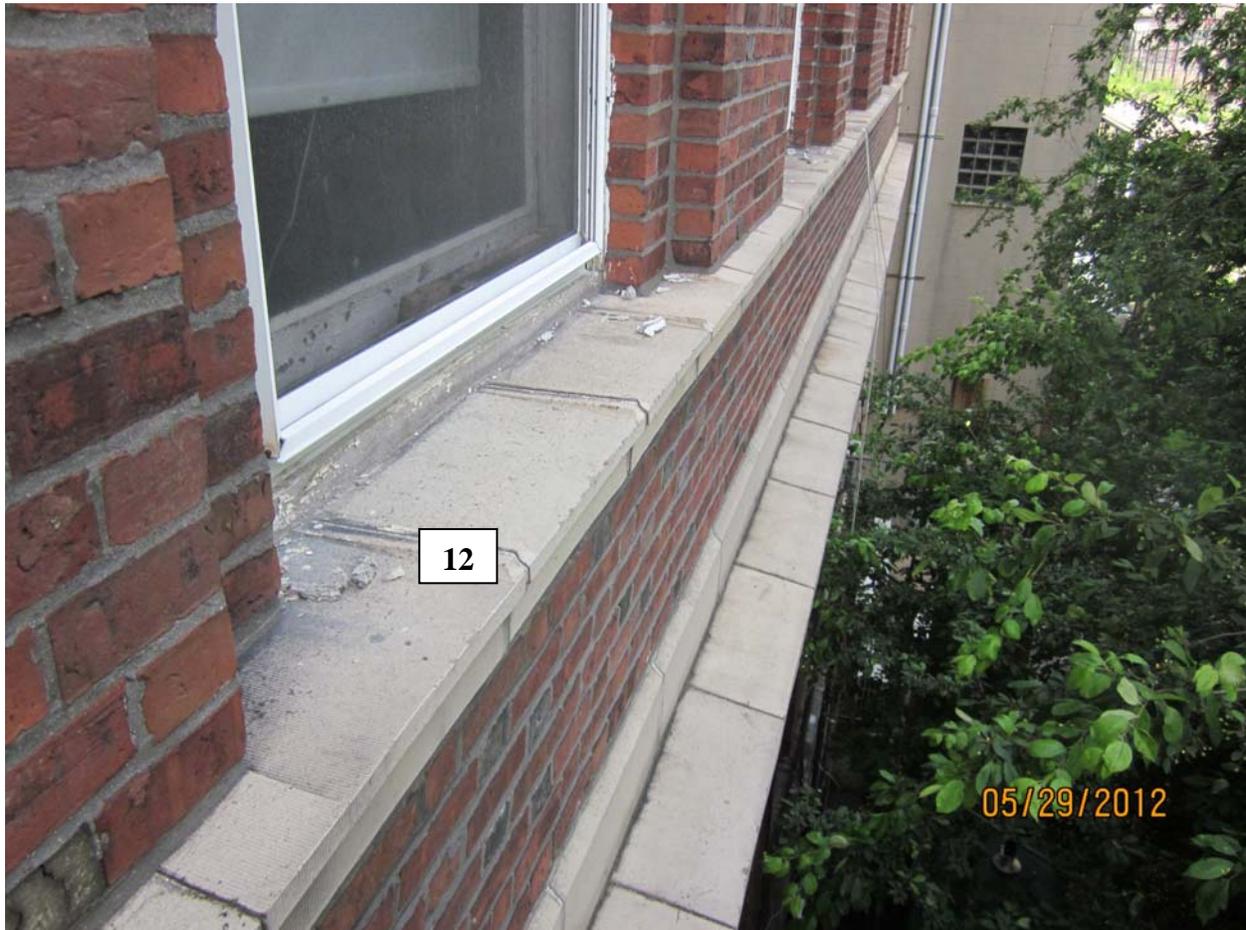
Photo 70

12. JOINTS IN POOR CONDITION

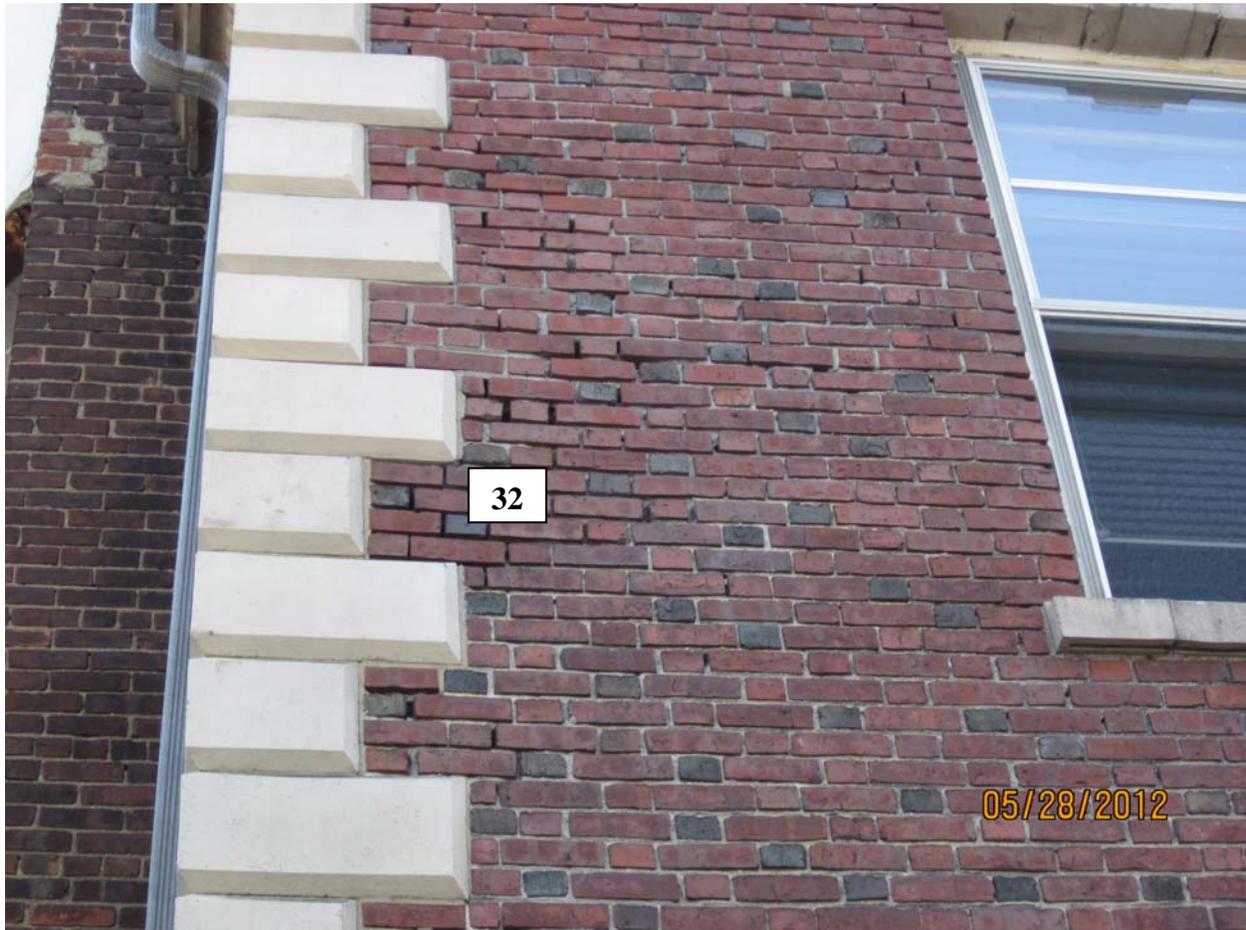
Photo 71

32. REPOINTING/EXTENSIVE ERODING OF ORIGINAL POINTING OF MASONRY

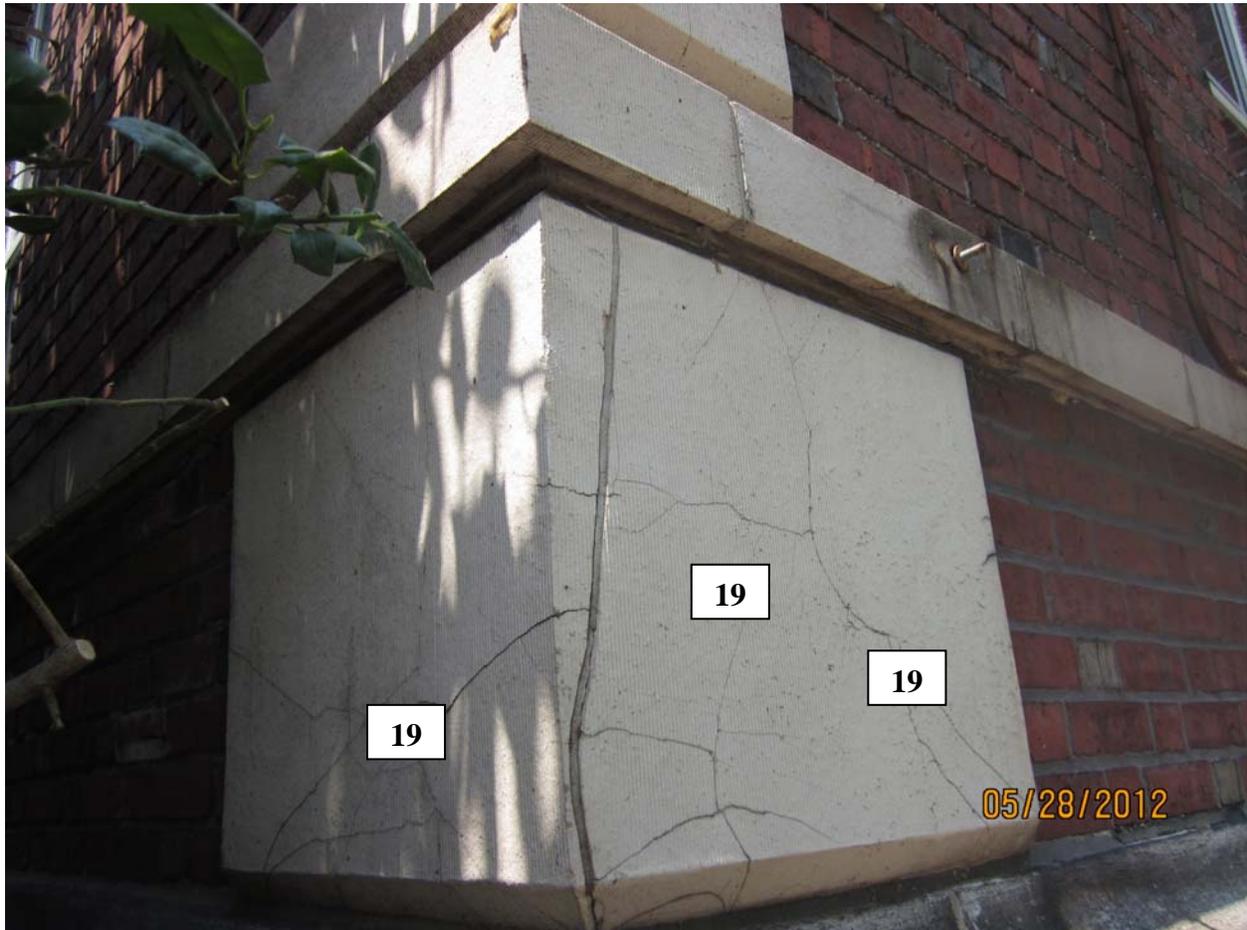
Photo 72

19. CRACKED TERRA COTTA

Terra Cotta spalling and cracking areas throughout the building we recommend the use of Custom System 45 and Elastowall 351, Elastomastic 352 or similar products for the miscellaneous patching and repair of the damaged areas. An allowance is also recommended for miscellaneous isolated areas requiring patching.

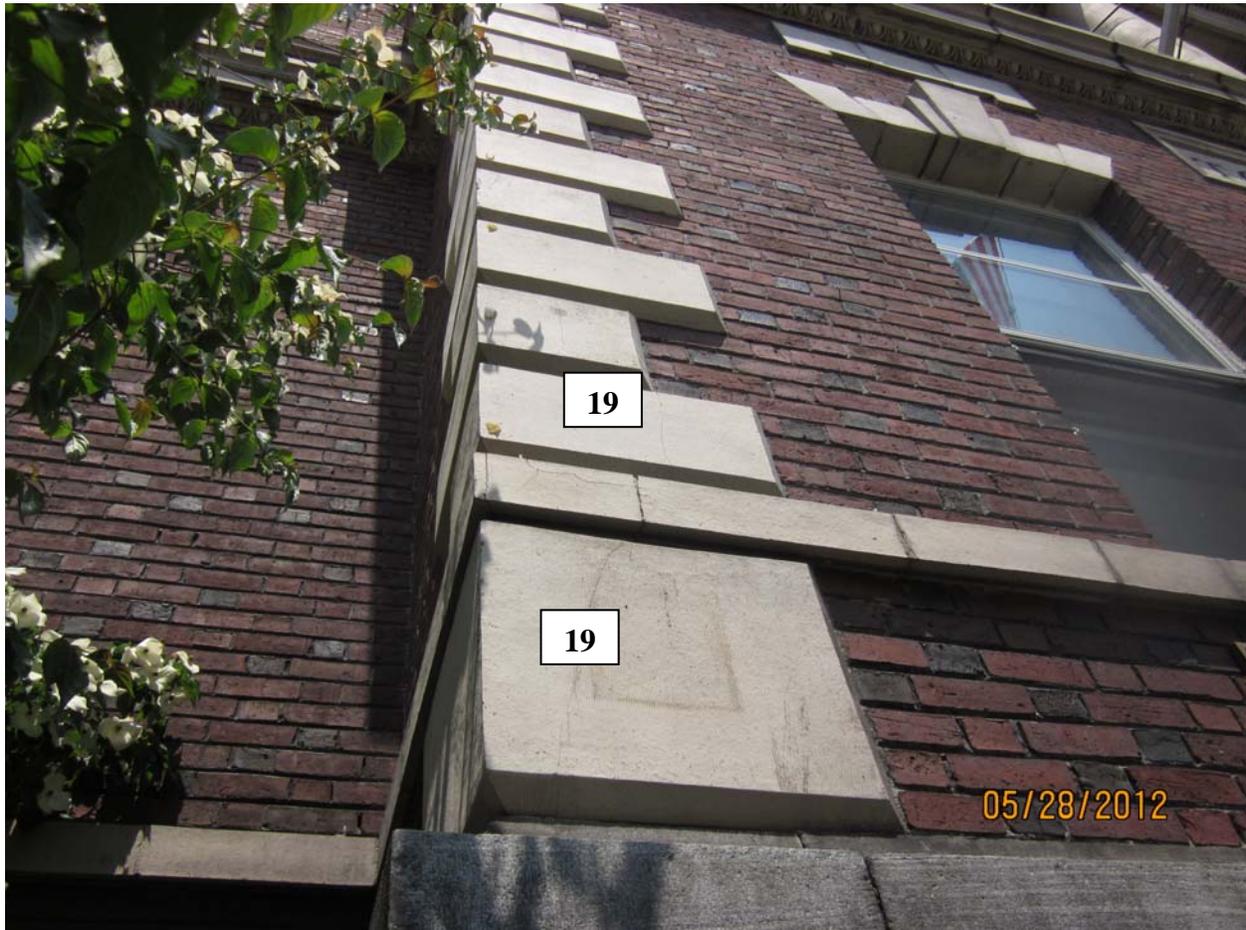
Photo 74

19. CRACKED TERRA COTTA

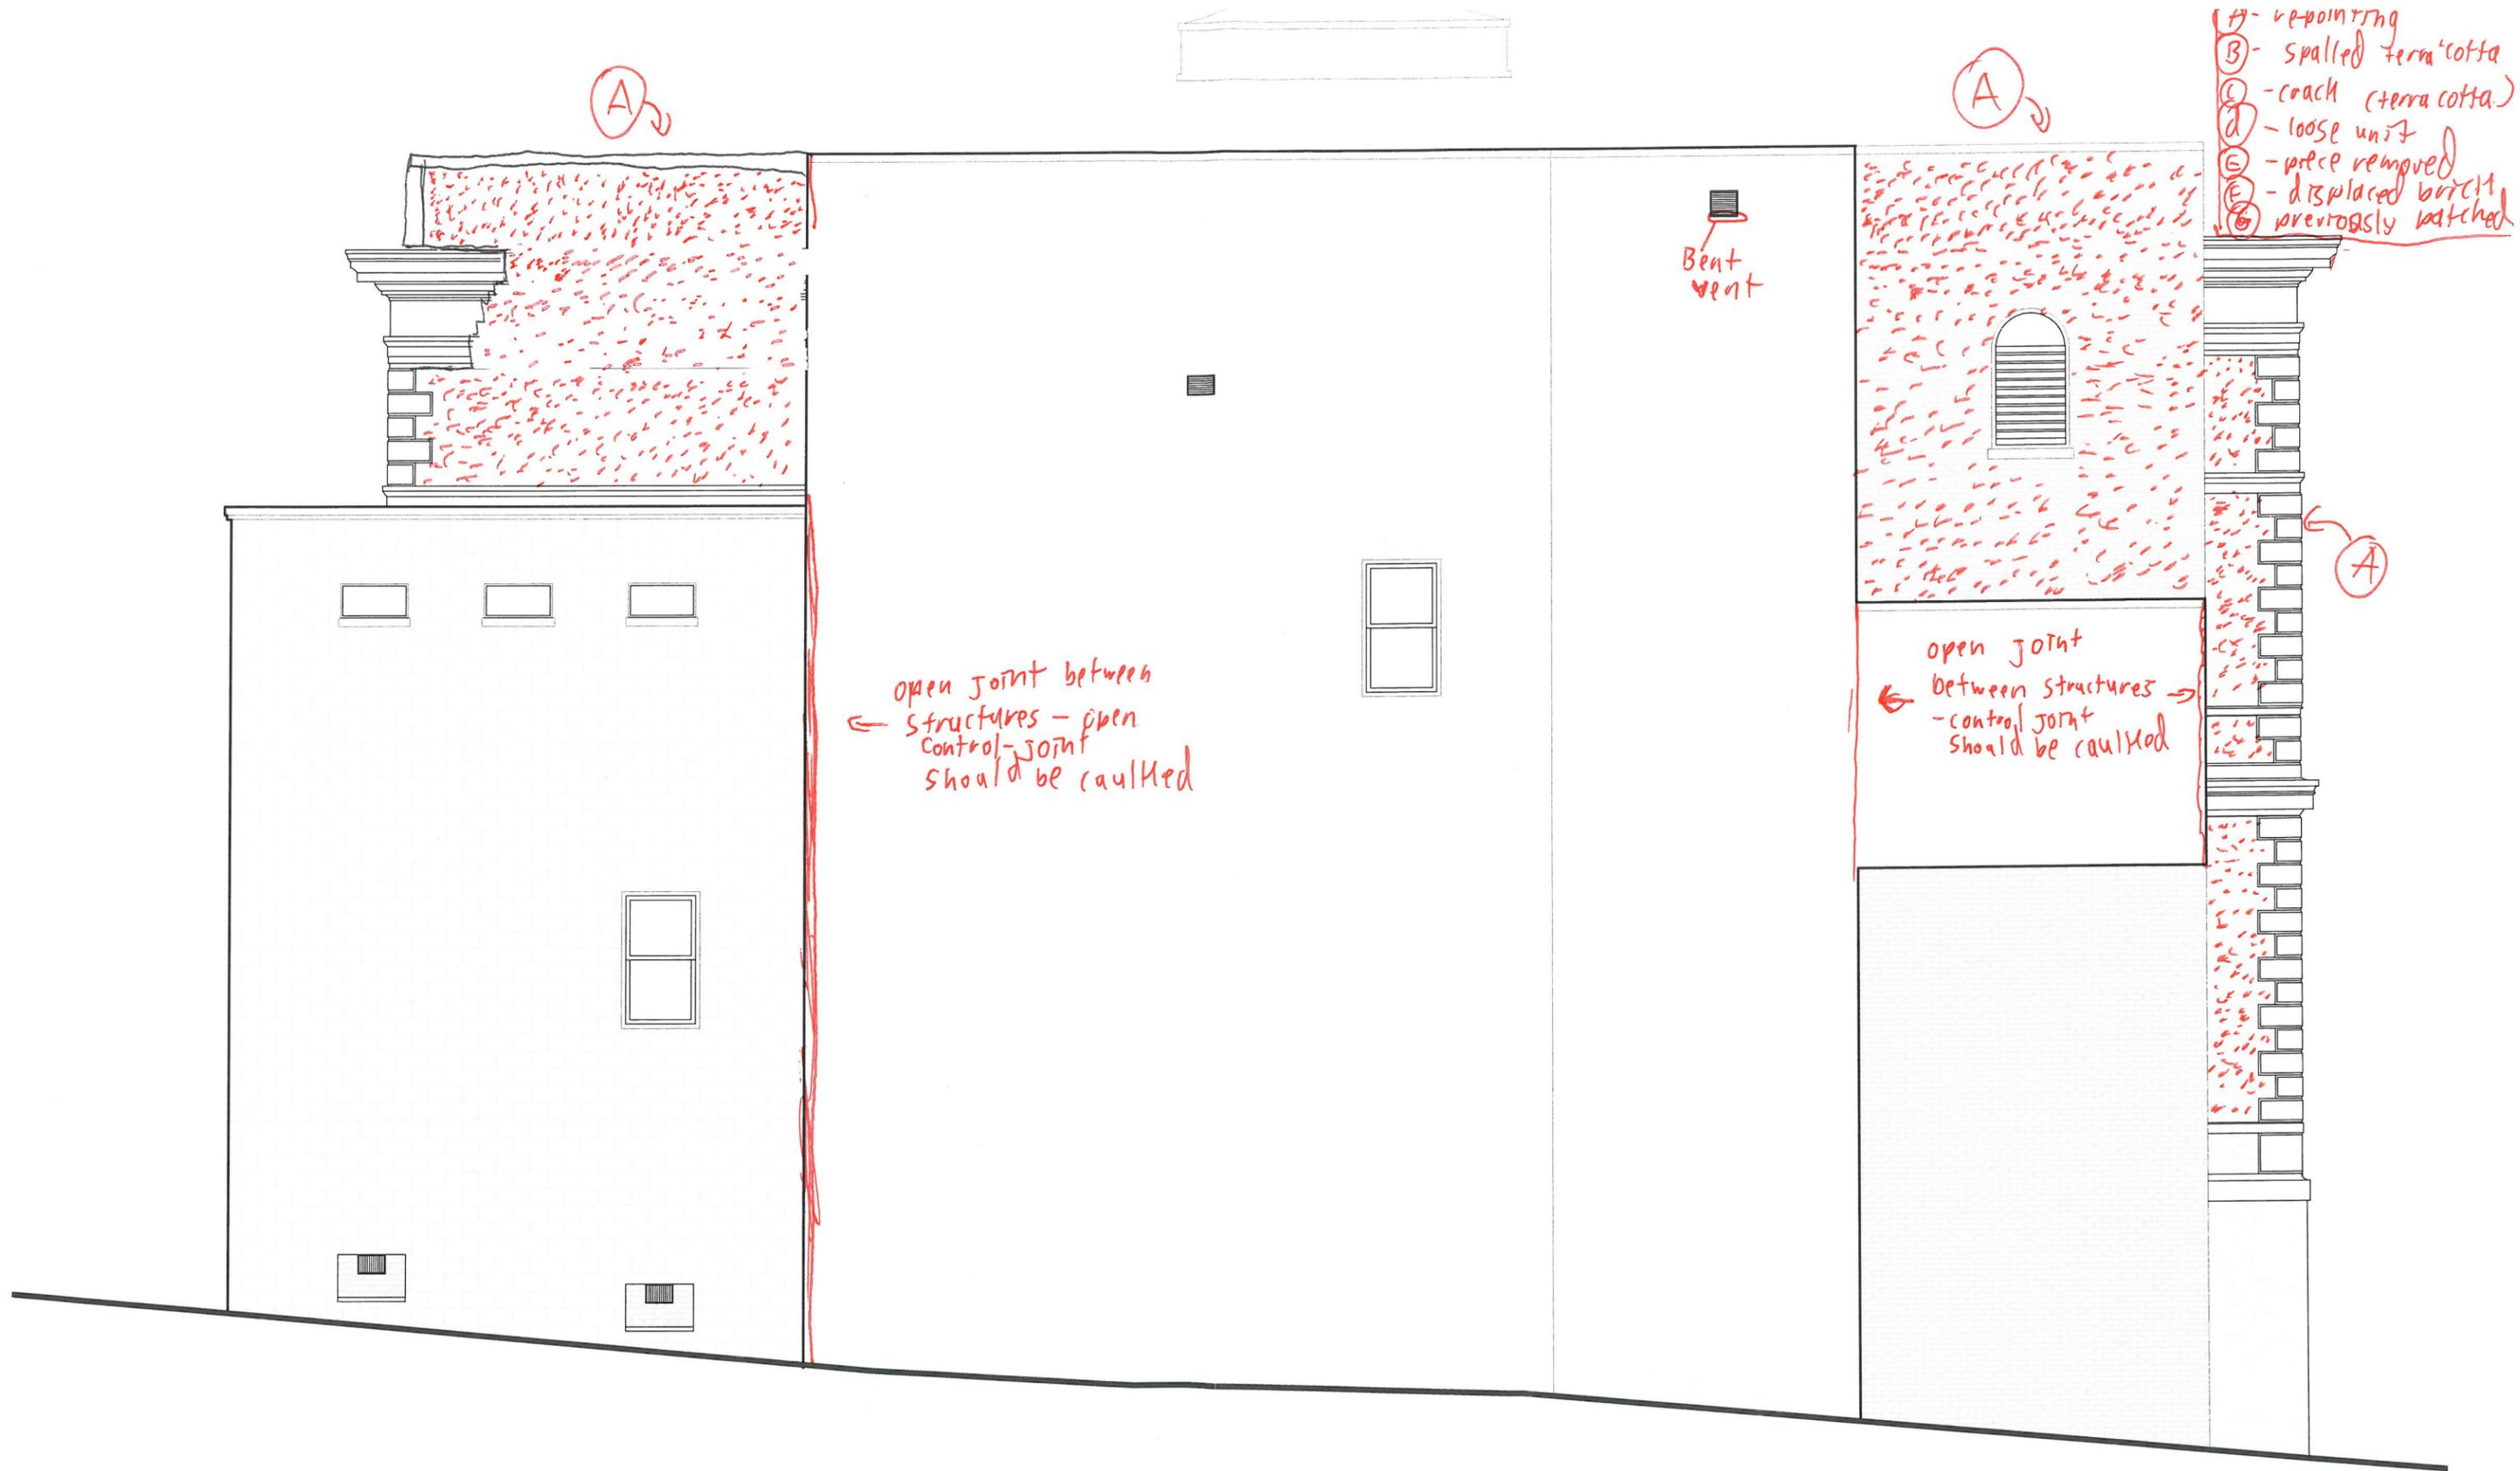
← open joint between structures - open control-joint should be caulked
