ROADWAY ASSESSMENT REPORT
FOR THE
VILLAGE OF IRVINGTON
PUBLIC WORKS DEPARTMENT

PREPARED BY
JAMES J. HAHN ENGINEERING, P.C.
PUTNAM BUSINESS PARK
1689 ROUTE 22
BREWSTER, NEW YORK 10509

April, 2023

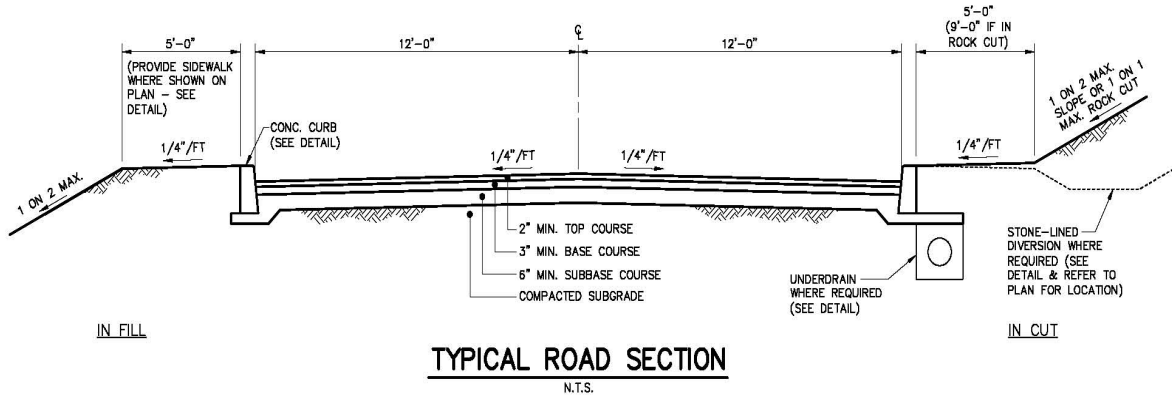
The detail above is a typical cross section of a road that includes curbs, asphalt surface, subbase material and an under drain. The typical cross pitch is ¼ inch per foot. The crown of the roadway is at the center line where water pitches to either side. An underdrain may be used in high groundwater table conditions or excessive runoff from an uphill slope.

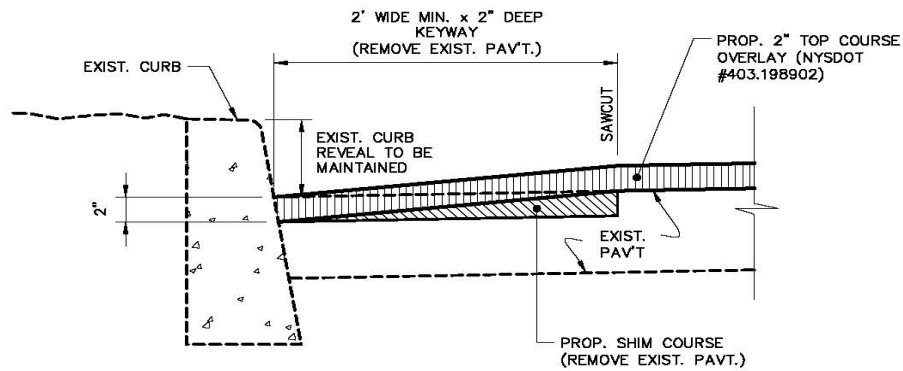
SECTION

NOTE:
TACK COAT EXISTING SURFACES PRIOR TO PLACEMENT OF NEW ASPHALTIC COURSES.

The detail above is a typical cross section of a pavement keyway used to maintain proper curb reveal during pavement overlaying.
