Village of Irvington Town Hall Exterior Conditions Analysis
85 Main Street
Irvington, NY 10533

Re: **Village of Irvington Town Hall Exterior Conditions Analysis**

Exterior Conditions Analysis Irvington Town Hall

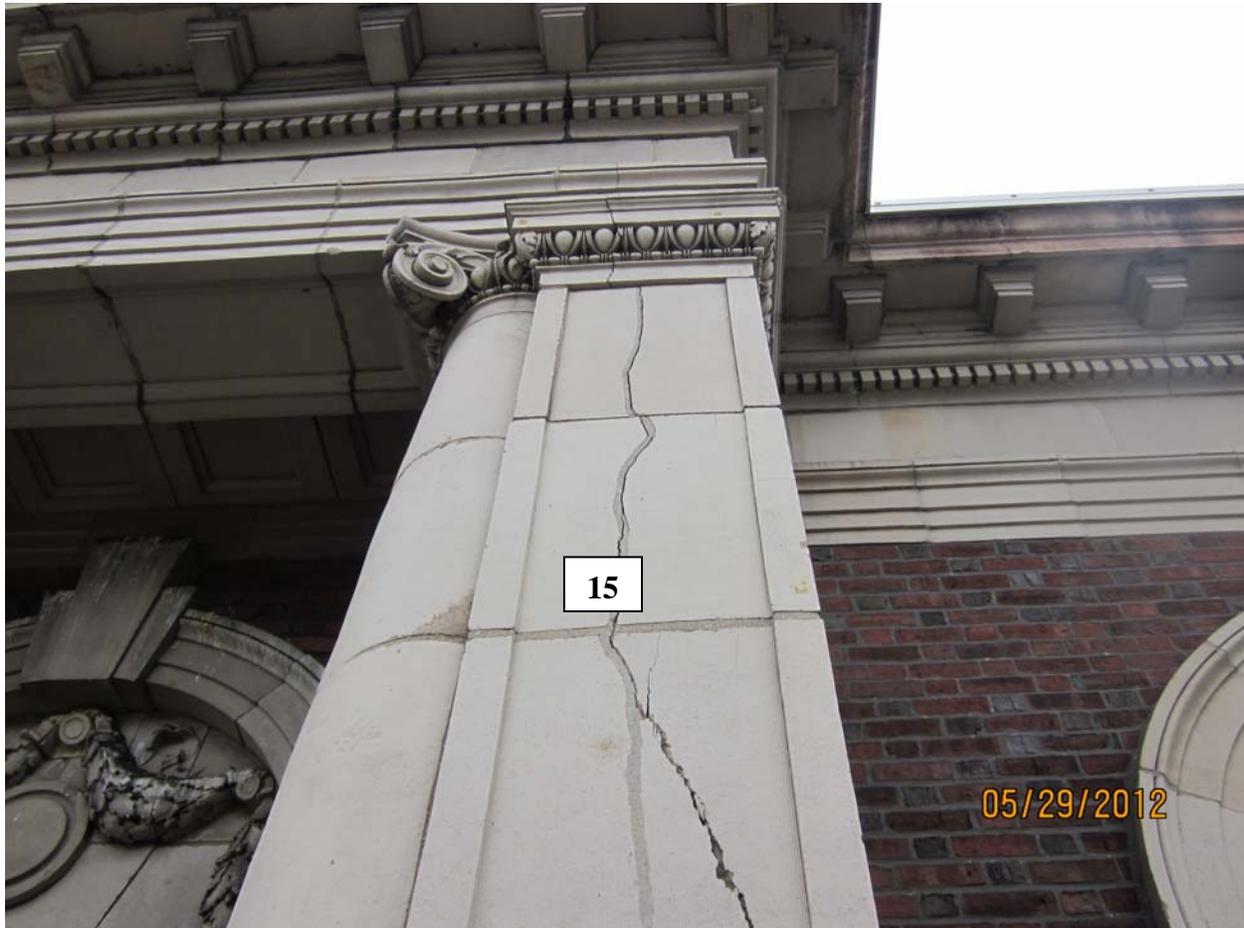
Photo 10

23. PREVIOUSLY PATCHED AND PINNED AREA. IN POOR CONDITION

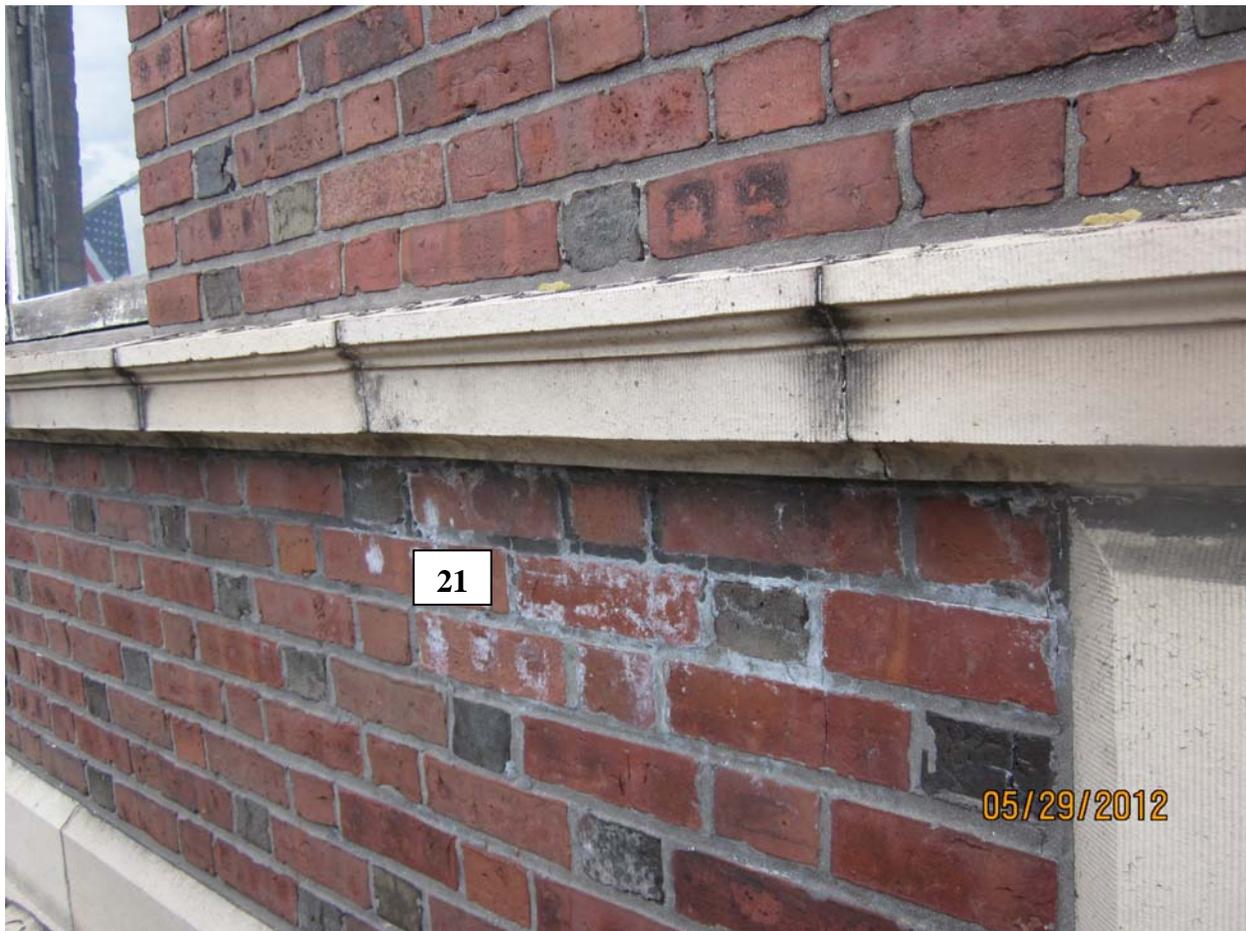
Photo 22

21. PRESENCE OF EFFLORESCENCE

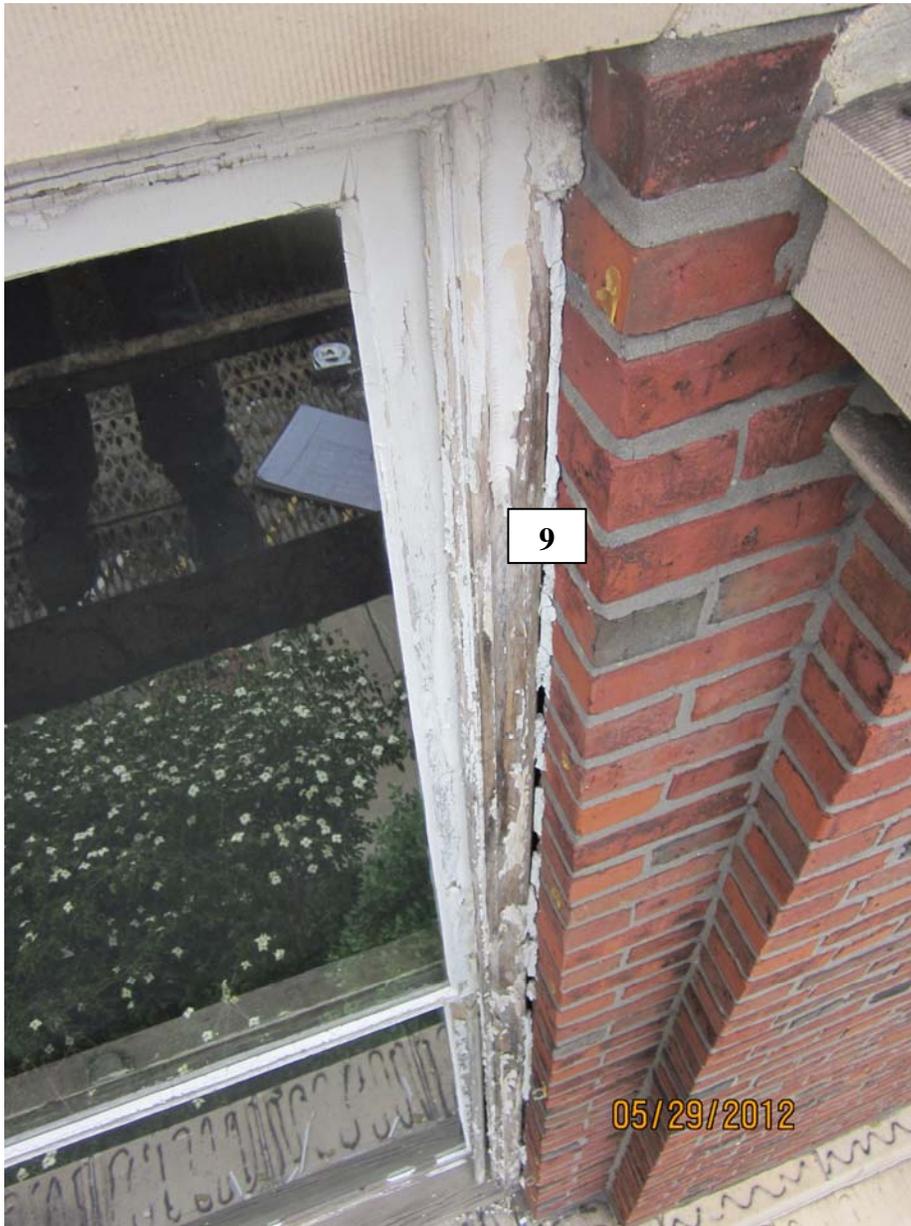
Photo 26

9. EXISTING CAULK JOINT IN POOR CONDITION

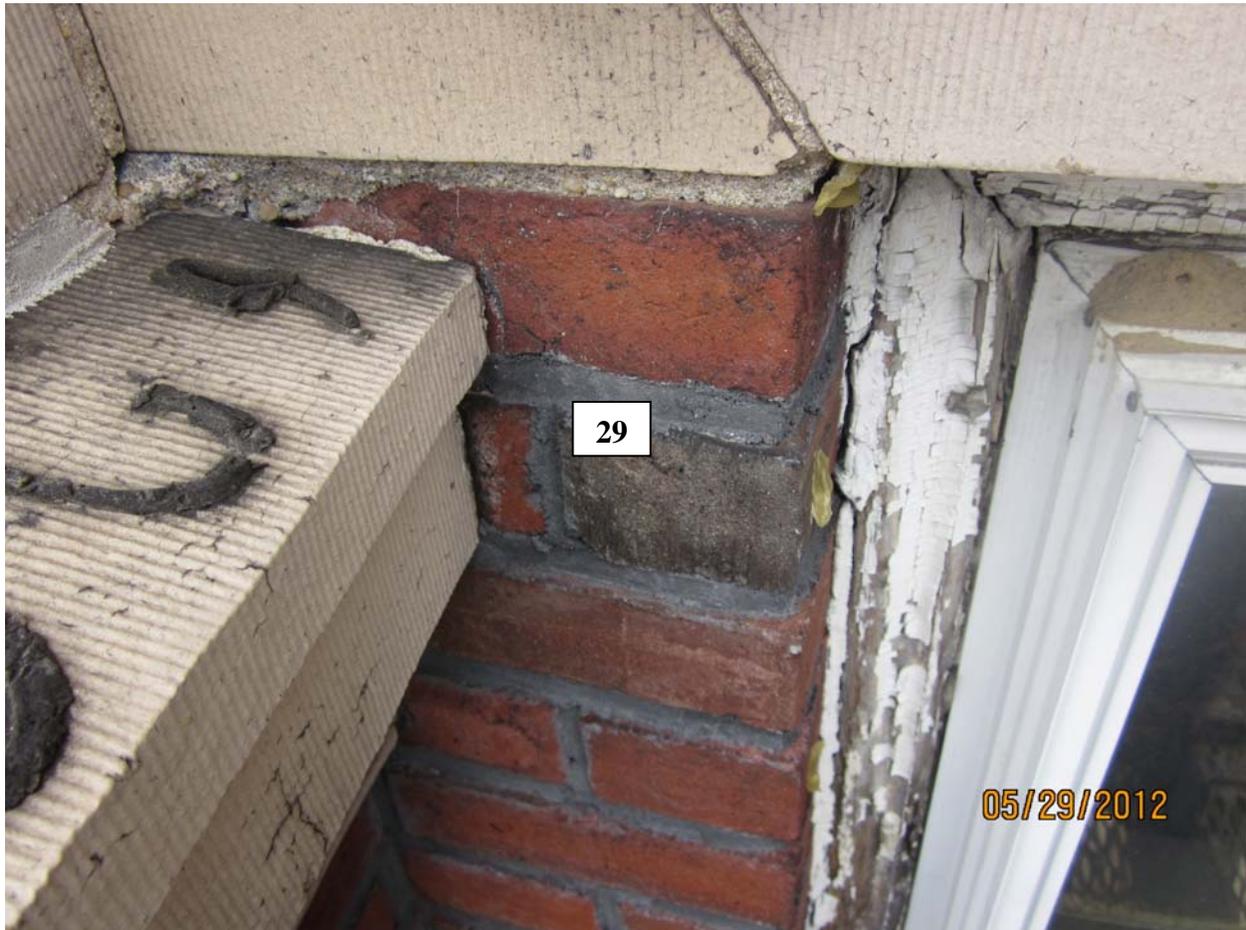
Photo 54

29. DISPLACED BRICK

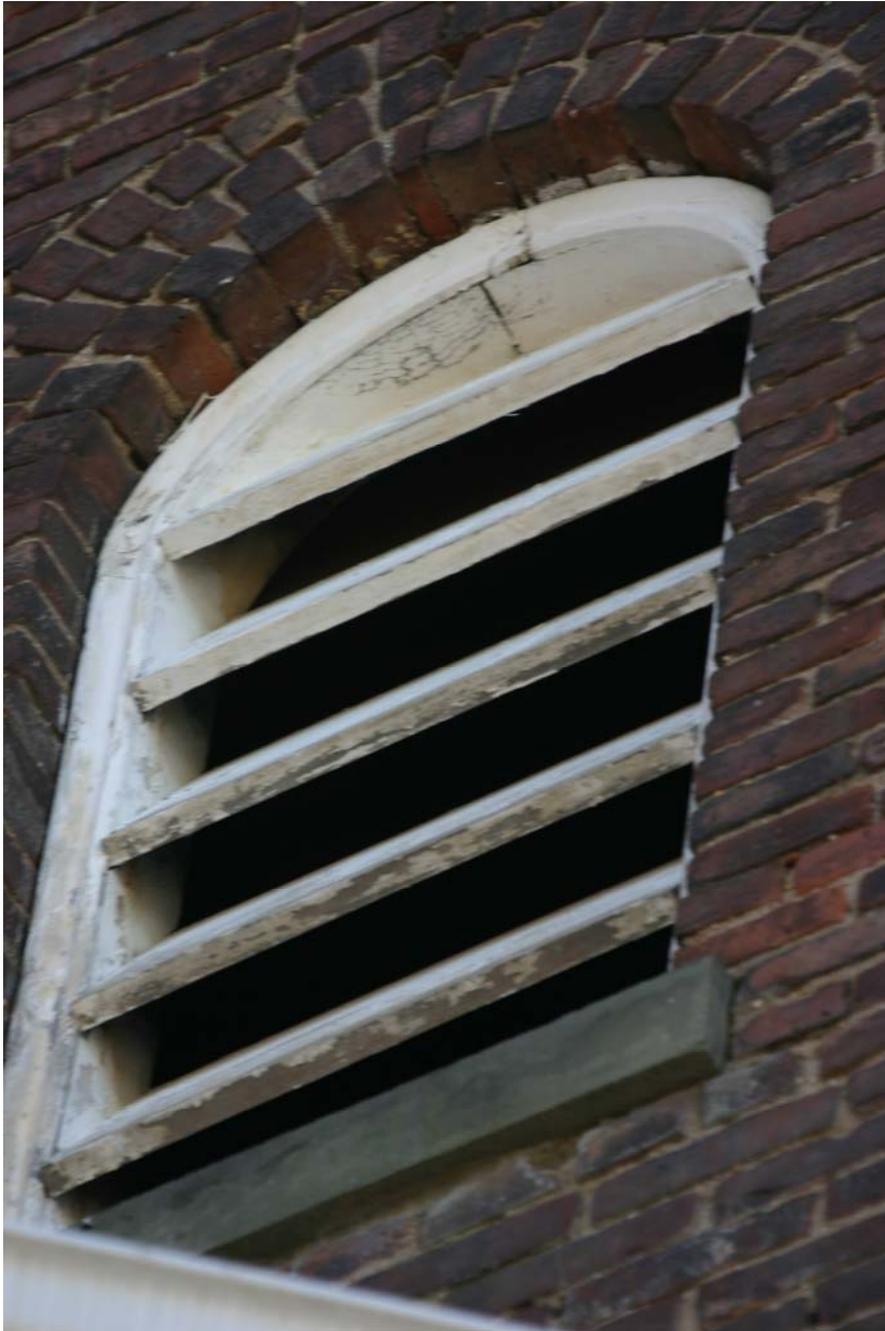
Photo 76

All exterior wood window components including the window casings/frames, sashes, window wells and jambs at all elevations and all levels of the building are classified as containing LBP. The basement door, door casing and frame at the East elevation were also found to contain lead based paint (Refer to reference Photo 76).

34. EXISTING WOOD DOOR AND TRIM PAINT CONTAINS LBP

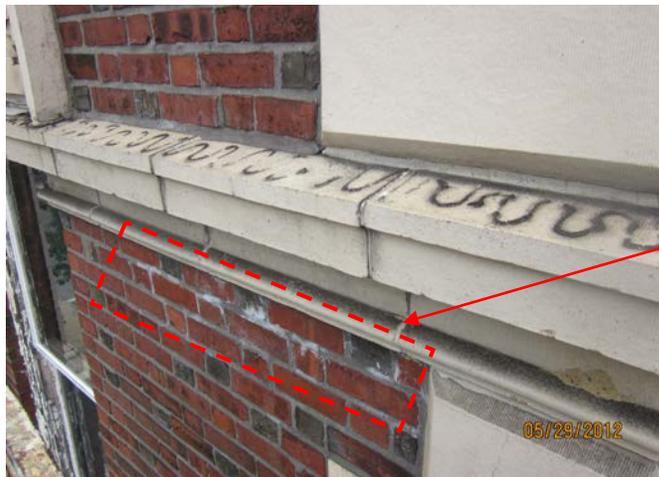
**Photo 5:**

- Ref Brick Observation #4
- South-east facade
- Efflorescence observed at corner.

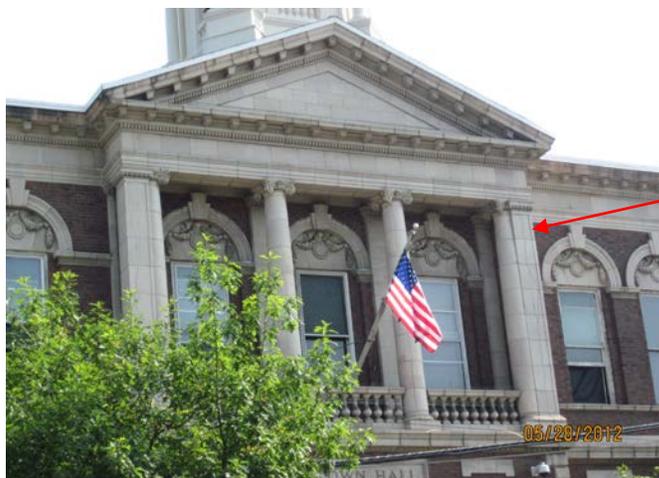
**Photo 6:**

6. A brick-masonry probe was performed on the building. One brick was removed and confirmed that the exterior wall is a true Flemish Bond with real headers. No residual moisture was observed behind the first wythe. (Refer to photo #6)

- Ref Brick Observation #6
- Brick-Masonry Prob at west facade

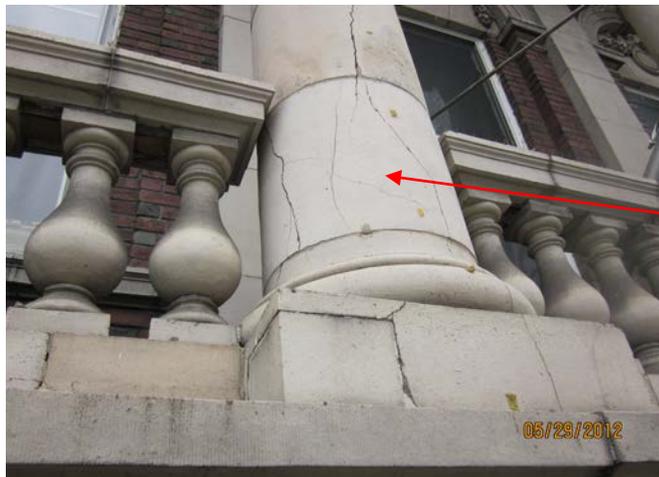
**Photo 7:**

- Ref Terra Cotta Observation #2
- South façade column cracks

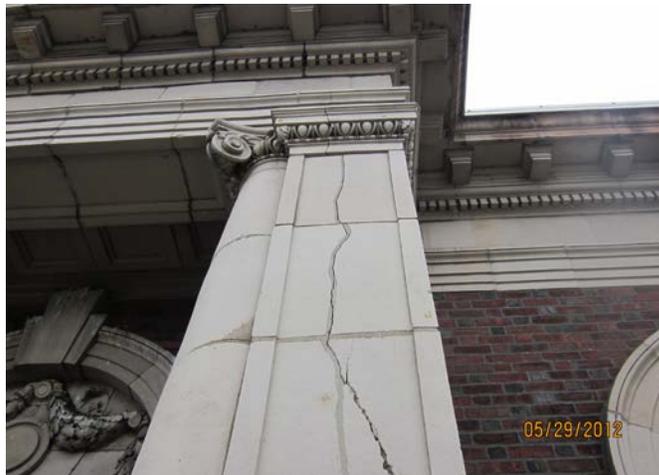
Photo 8:

- Ref Terra Cotta Observation #2
- South façade column cracks
- Second column from the west
- Loose section of terra cotta unit

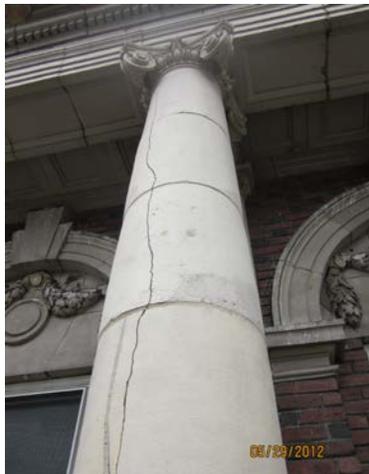
Photo 9:

- Ref Terra Cotta Observation #2
- South façade column cracks
- Eastern Pilaster
- Crack had been previously repaired with mortar, but has since opened

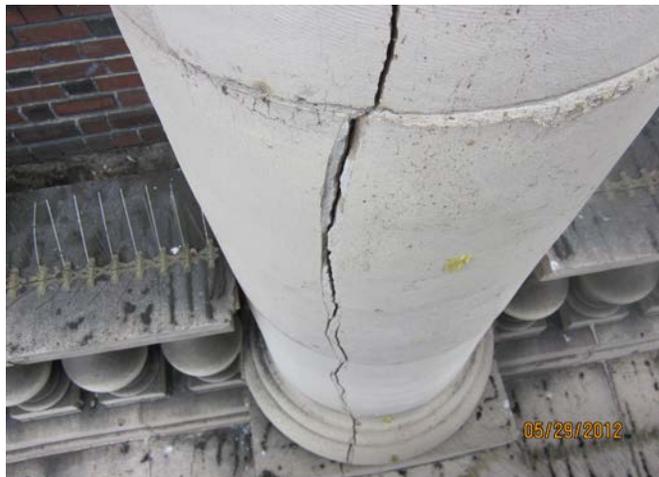
Photo 10:

- Ref Terra Cotta Observation #2
- South façade column cracks
- Second column from east

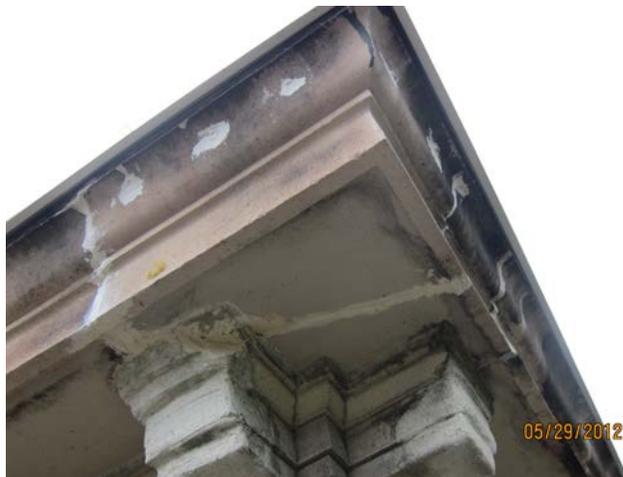
Photo 11:

3. Terra cotta units, which had previously been patched, were checked and found to be in fair condition. However, an allowance for isolated patching is recommended. (Refer to photo #12)
4. Terra cotta mortar joints appeared to be in fair condition, except in the portico, which was previously mentioned to have experienced severe cracking.

- Ref Terra Cotta Observation #2
- South façade column cracks
- Second column from east

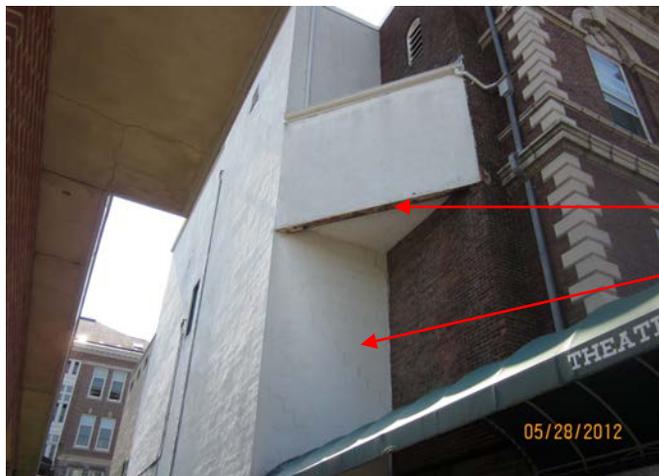
Photo 12:

1. There are a number of step cracks noted at the CMU blocks in the north-west corner. These cracks go through the existing masonry coating into the CMU. (Refer to photos # 13,14)
2. The steel beam on in the center of the north-west extension façade is exposed and deteriorating. (Refer to photo #13)
3. The sealant at the control joints between substrates is in poor condition or is absent, in some locations. Daylight was visible from the interior, where sealant was found to be missing. (Refer to photo #15)

- Ref Terra Cotta Observation #3
- South-east corner
- Previously repaired terra cotta

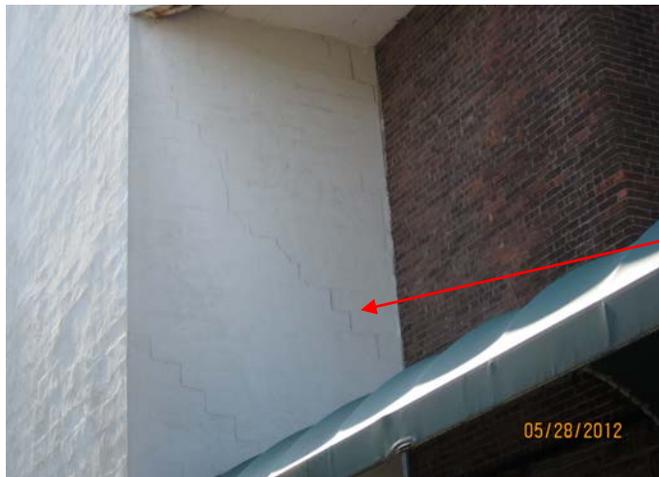
Photo 13:

- Ref CMU Observation #1&2
- North-east corner
- Corroded beam
- CMU step cracks

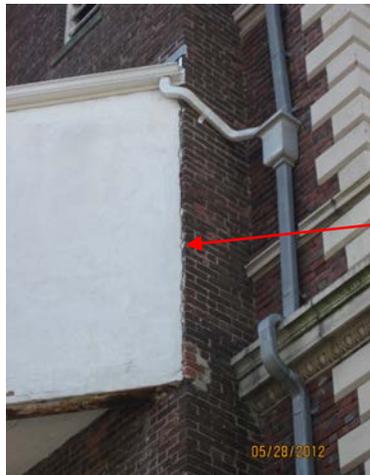
**Photo 14:**

- Ref CMU Observation #1
- North-east corner
- CMU step cracks

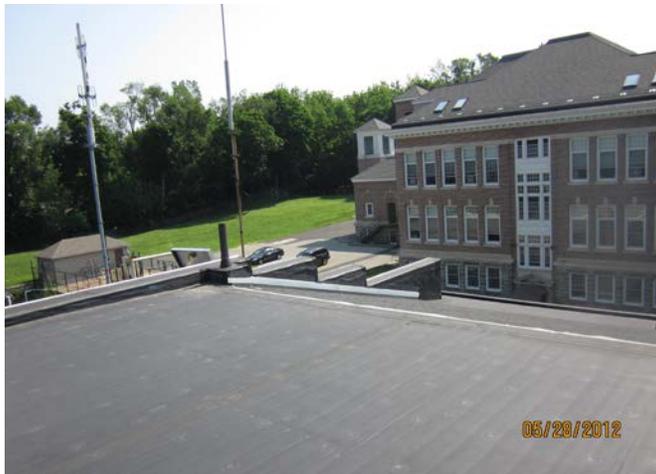
**Photo 15:**

1. The main roof was recently replaced with a black EPDM mechanically fastened system over insulation board by Carlisle. The roof in this area was found to be in acceptable condition and does not need further maintenance. (Refer to photos #16,17)
2. The roof drains appear to be clear, with no deficiencies observed.

- Ref CMU Observation #3
- North-east corner
- Damaged sealant at control joint

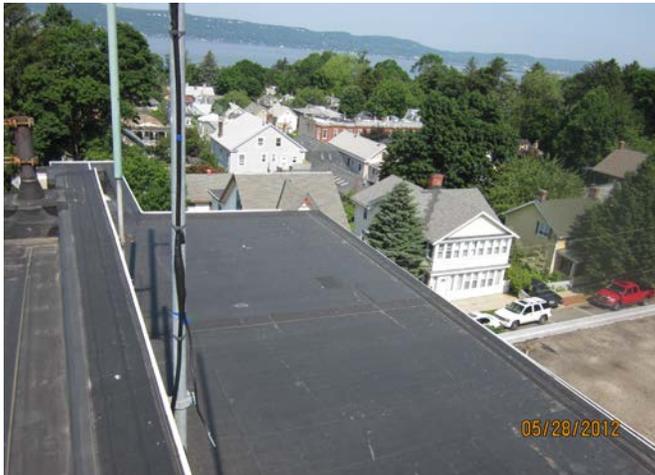
**Photo 16:**

- Ref Roof Observation #1
- Main Roof

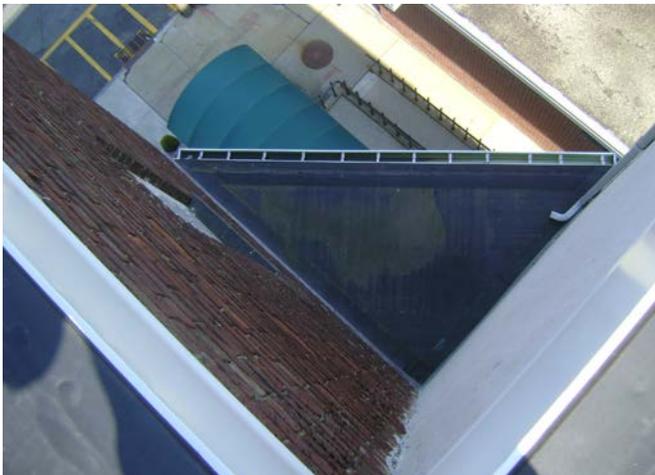
Photo 17:

1. The lower extension roof, at the north-west corner was also recently replaced with a black EPDM mechanically fastened system over insulation board by Carlisle. The roof in this area was found to be in acceptable condition and does not need further maintenance. (Refer to photo #18)
2. The roof drains, scuppers, and downspouts appear to be clear, with no deficiencies observed.

- Ref Roof Observation #1
- Main Roof

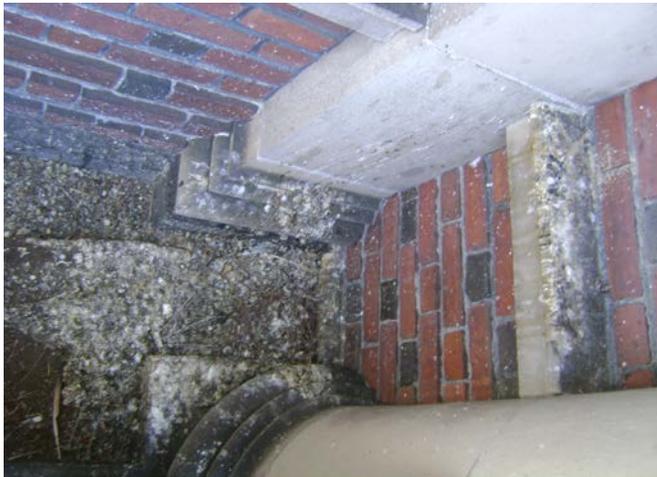
Photo 19:

1. The roof over the portico, at the south façade, appears to be a modified bitumen membrane and is in poor condition. Various debris and pigeon guano are clogging the through wall scuppers drains. Trapped moisture is contributing to both roof deterioration and leaks in the closet below. (Refer to photos #19,20,21)

- Ref South Balcony Roof Observation #1
- Deteriorations and Guano

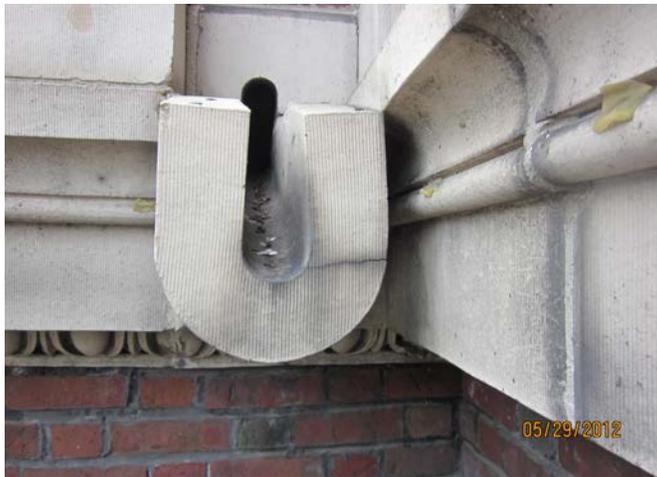
Photo 20:

- Ref South Balcony Roof Observation #1
- Deteriorations and Guano

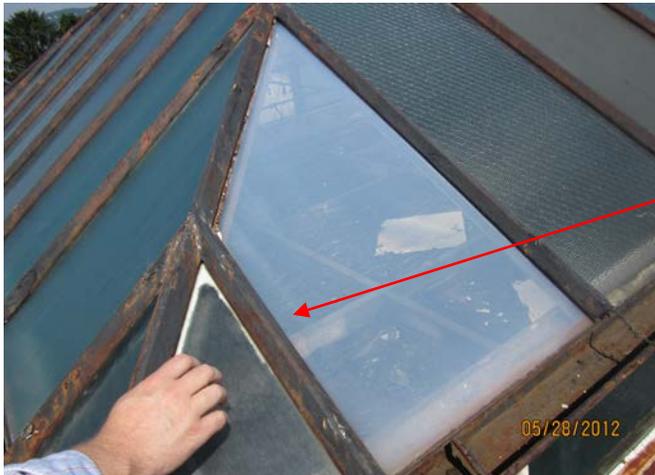
Photo 22:

1. The roof-skylight is in fair condition and retains much of its original material. The paint around the metal mullions is cracking and the condition of the glass is poor in some areas. (Refer to photos #22,23)

- Ref Roof Skylight Observation #1

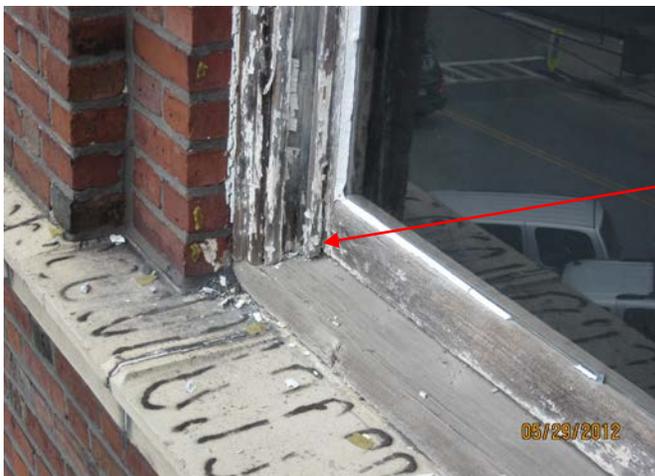
**Photo 24:**

1. The windows appear to be in fair condition. The original oak sash had previously been retrofitted with bronze weather stripping. In addition, the paint around the sash is cracking and has deteriorated. (Refer to photos #24,25)

- Ref Window Observation #1
